Report A-026/2014

Accident involving an AGUSTA AW 119,
registration EC-KSD,
operated by the company FAASA,
in the municipality of Alpera
(Albacate, Spain) on 13 September 2014

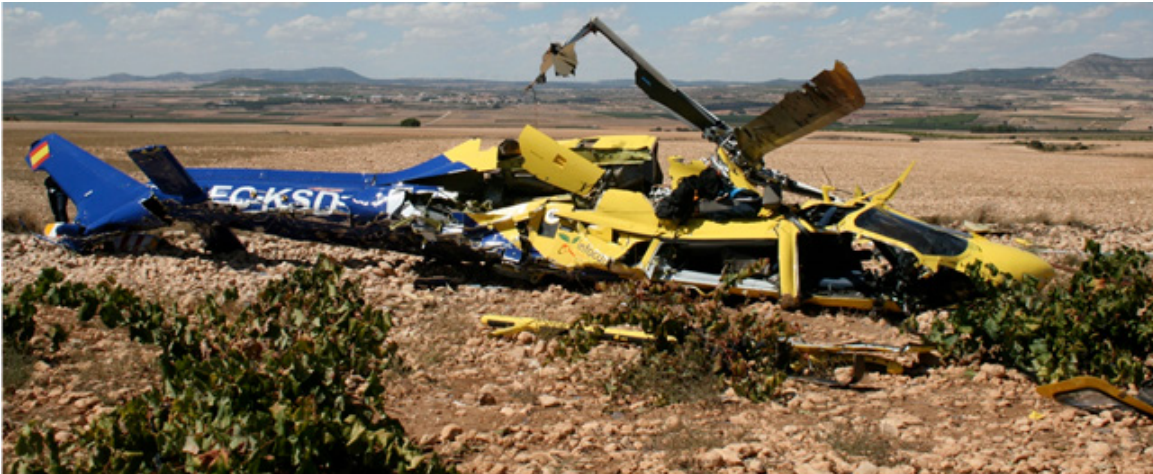
Figure 2. Final condition of the aircraft

The helicopter was found at coordinates 38° 56' 17" N – 1° 10' 15" W, with the fuselage pointing toward 025°. It was in a horizontal position. It showed signs of a strong vertical impact. The fuselage was flattened to a third of its height. The main rotor and the gearbox were leaning forward.

The damage exhibited by the main rotor blades was consistent with an impact at a very low rotational speed, and thus the damage was due exclusively to the vertical impact. The side edge was gone on one of the blades, but no impact marks were found on any of the leading edges of the blades. One was broken in half along the trailing edge and one of the parts had fallen vertically. All of the blades exhibited very light superficial scratches and stripes along their lower surface.

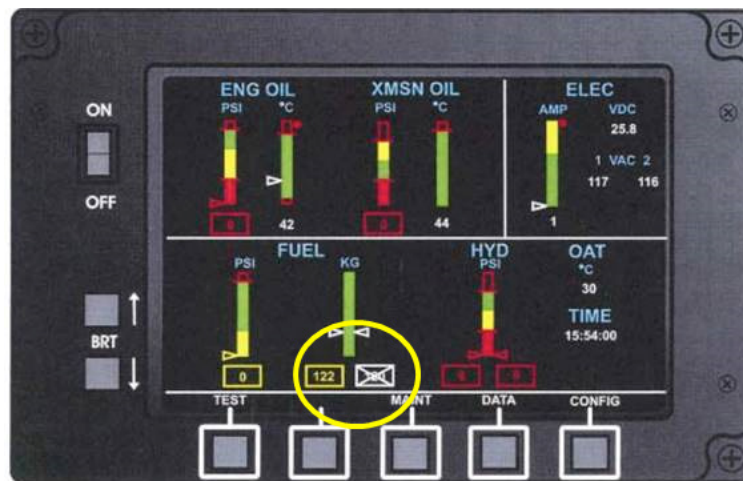
Figure 5. EDU 2 displaying the XFER PUMP warning

If the fuel transfer pump is disconnected or fails, and the amount of fuel in the right tank is below 120 kg, the fuel level reading in the cockpit for the right tank will be crossed out to indicate that the fuel remaining in the tank is not usable. This is shown in the lower display, EDU 2 (see Figure 5).

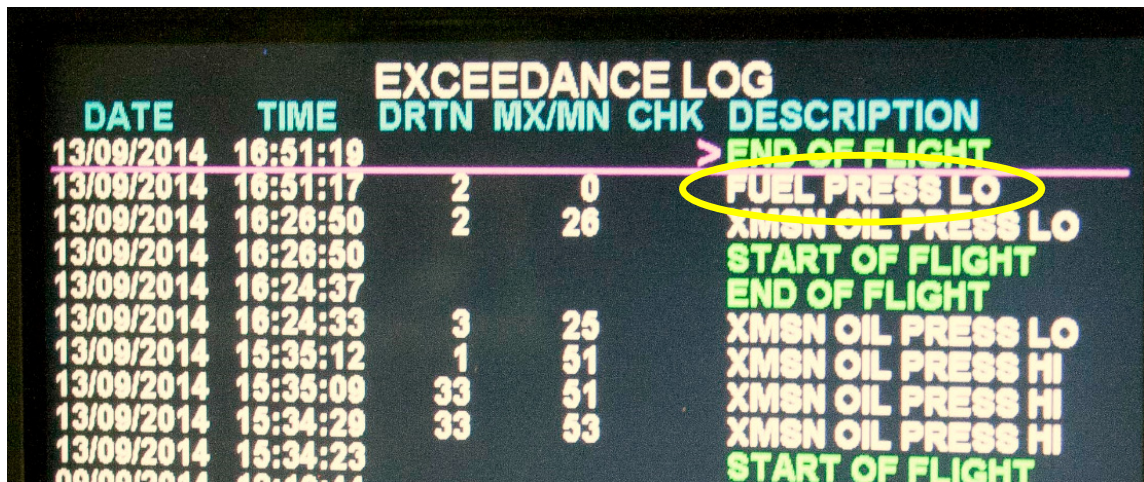
Figure 10. EDU 1 display reproduced on a workbench

The two displays installed in the cockpit showed the engine parameters (EDU) and recorded some readings from the accident flight. When the memory card was installed on a similar EDU, it revealed a low fuel pressure warning at 16:51:17⁶, which was the only evidence detected pertaining to the fuel.

DATE	TIME	DRTN	MX/MN	CHK	DESCRIPTION
13/09/2014	16:51:19				END OF FLIGHT
13/09/2014	16:51:17	2	0		FUEL PRESS LO
13/09/2014	16:26:50	2	26		XMSN OIL PRESS LO
13/09/2014	16:26:50				START OF FLIGHT
13/09/2014	16:24:37				END OF FLIGHT
13/09/2014	16:24:33	3	25		XMSN OIL PRESS LO
13/09/2014	15:35:12	1	51		XMSN OIL PRESS HI
13/09/2014	15:35:09	33	51		XMSN OIL PRESS HI
13/09/2014	15:34:29	33	53		XMSN OIL PRESS HI
13/09/2014	15:34:23				START OF FLIGHT

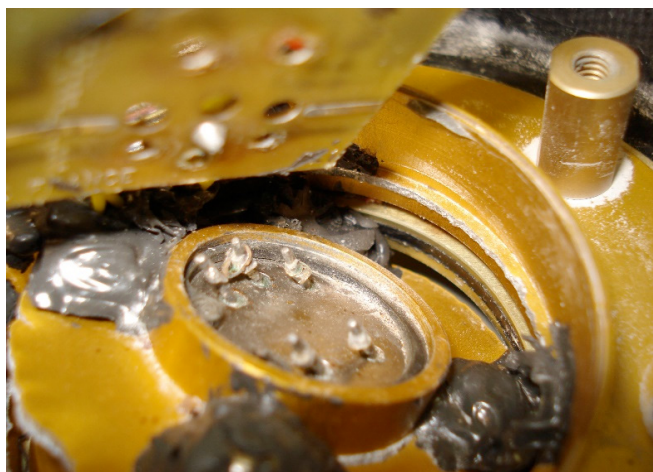
Figure 11. Parts of LLS probe

The probe has an induction sensor, which was divided into two parts for analysis. One contained the float and the coil, and the other the oscillating circuit and its associated components. These two parts are joined by tin soldered pins.

The float system was broken (probably by the impact), but it was still able to move, and thus it was operating correctly.

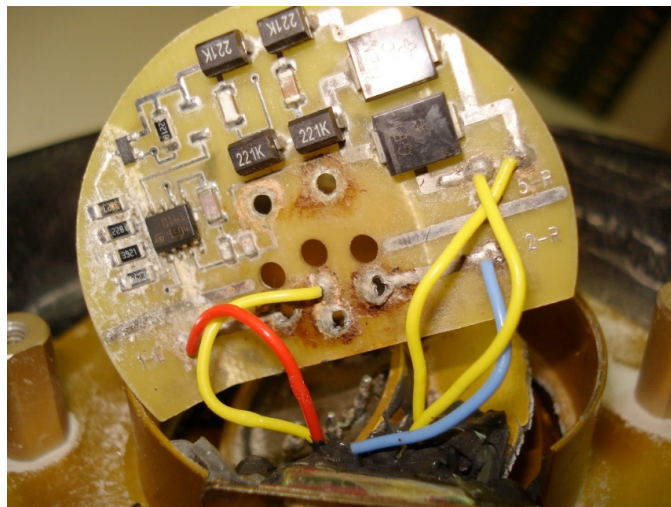
Figure 12. LLS probe plate

The analysis showed that the pin welds on the sensor board exhibited clear signs of having been welded atop previous welds.

The printed circuit board also revealed that the contacts from several components had detached. In the opinion of the laboratory personnel who conducted the test, this could have been due to soft welds, which could have caused intermittent faults.

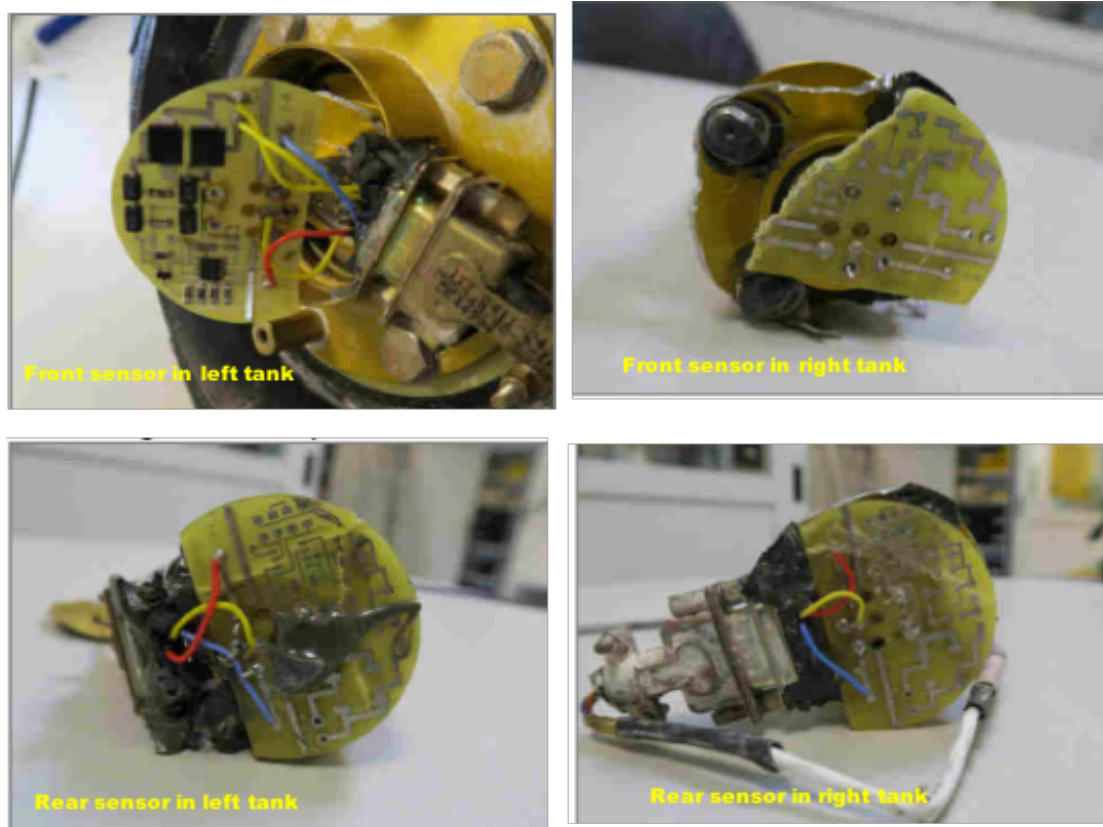
Figure 15. Condition of the sensor circuit boards

The components in the left tank front sensor did not show any signs that a functional failure could have occurred prior to the impact, since the welds on the PCB and the SMD were in good condition, as were the contact elements between the PCB and the IP. This indicates that both the fuel level and low fuel level sensors (LLS) were in condition to send a good signal to the DB9 connector prior to the impact. There were indications, however, of what seemed to have been a repair made to the PCB.
