Report A-027/2015

Accident involving a Piper PA-28-181
aircraft, registration D-ELMN,
in the municipality of Toses (Girona)
on 8 September 2015

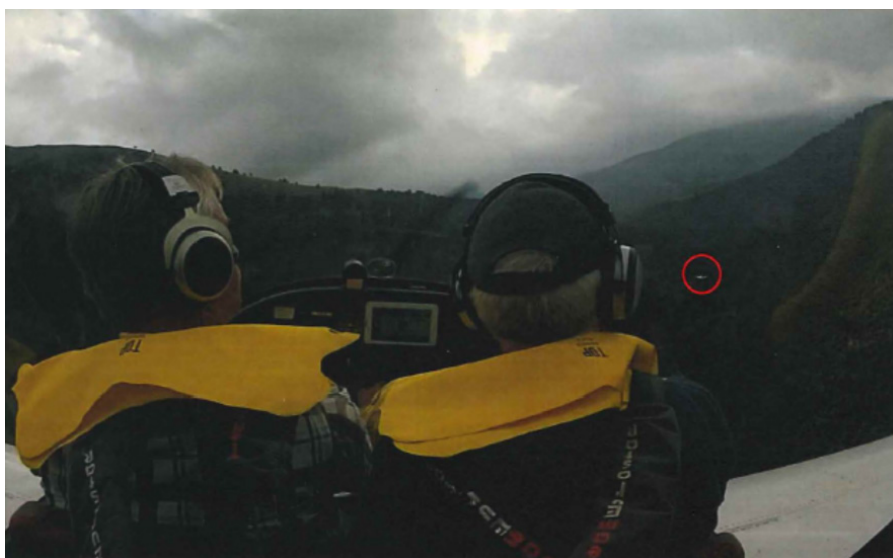
Fig. 1. Aircraft D-ELMN, inside the red circle, recorded by the camera

Images were recovered from a camera installed on the second aircraft (D-MFSB) that showed the final moments of the accident aircraft's flight.

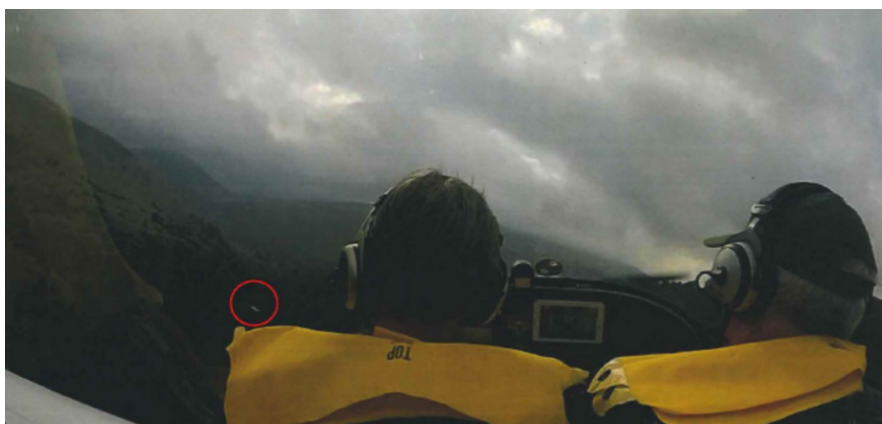
These images show how the aircraft, which was flying very close to the ground in a valley, started a turn to the left, a few seconds after which it directly impacted some trees located on the left slope of the valley. The impact was followed by an explosion and a fire.

Fig. 2. Aircraft D-ELMN, inside red circle, prior to the impact

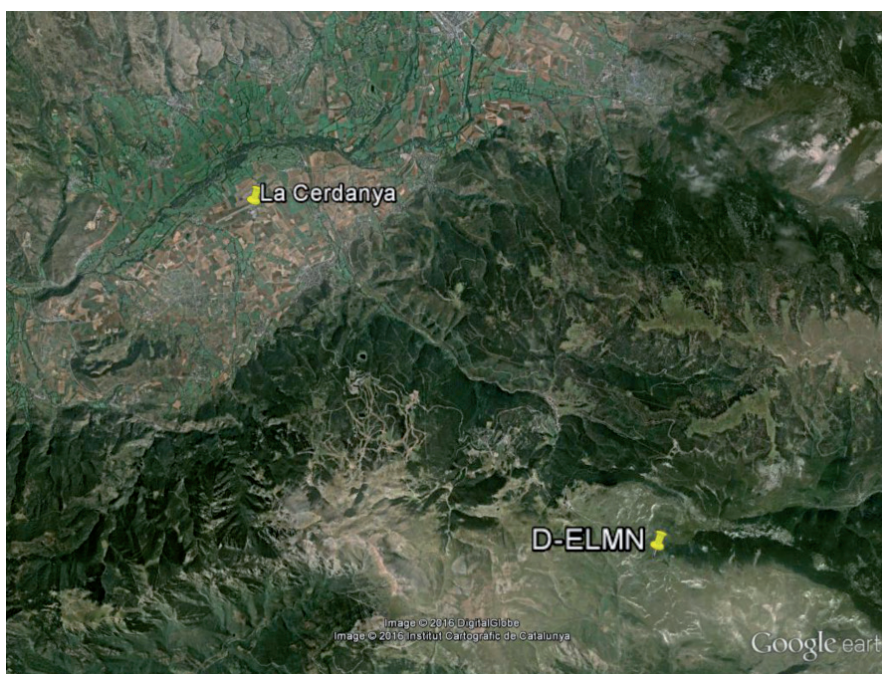
Fig. 3. La Cerdanya aerodrome and accident site

The accident occurred in the municipality of Toses, which is approximately 13 km away from the La Cerdanya aerodrome.

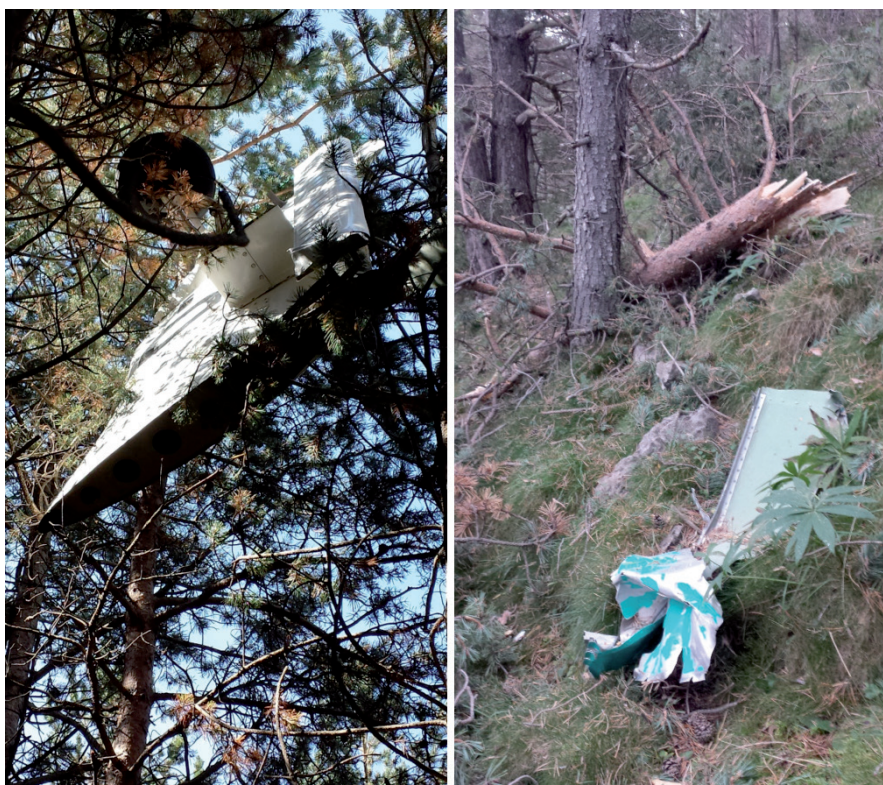
The aircraft first impacted a pine tree, severing much of its upper section, which fell to the ground alongside the base of the tree. As a result of the impact, the aircraft lost its left wing, which was found hanging from the lower branches of the same pine tree.

Fig. 4. Left half wing (L) and debris from the pine tree and aileron (R)

The aircraft was making a turn to the left at the time of the initial impact. The turn caused the left wing to be lower than the right, resulting in the left wing striking the pine tree, detaching from the fuselage and remaining tangled in the branches. The rest of the aircraft continued on a downward left turn, striking the branches of other nearby pine trees and turning over on its longitudinal axis, impacting the ground in an inverted position. Still upside down, it continued sliding downhill before coming to a stop in a small clearing, where it began to burn. The fire spread quickly, possibly fed by the fuel still inside the aircraft.

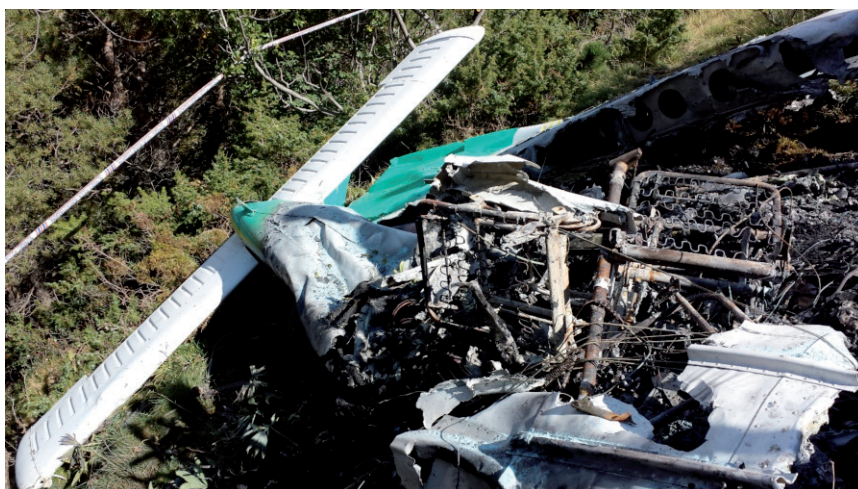
After losing its left wing, the aircraft continued turning about its longitudinal axis, falling to the ground in an inverted position. As it fell, it broke branches off other pine trees. Once on the ground it slid downhill before coming to a stop, at which point a fire broke out that consumed the entirety of the cabin.

The fuselage was almost entirely burned by the fire, which also reached the root of the right wing and the area of the fuel tank. The empennage was not affected by the fire.

The engine and propeller remained attached to the aircraft and were affected by the fire. There were no signs of a failure or fracture prior to the accident.

Fig. 5. Aircraft wreckage

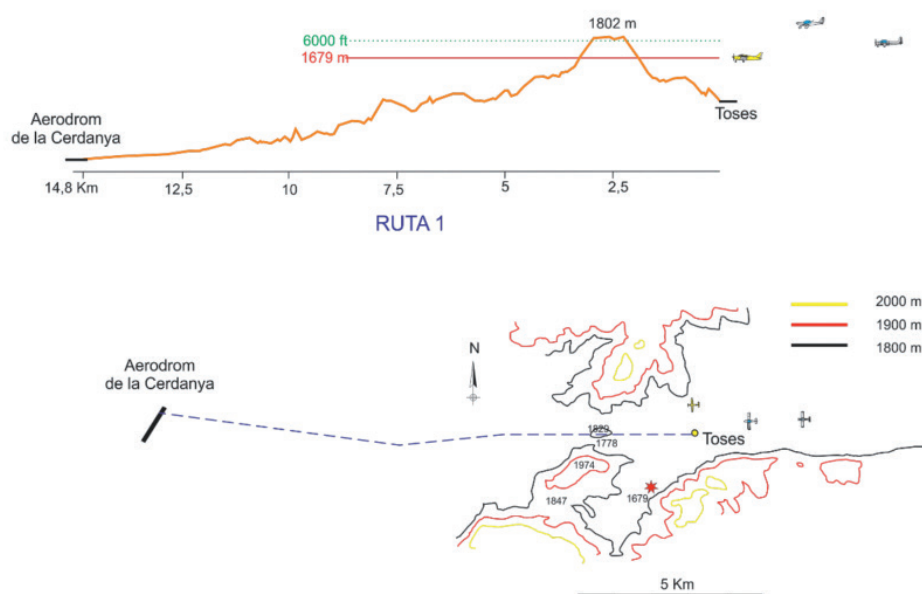
The natural exit out of the valley is at an approximate elevation of 1800 meters. It is possible that, upon reaching the vicinity of the exit, the pilot thought there was insufficient distance to climb and fly over the terrain with a suitable safety margin. Consideration must also be given to the fact that there was turbulence in the area, meaning he may have turned left in an effort to turn around.

All of this leads to the conclusion that the pilot's preparation in terms of the safety altitudes above the ground was deficient. Had the pre-planning been correct, the pilot may have been aware of the elevation at the outlet of the valley and maintained an altitude that would have allowed him to pass through this area with a margin of safety, even in the presence of turbulence.

Fig. 6. Aircraft's flight path
