DATA SUMMARY

Date and time	Wednesday, 3 may 2000; 10:30 hours
Site	Airport of Valencia (Valencia)

Registration	EC-HIA
Type and model	AEROSPATIALE SN 601 CORVETTE

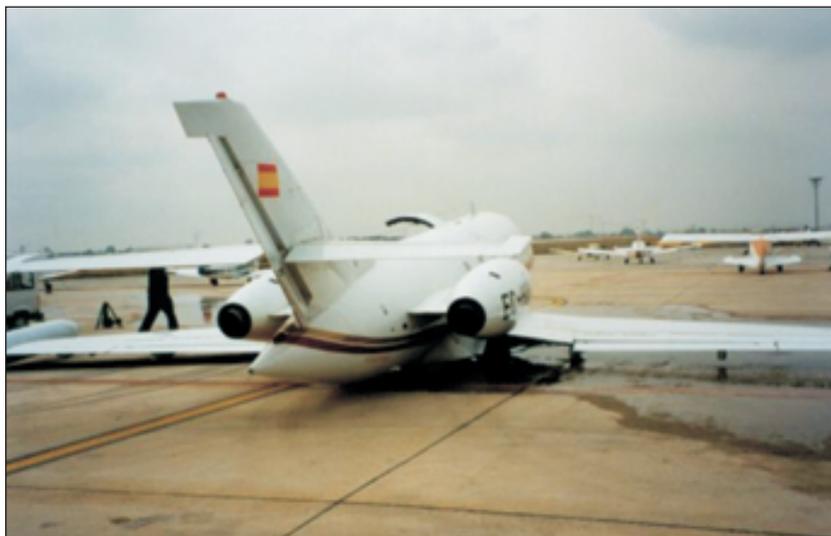
Both main landing gear legs folded up, and the aircraft hit the ground with the rear part of the fuselage and then with both wings.

Photo 1. General view of the aircraft

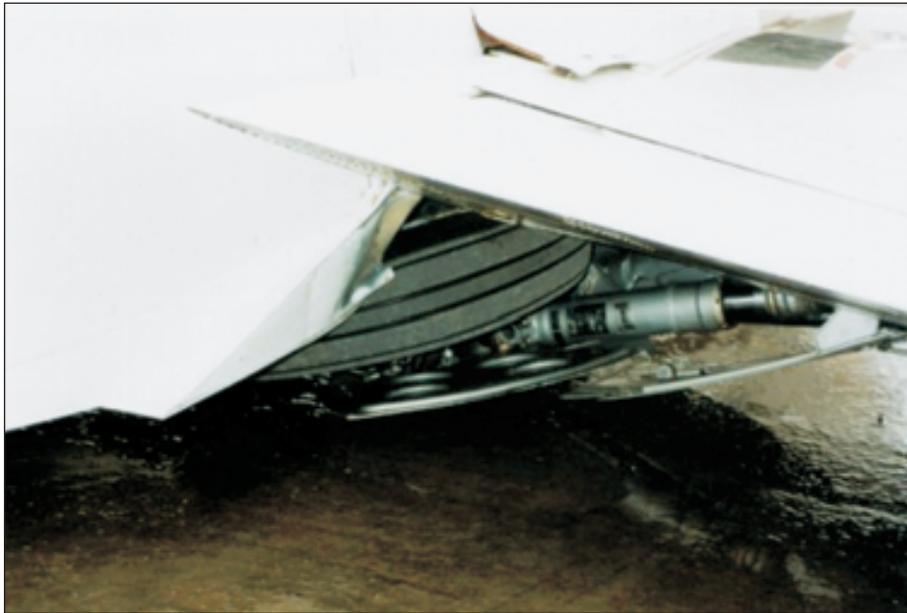
As a result of the impact, the aircraft suffered damage to the wing tips, flaps area (especially in the RH wing), wing-fuselage fairings, landing gear doors and landing gear well.

Photo 2. Detail of the RH landing gear

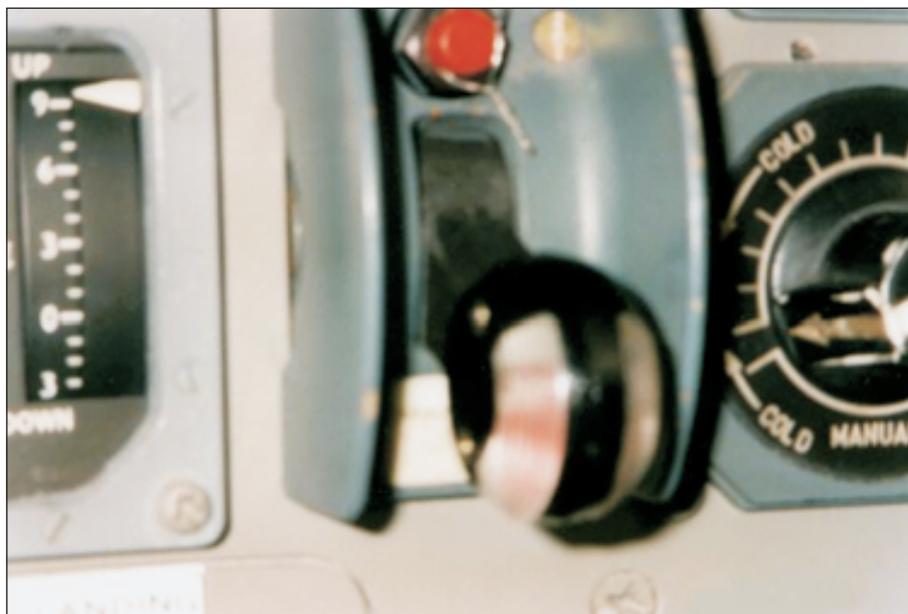
Nevertheless, this system has also an inhibiting mechanism, in a manner such that, when it is activated, the gear may be retracted even while the shock absorbers are compressed. Such a mechanism is activated through a red push button (crash button) which is located besides the landing gear lever, in the same panel in the cockpit. When the button is pushed, it is possible to move the lever to the «gear up» position. This button is

Photo 3. Landing gear lever and «crash button»

It was noted that the button had previously been pushed, but the break wire was deformed instead of breaking, in a manner such that left the button in the «pushed» position, which in turn allowed the lever to be moved to the «gear up» position.

REC 25/04. It is recommended to the «Direction Générale de l'Aviation Civile» of France (DGAC-F) that requests EADS France (formerly Aerospatiale), as holder of the type design of the aircraft, to modify the Airplane Flight Manual of the SN-601 Corvette in order to include instructions to verify the position of the landing gear actuation device («crash button») as a part of the check to be carried out by the crew before the flight.

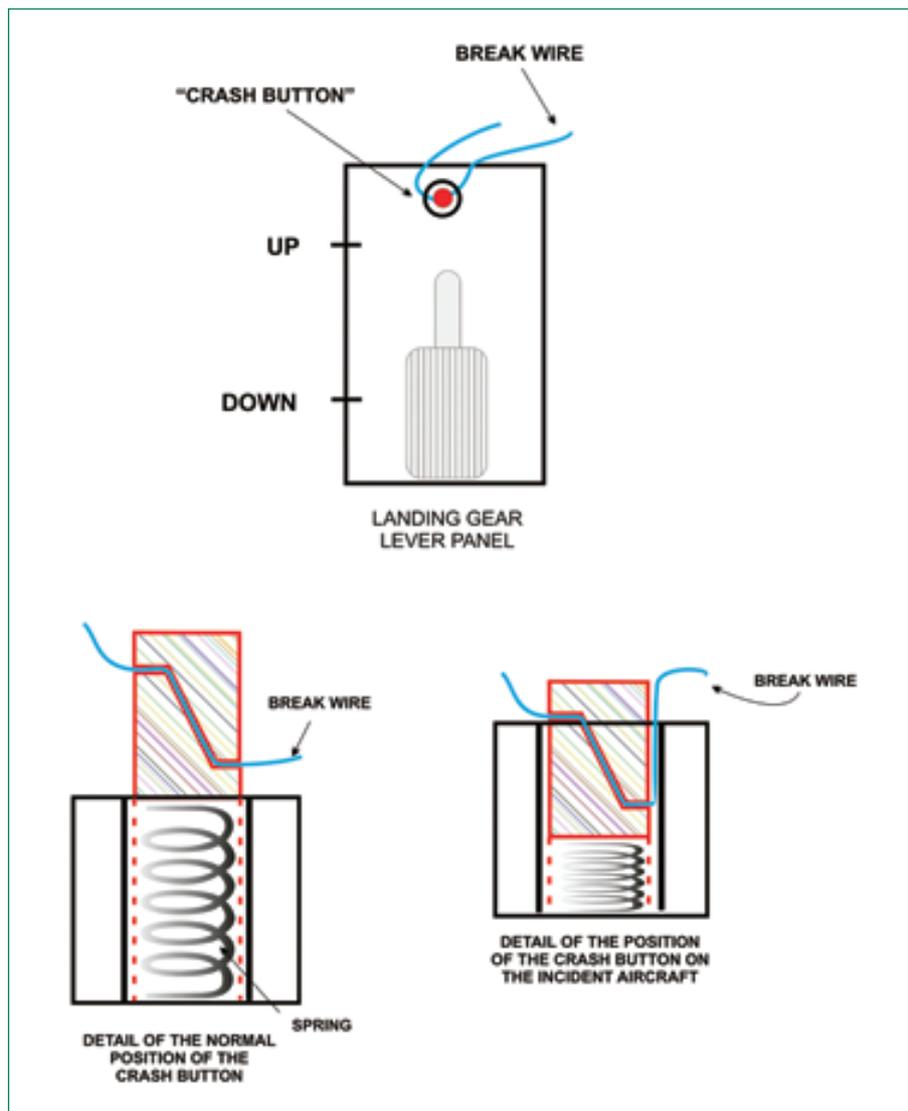
After the incident, it was noted that the break wire of the crash button had a diameter of 0.8 mm, being therefore lower than the specified one, and that the wire composition was also different from the required according to the Maintenance Manual.

Graph 1. Schematics of the crash button and associated break wire

As a consequence of the previous information, it is considered that this incident was caused by a defective maintenance of the aircraft, when a break wire of different dimensions and characteristics from those specified in the Maintenance Manual was installed in the landing gear retraction mechanism. It was not possible to trace this defective maintenance.
