TECHNICAL REPORT

A-030/2000

Accident to aircraft
SCHLEICHER ASW 22,
registration GB-499,
in Peñalara, San
Ildefonso (Segovia),
on 4 August 2000

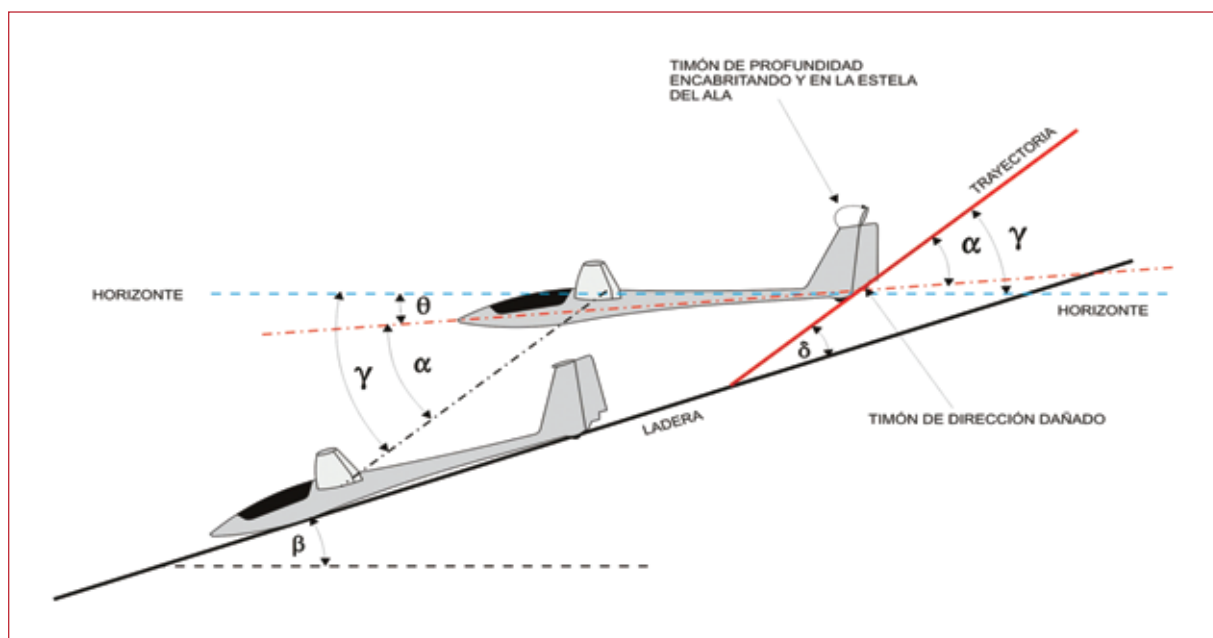
Figure 2. Diagram of final trajectory

The aircraft thus entered a downward trajectory with a greater angle to the horizontal than that of the slope of the hillside. The angle of attack of the wing, with the control stick of the elevator pulled all the way back, would remain stable and at a value close to that of the trajectory, reduced by the aircraft's pitch angle with respect to the horizontal plane (see Figure 2). It is believed that the incidence of the slipstream of the wing on the tail would contribute to maintaining the glider in stall.

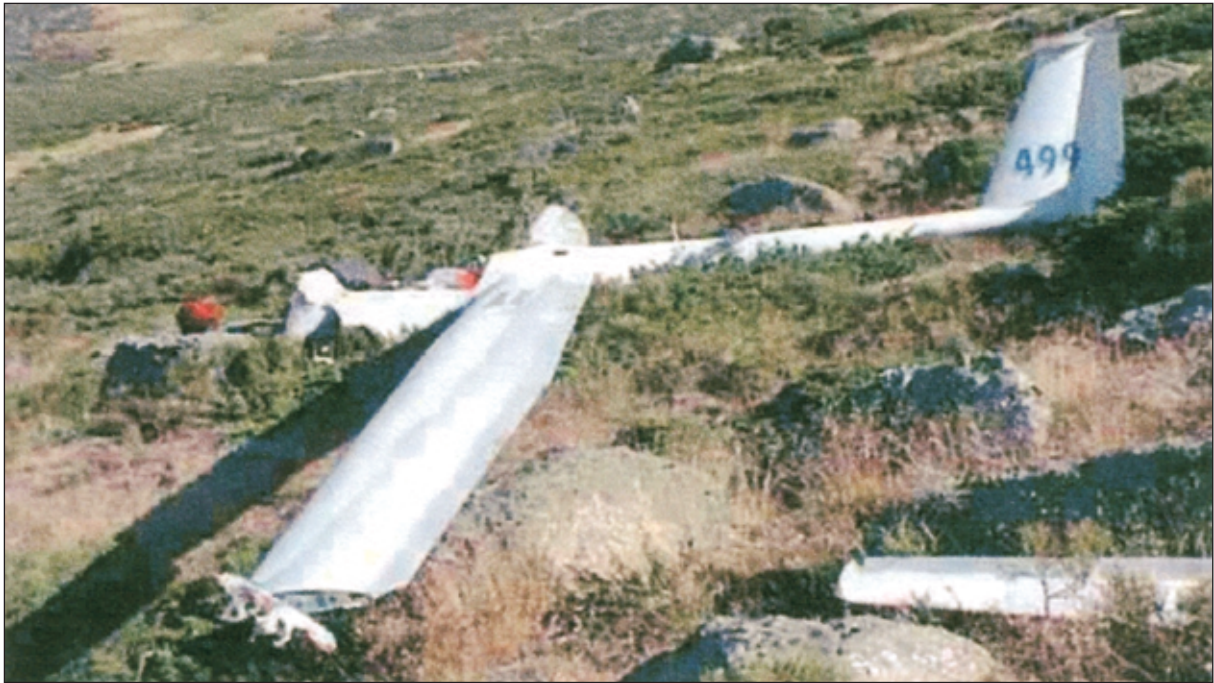
Photograph 1. *Final position of the aircraft*

The wings and the central and rear fuselage were joined together and showed slight damage, except for the left wingtip, which had broken off at its assembly joints and was resting two metres behind the rest of the wing (see Appendix B, Photograph 1).

The tail had suffered a blow in the lower corner of the rudder at an angle of approximately 30° (see Appendix B, Photograph 1). The tailplane was out of alignment, leaning slightly to the right.

In its downward flight, the glider's first contact with the ground may have been with the tail. The scraping of the rudder against a rock or the scrub would indicate the direction of the trajectory in the damage displayed by this control surface, perhaps also influenced by a pitching movement. The angle of cut would approximately indicate the aircraft's angle of attack.

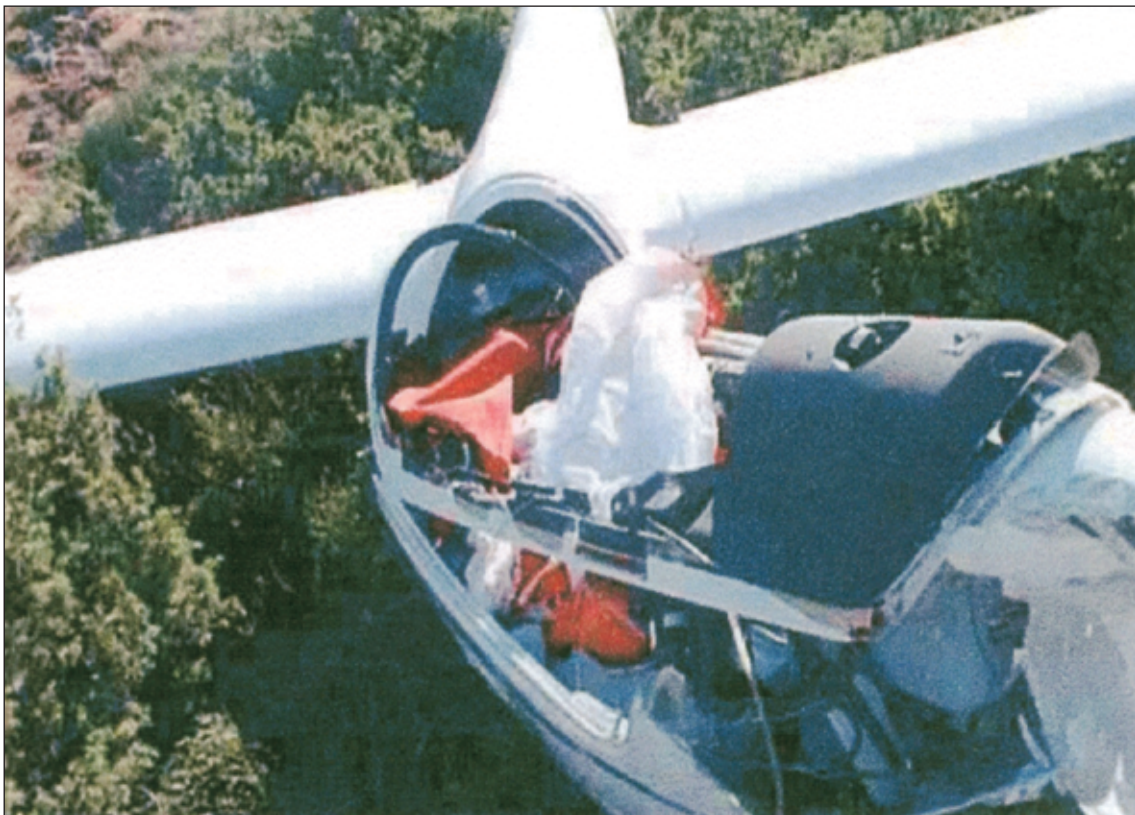
Photograph 2. *Wreckage of the cockpit*

The front fuselage, which includes the cockpit, was split and displaced to the left (see Appendix B, Photograph 2), with the keel broken. The instrument panel was displaced, and intact, although the logger had been separated from its anchorages. The forward part of the fuselage, touching a granite rock a metre in height, had split and opened like a pointed arch half a metre in length.

The main impact was a violent collision with the underside of the front fuselage. The keel of the fuselage broke and the pilot received the impact directly in the hip; the undercarriage, not being deployed, did not cushion the impact.

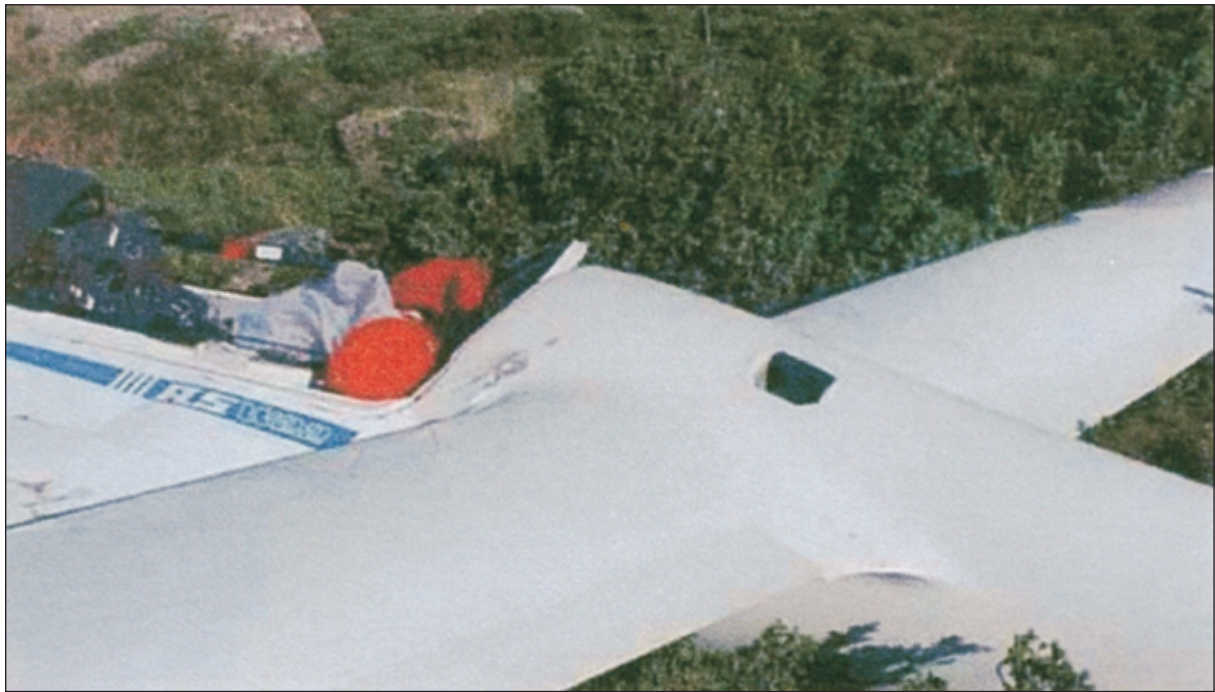
Photograph 3. *Wing-fuselage joint zone. Position of flaps*

The main landing wheel was retracted, as were the aerodynamic brakes. The flaps were in a slightly negative position (see Appendix B, Photograph 3) and there was no ballast in the wings.
