## Technical report A-032/2001

Accident to aircraft  
Beechcraft B300C, registration  
F-GOAE, near Santiago  
Airport on 7 June 2001

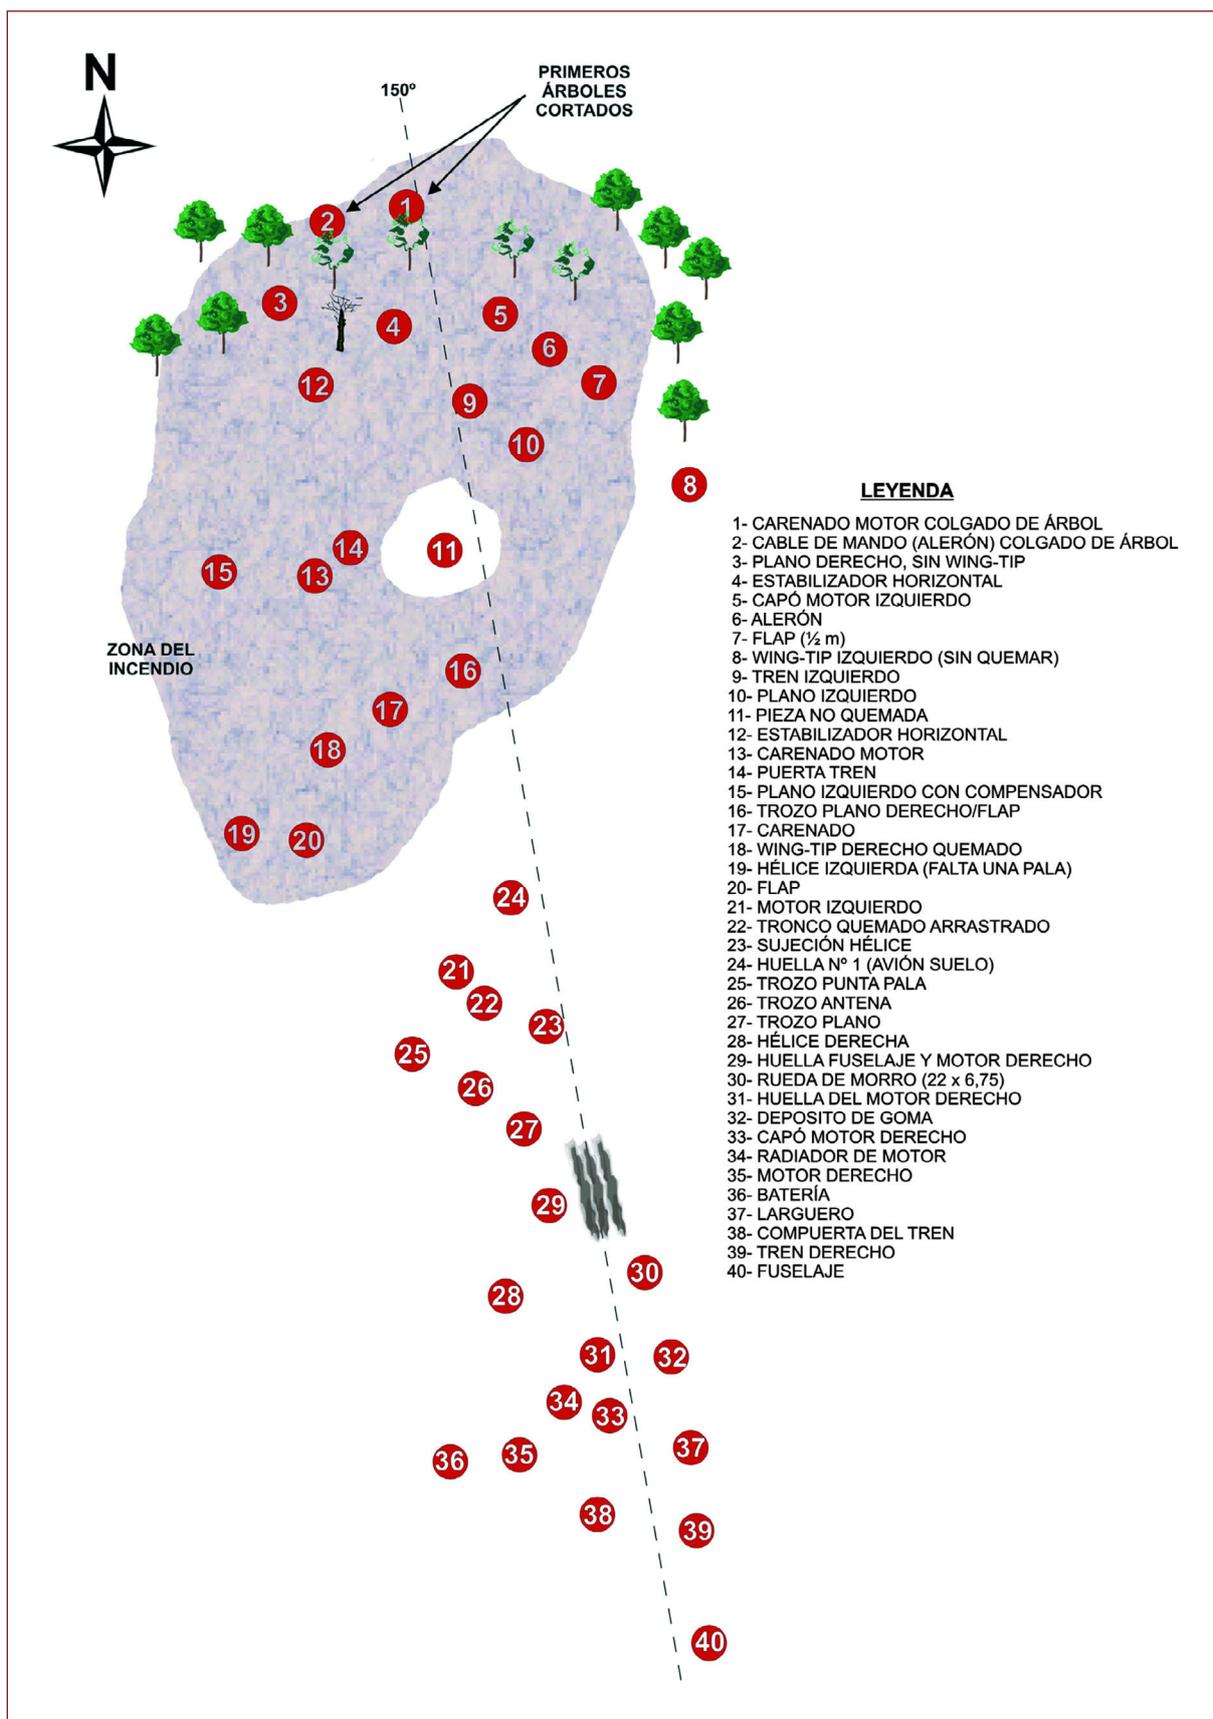
### **Wreckage distribution**

The aircraft wreckage was symmetrically distributed with respect to the trajectory held by the main fuselage after the impact, which was the one it had previously. Firstly and on the burnt area with a length of 50 meters approximately, there were parts of the left wing, the left landing gear and left propeller. In that area parts of the right wing were also found.

Following the trajectory of the aircraft, the right engine was found and beyond, the right landing gear. The right propeller was far apart from the trajectory held by the aircraft and turned aside to the right with deformations which indicated that it had power.

Some 140 meters from the first impact was the aircraft's fuselage, positioned perpendicular to the trajectory it had held, and leaned on the left side. The vertical stabilizer and rudder remained attached to the fuselage and showed no signs of being damaged, but the rudder was stuck.

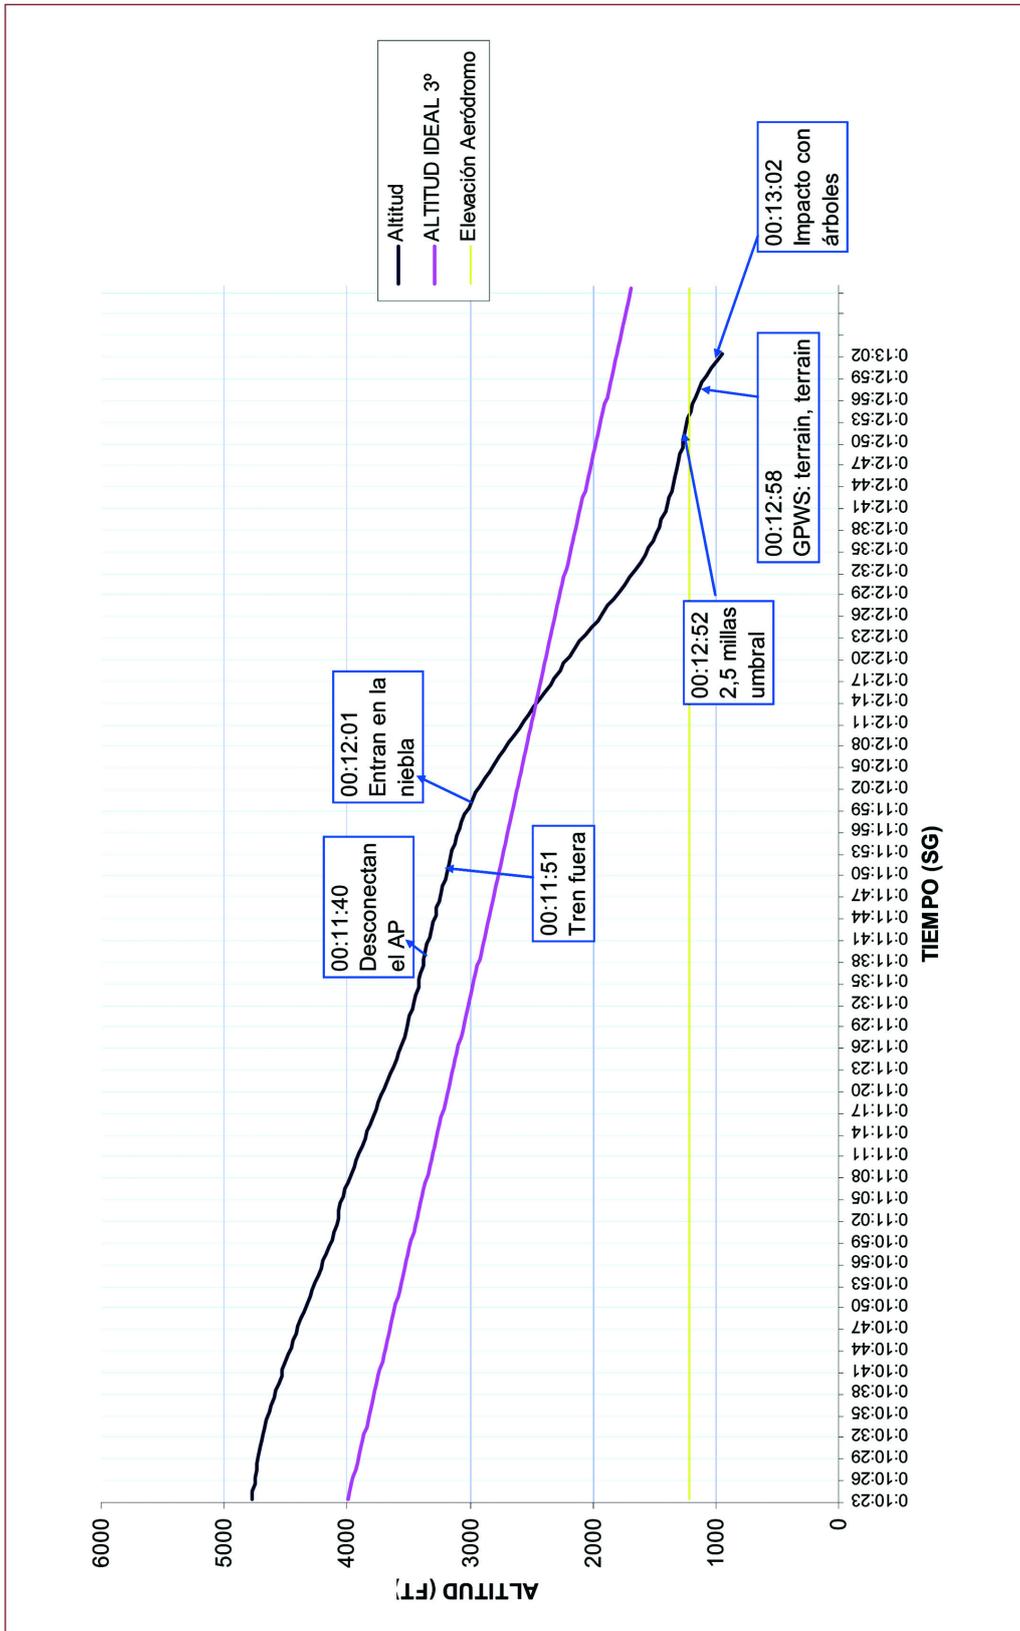
Graph 1. Actual versus nominal glide slope

At 00:12:52 the copilot reported that they were 2.5 DME. At this time the aircraft had an altitude of 1,242 ft (800 ft below the defined glide path for the ILS approach for runway 17) and with 1,300 ft/min descent rate.

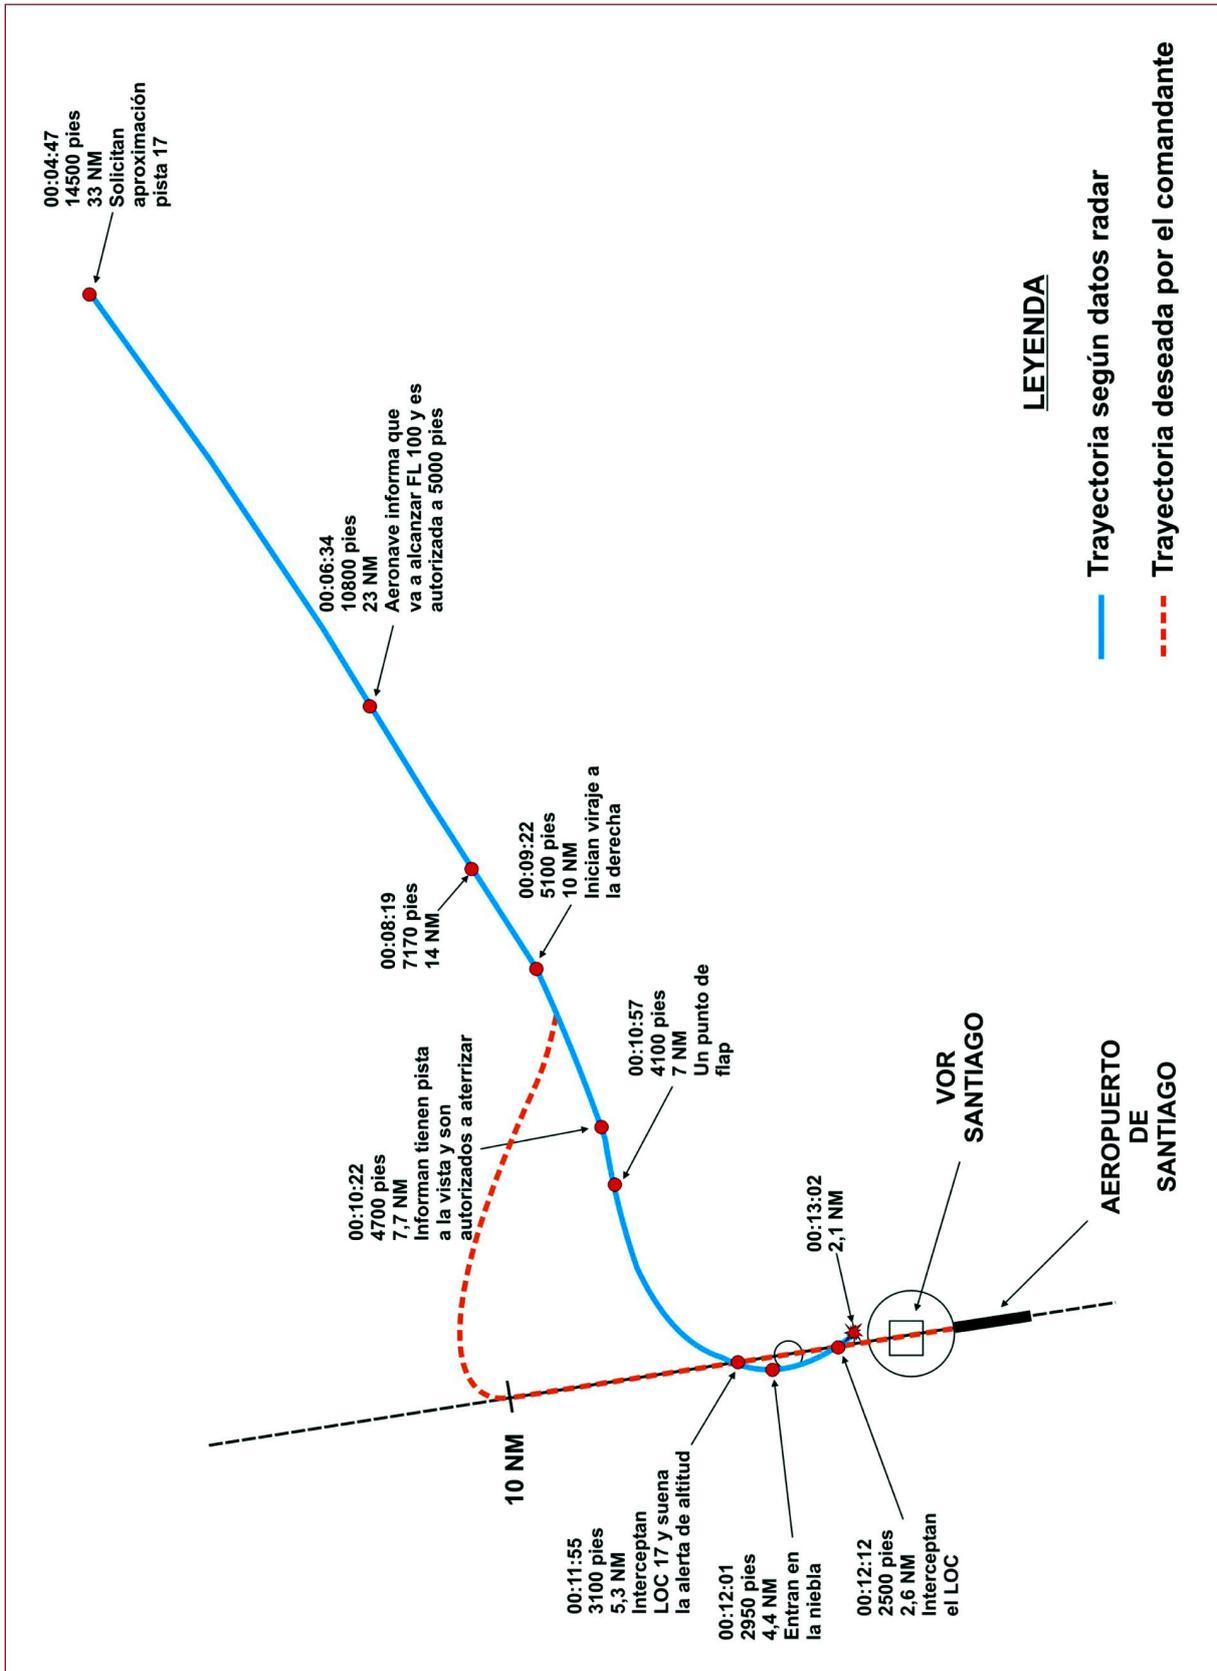
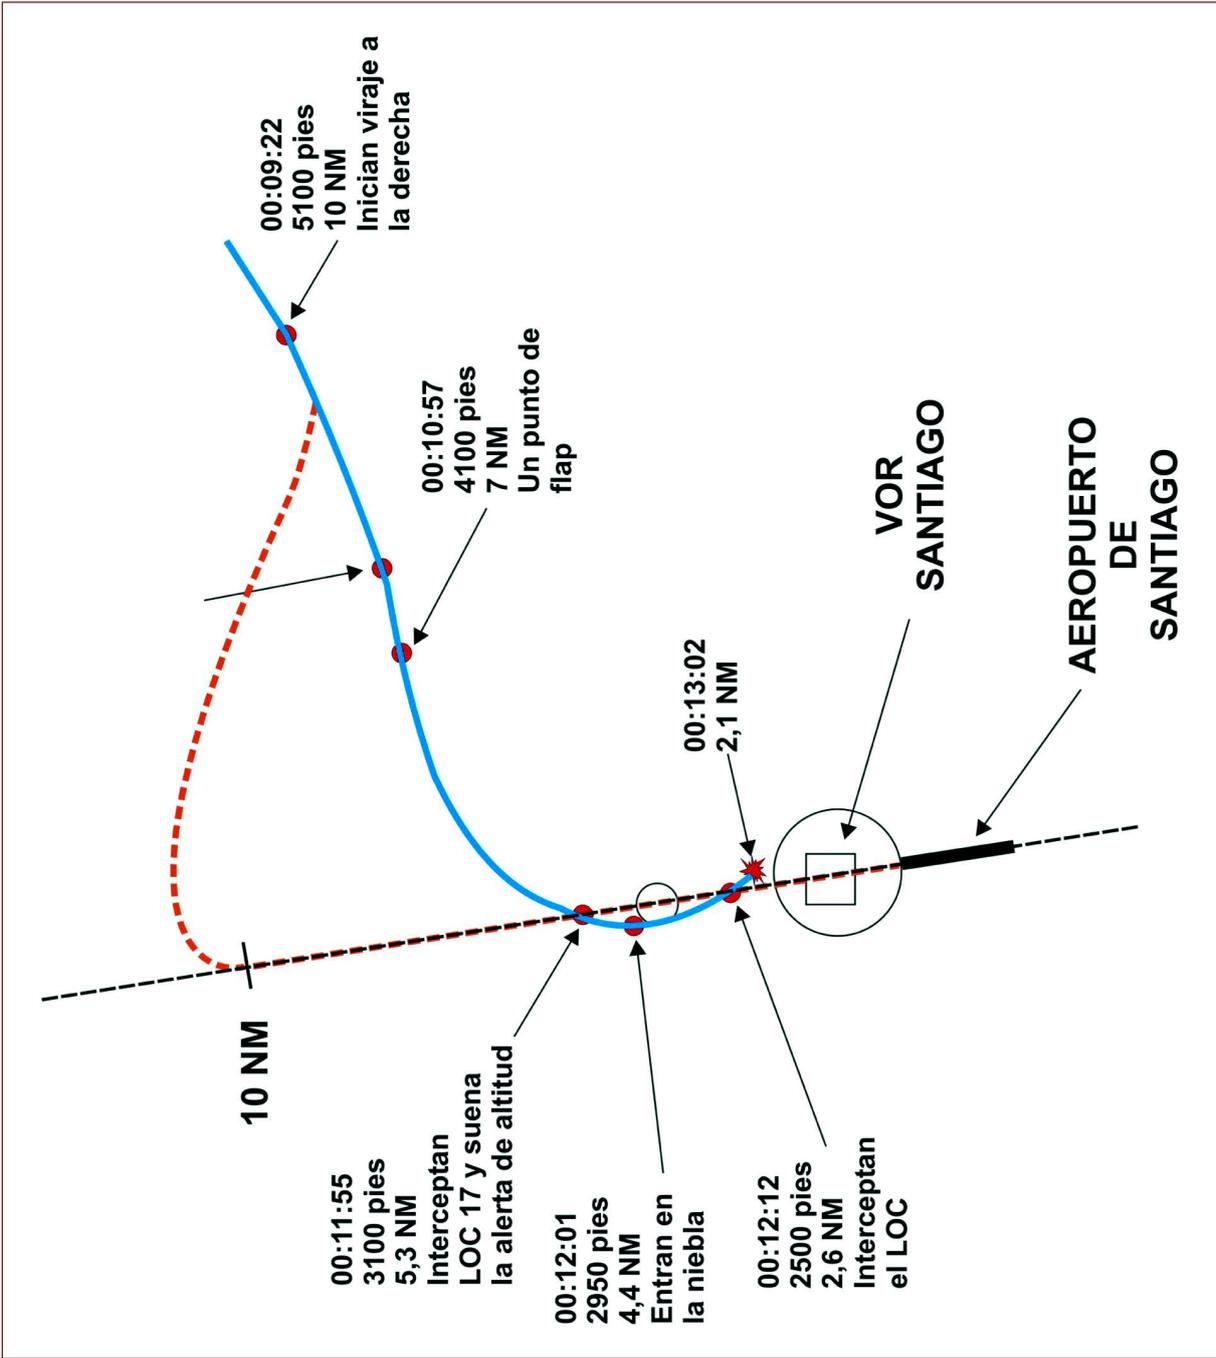
### **Truel path versus ideal path**

Appendix D shows the final trajectory followed by the aircraft according to radar information.
