**DATA SUMMARY**

Date and time	<b>Sunday, 15 July 2001; 13:10 hours</b>
Site	<b>Arraga farmhouse, Deba (Guipúzcoa)</b>

Registration	<b>F-PLJP</b>
Type and model	<b>JODEL D 140 E; serial number 452</b>
Operator	<b>Private</b>

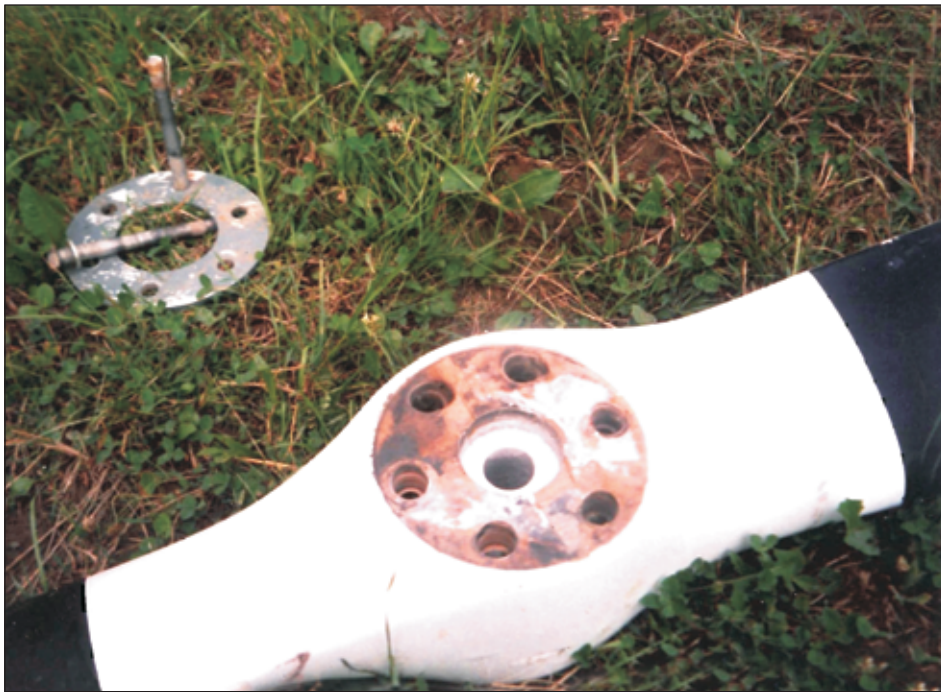
Wreckage of the propeller located on the landing place

The terrain where the aircraft landed is slightly uphill and covered with grass. The aircraft did not sustain any damage, except for the loss of the propeller which was located close to the landing area together with two fastening screws and the disk which fastens the assembly system to the rotating axis. The other four screws could not be found.

The visual inspection of the fastening points of the propeller showed a similar wear and tear, evenly distributed in the rim of each of the six holes, more marked in two of them, probably because they were the last ones to maintain the position.

From the information provided, it is considered that the probable cause of the in flight detachment of the propeller was the incorrect fitting and locking of the screws of the propeller that was not detected in the maintenance tasks carried out after the last recorded inspection of the aircraft.
