TECHNICAL REPORT

A-055/2001

Accident to aircraft
FAIRCHILD SA-226-AT,
«Metro II», registration
EC-GDV, in the vicinity of
the Columbretes Islands
in the Mediterranean
Sea, on 10 October 2001

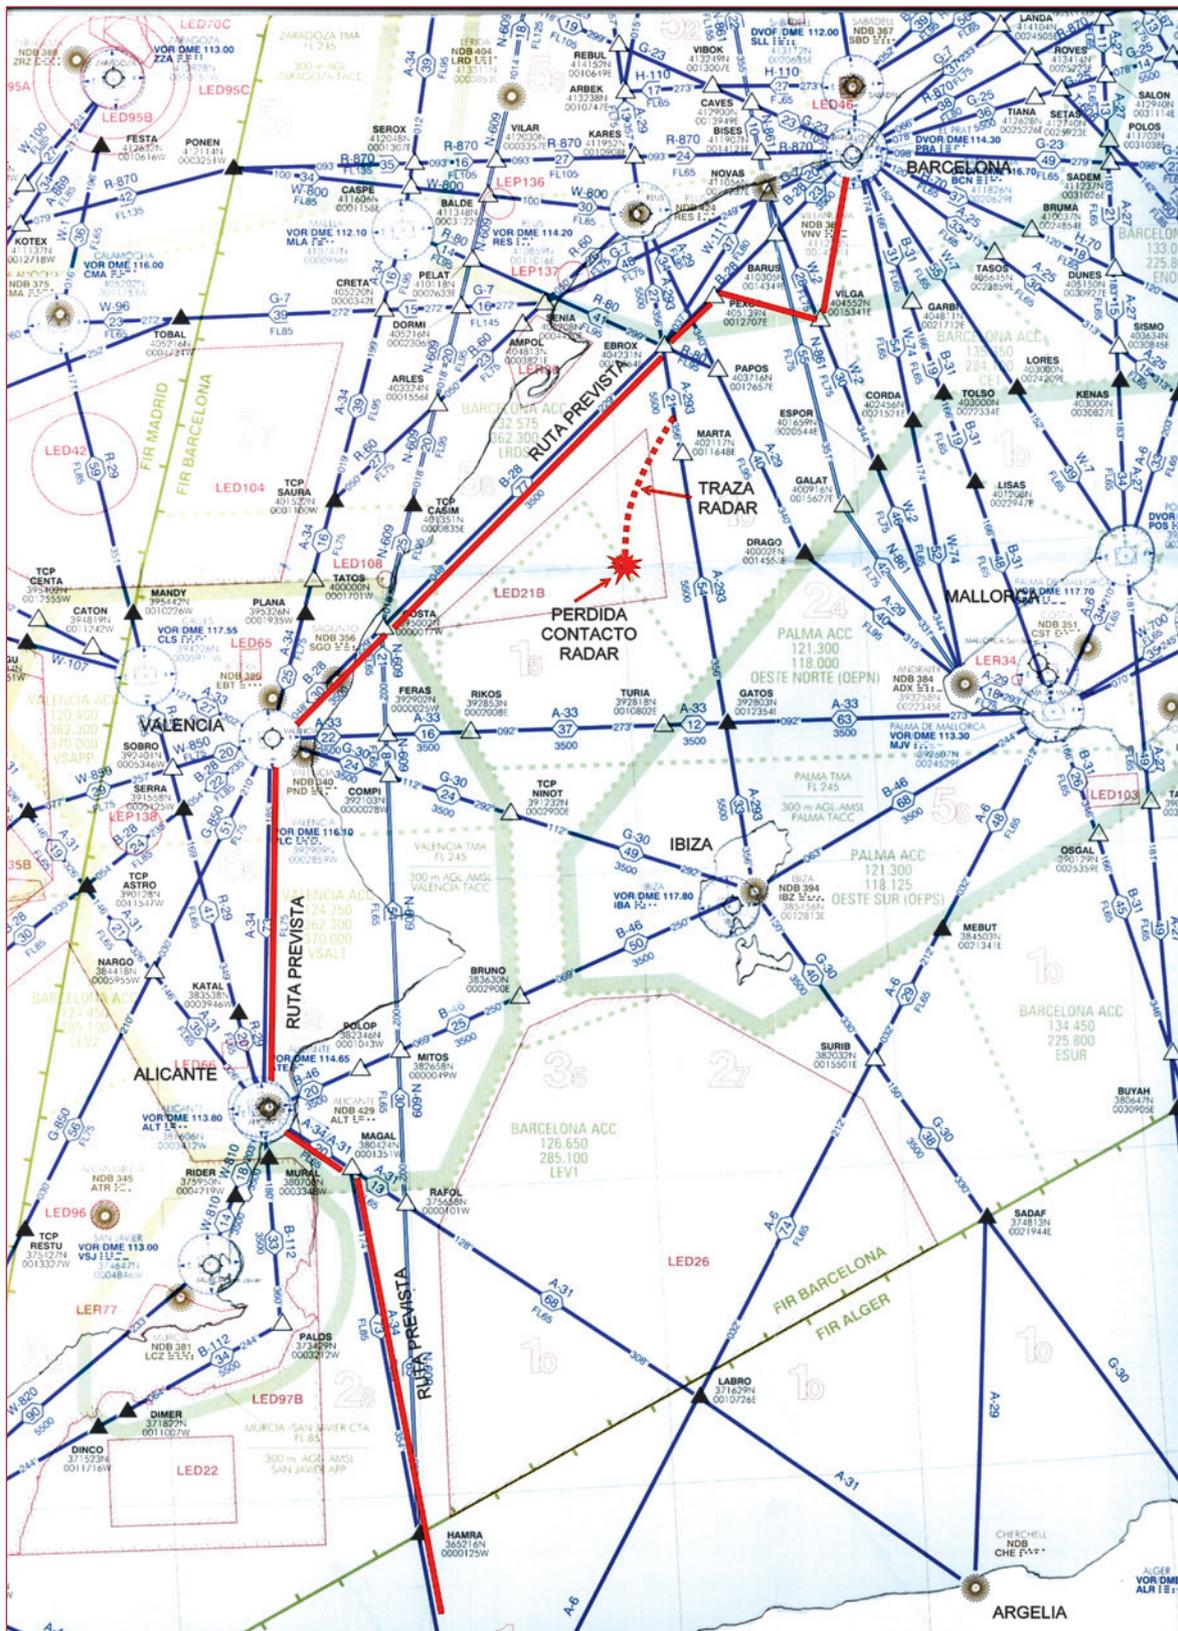
Figure A-1. Planned and actual flight routes

Figure A-1 reproduces the flight's planned route and the actual route of the last part of the flight, reconstructed on the basis of the available radar track.

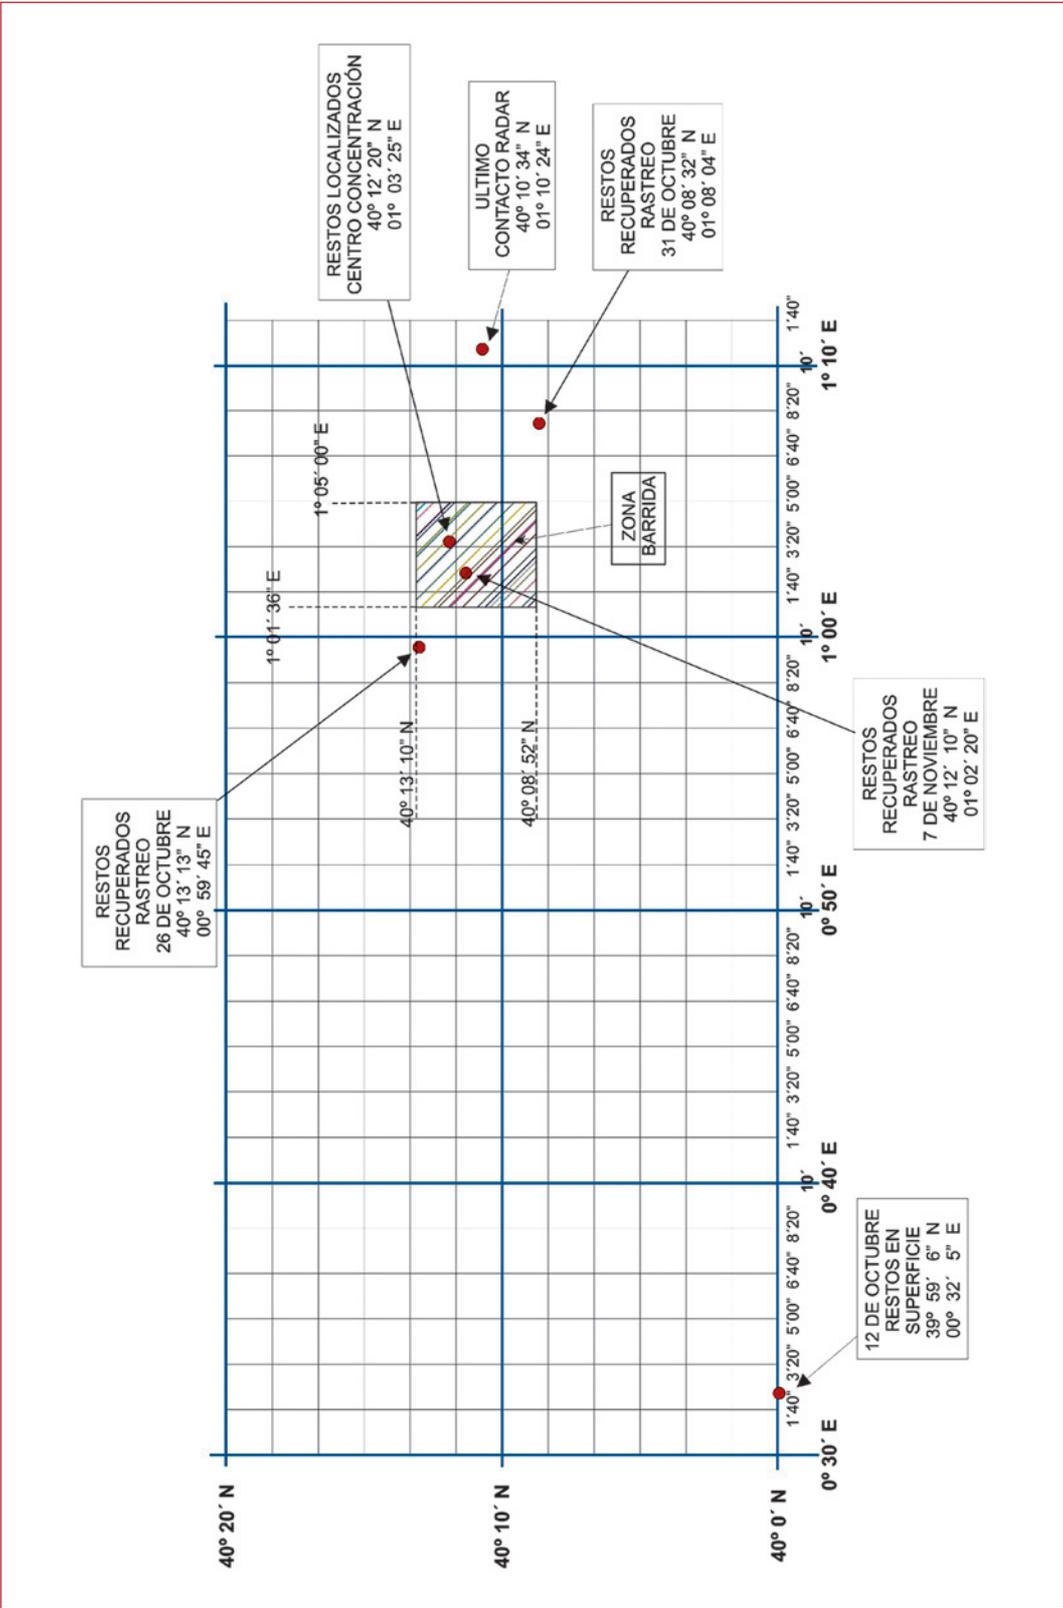
Figure A-3. Geographical positions of wreckage recovered or located on the sea bed

As can be seen, the wreckage was found in a very localized area, the majority of it being concentrated within an 1,800 m² circle, with its centre at the position 40° 12' 20" N/1° 3' 25" E, and at a depth of between 90 and 100 m. The exception of wreckage recovered on the surface at a greater distance is considered due to waves and marine currents, given that the wreckage found floating on the sea was light-weight (panel and seat wreckage).

This fall, as can also be seen in Figure A.3, must have occurred with a turn to the right, given the marked difference in length between the position of the point at which the radar display was lost and the positions of the located or recovered wreckage. This turn can only be explained by the existence of another failure caused by the aircraft being struck by lightning, but without ruling out the possibility of it being structural or because the aircraft reached undetermined pitch or roll angles that made it uncontrollable, due to the turbulence and lack of visibility already referred to and also to the crew's possible disorientation.

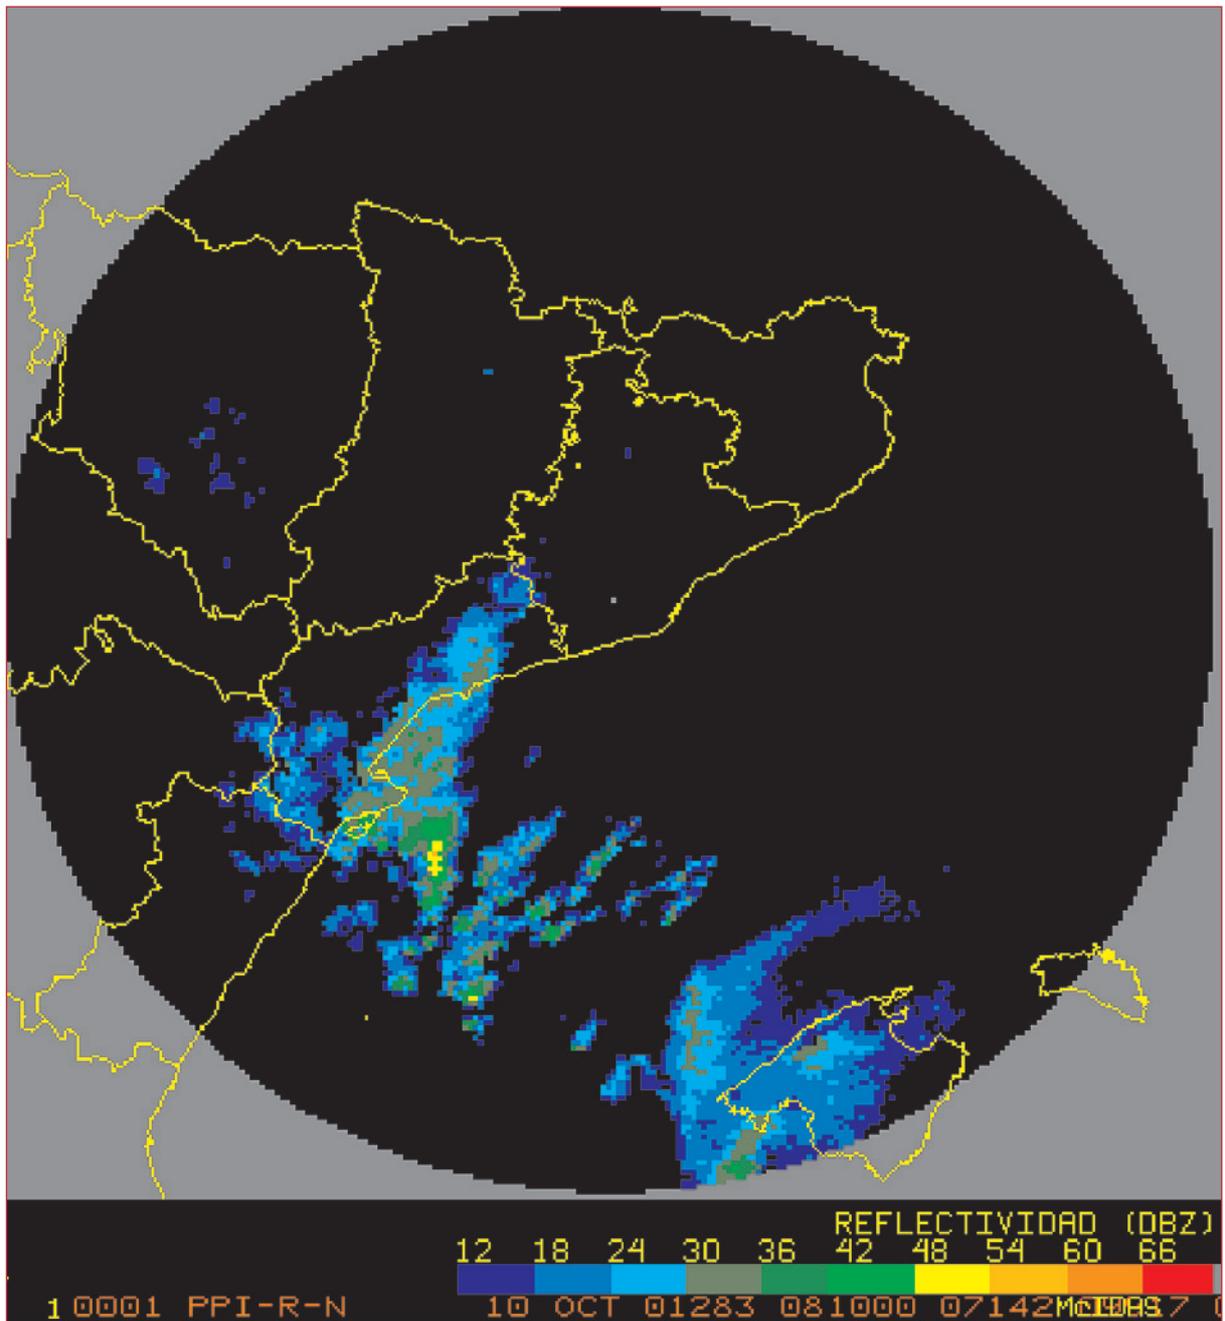
Figure B-1. *Barcelona radar, 10:10 h*

Cloud reflectivity images taken by the Barcelona and Valencia radars at 10:10 and 10:30 h (08:10 and 08:30 UTC) can be seen in Appendix B. Moderate to strong storm activity, in accordance with the forecasts, is observed in the area where the accident occurred.

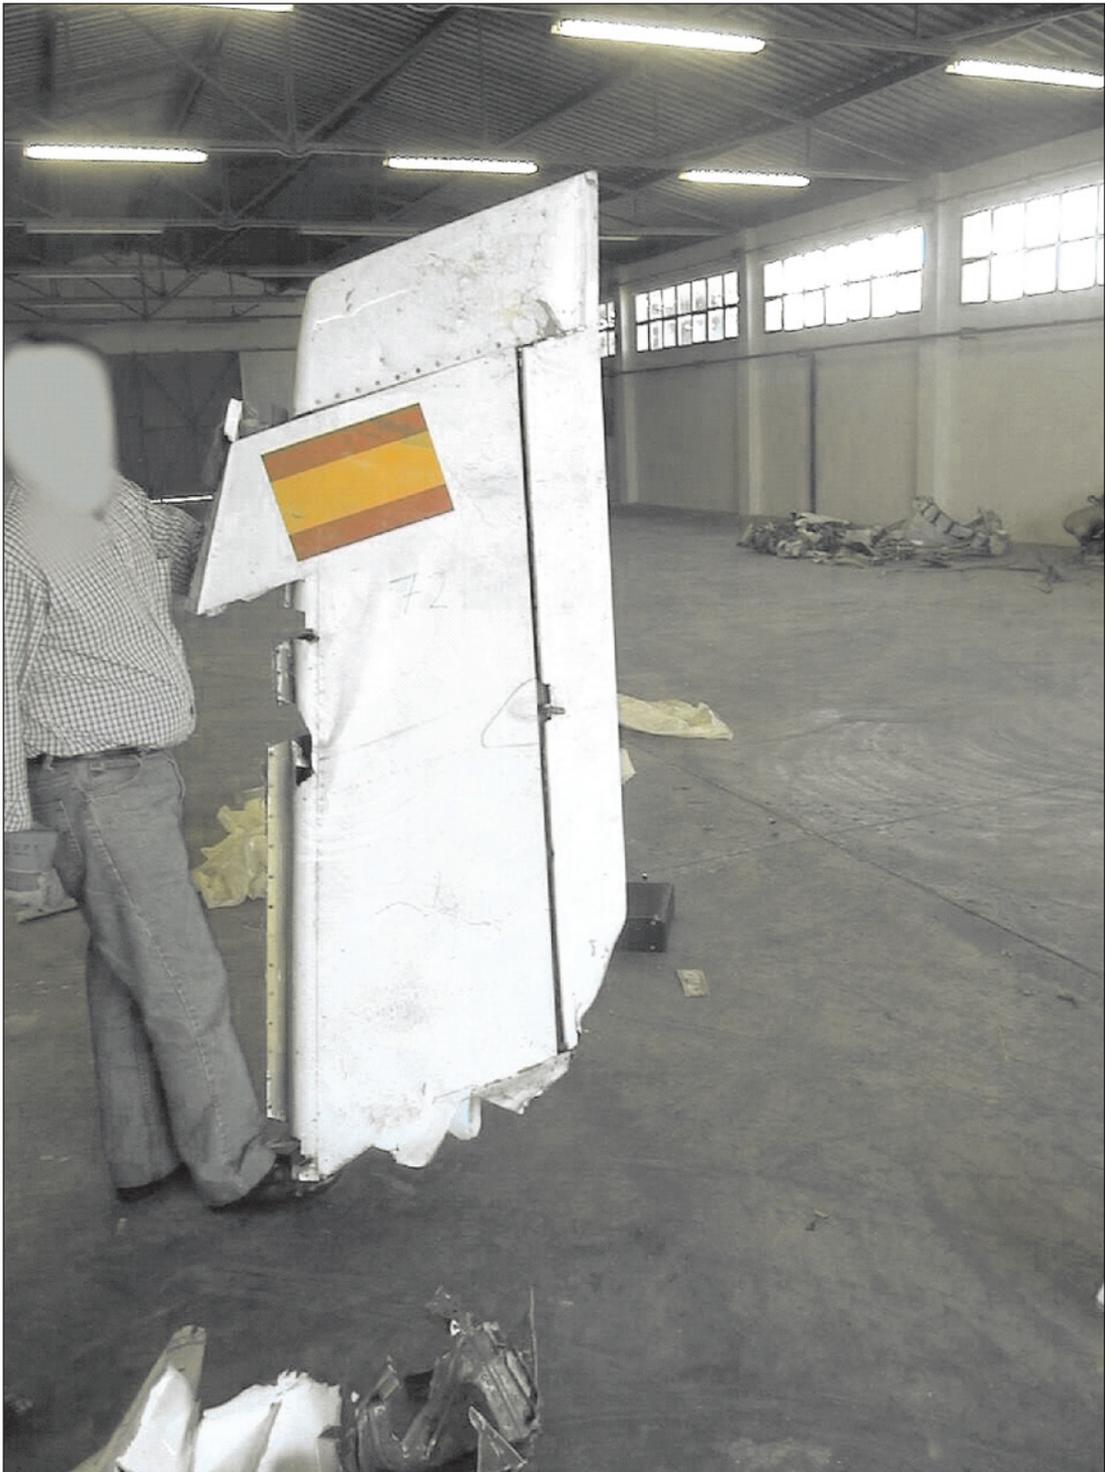
Figure C-1. *Vertical fin tail wreckage*

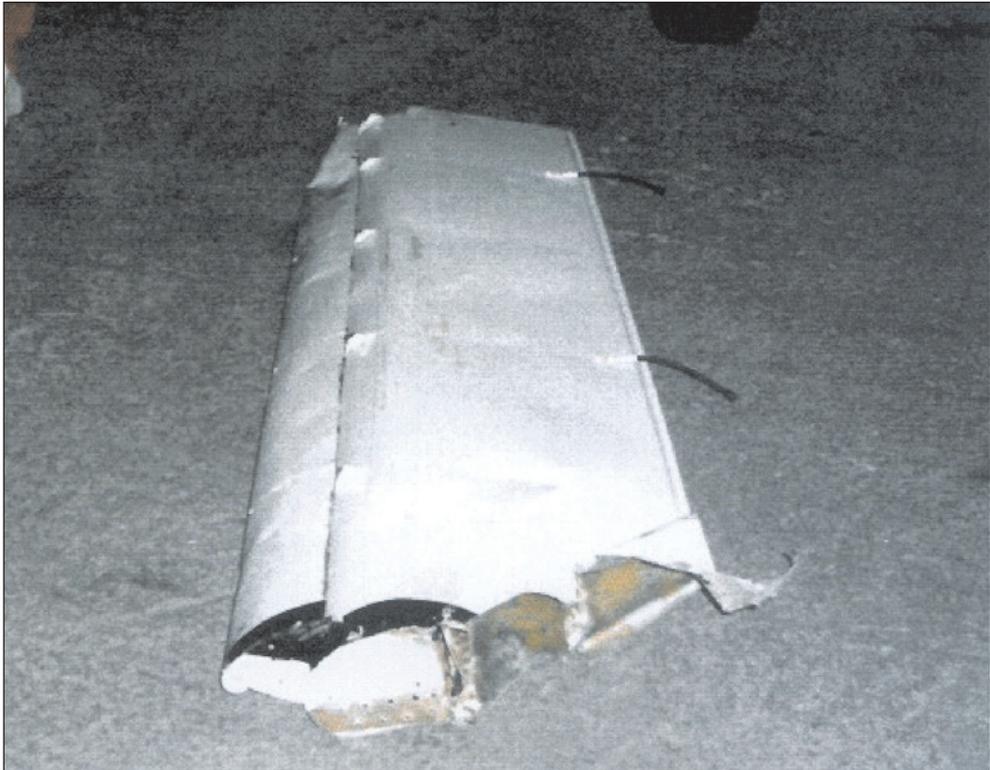
Figure C-2. *Right hand flap*

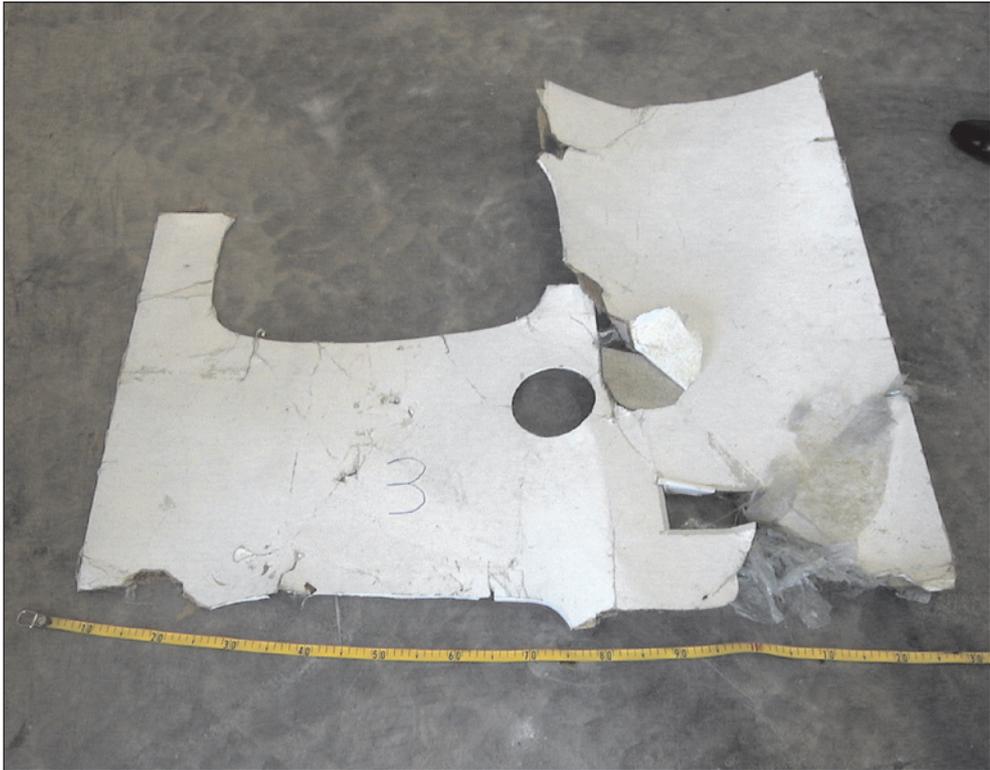
Figure C-3. *Window frame*

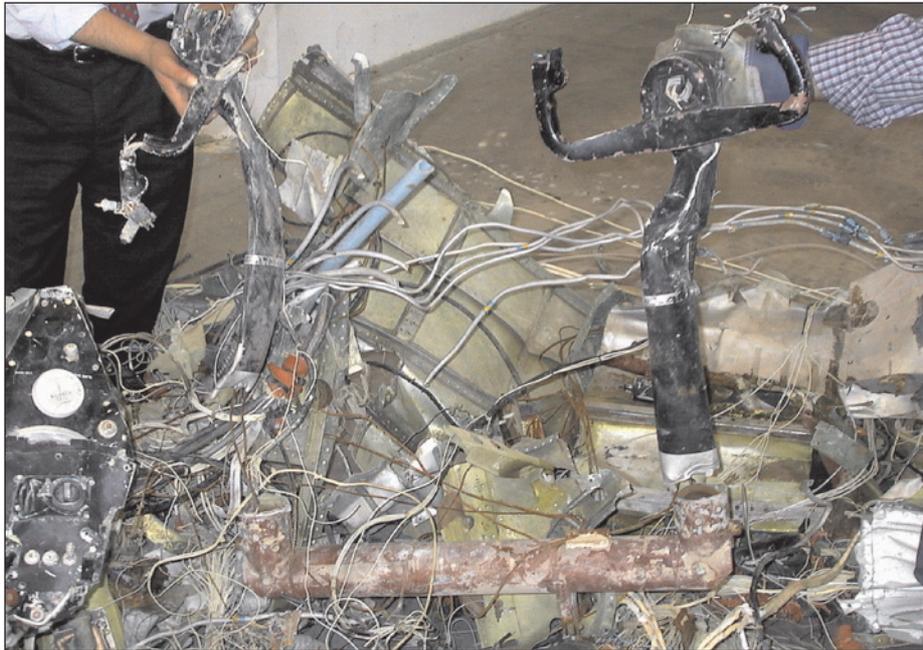
Figure C-4. *Control column and rod wreckage*

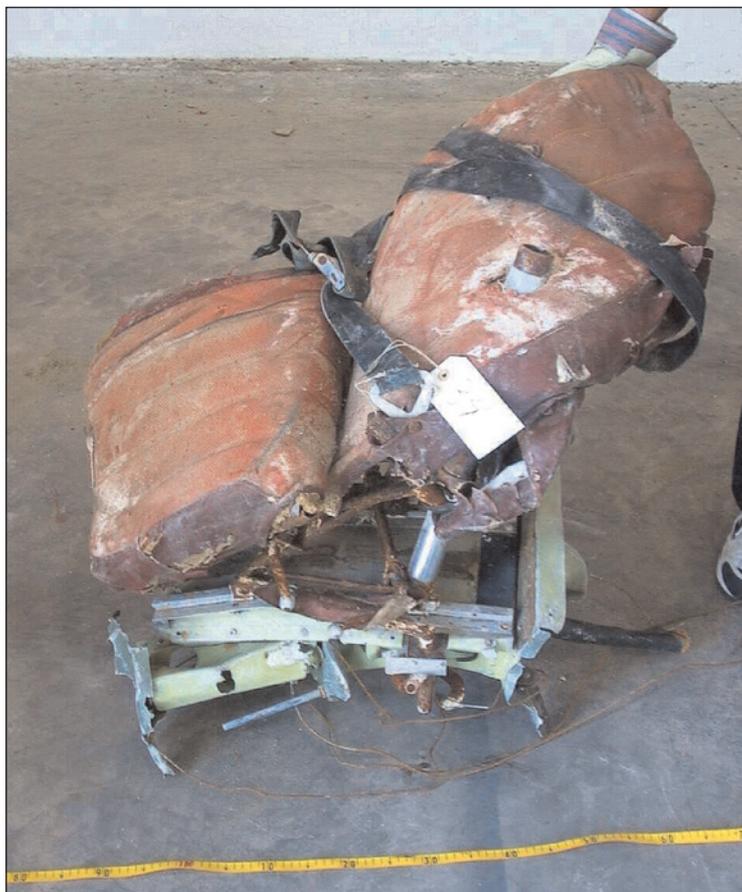
In spite of the aerial and marine teams involved in the consequent operations, no aircraft wreckage was recovered until two days after the accident. No remains of the aircraft's occupants were ever found. Later on other items of wreckage were recovered in the nets of fishing boats working in the area. Of all of them, the most explanatory were the pieces of vertical tail fin, rudder bar and right aileron as well as the pilots' seats,

which were bent backwards, although they did not allow the causes of the accident to be established. With the idea of being able to establish these causes, it was decided to organize the submarine search described in section 1.16 of this report.

Figure C-5. *Cockpit seat*

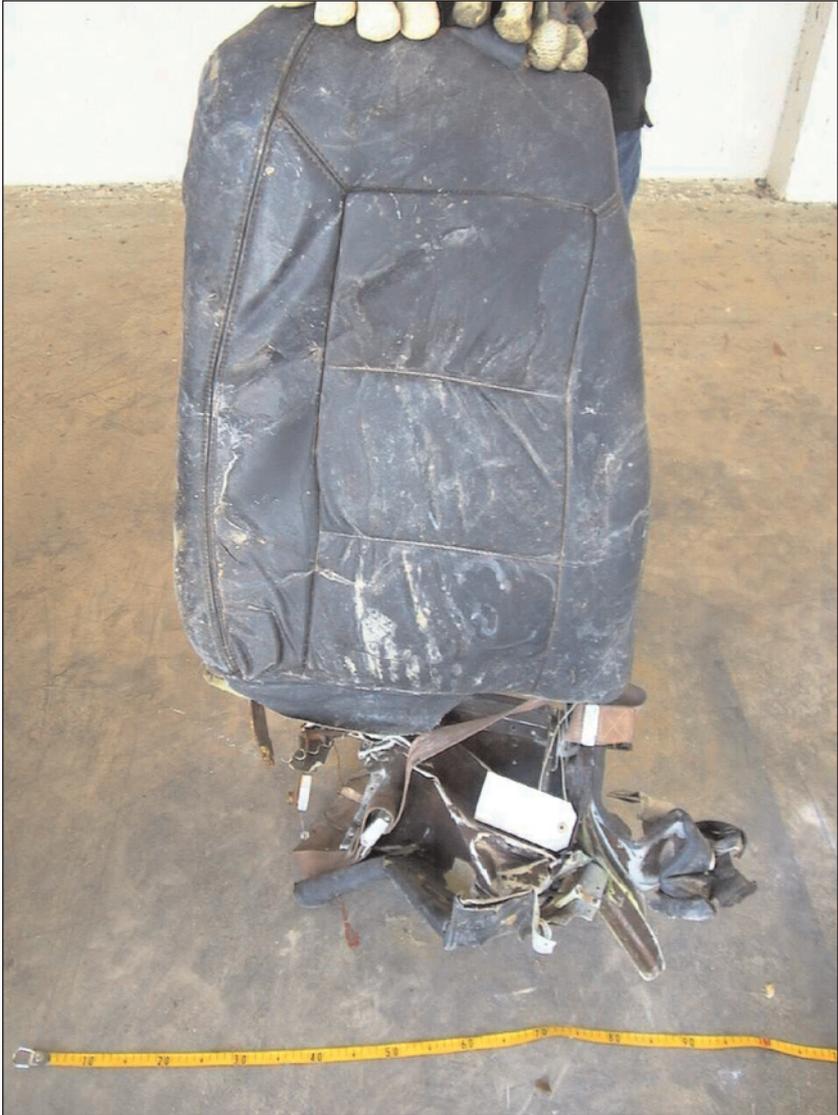
Figure C-6. *Passenger cabin seat*
