DATA SUMMARY

Date and time	January, 6th 2002; 13:18 UTC
Site	Fuerteventura Airport (Las Palmas)

Registration	D-AHLJ
Type and model	BOEING 737-400
Operator	Hapag Lloyd

REPORT

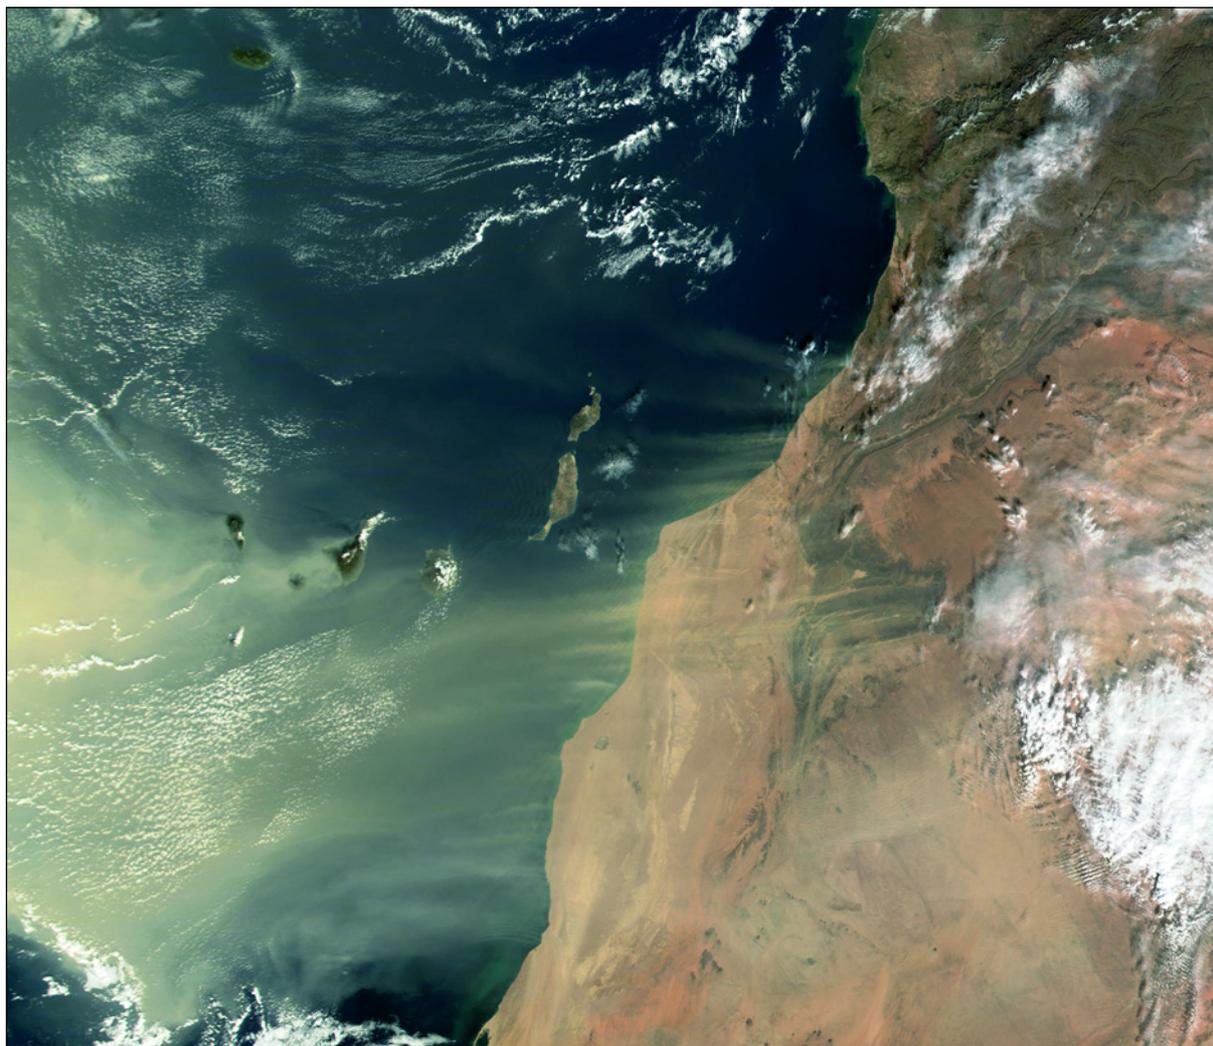
1.7.2. Satellite Image

This true-color image was captured by the Moderate-resolution Imaging Spectroradiometer (MODIS), flying aboard NASA's Terra satellite, on January 7, 2002.

«A thick pall of sand and dust blew out from the Sahara Desert over the Atlantic Ocean yesterday (January 6, 2002), engulfing the Canary Islands in what has become one of the worst sand storms ever recorded there».

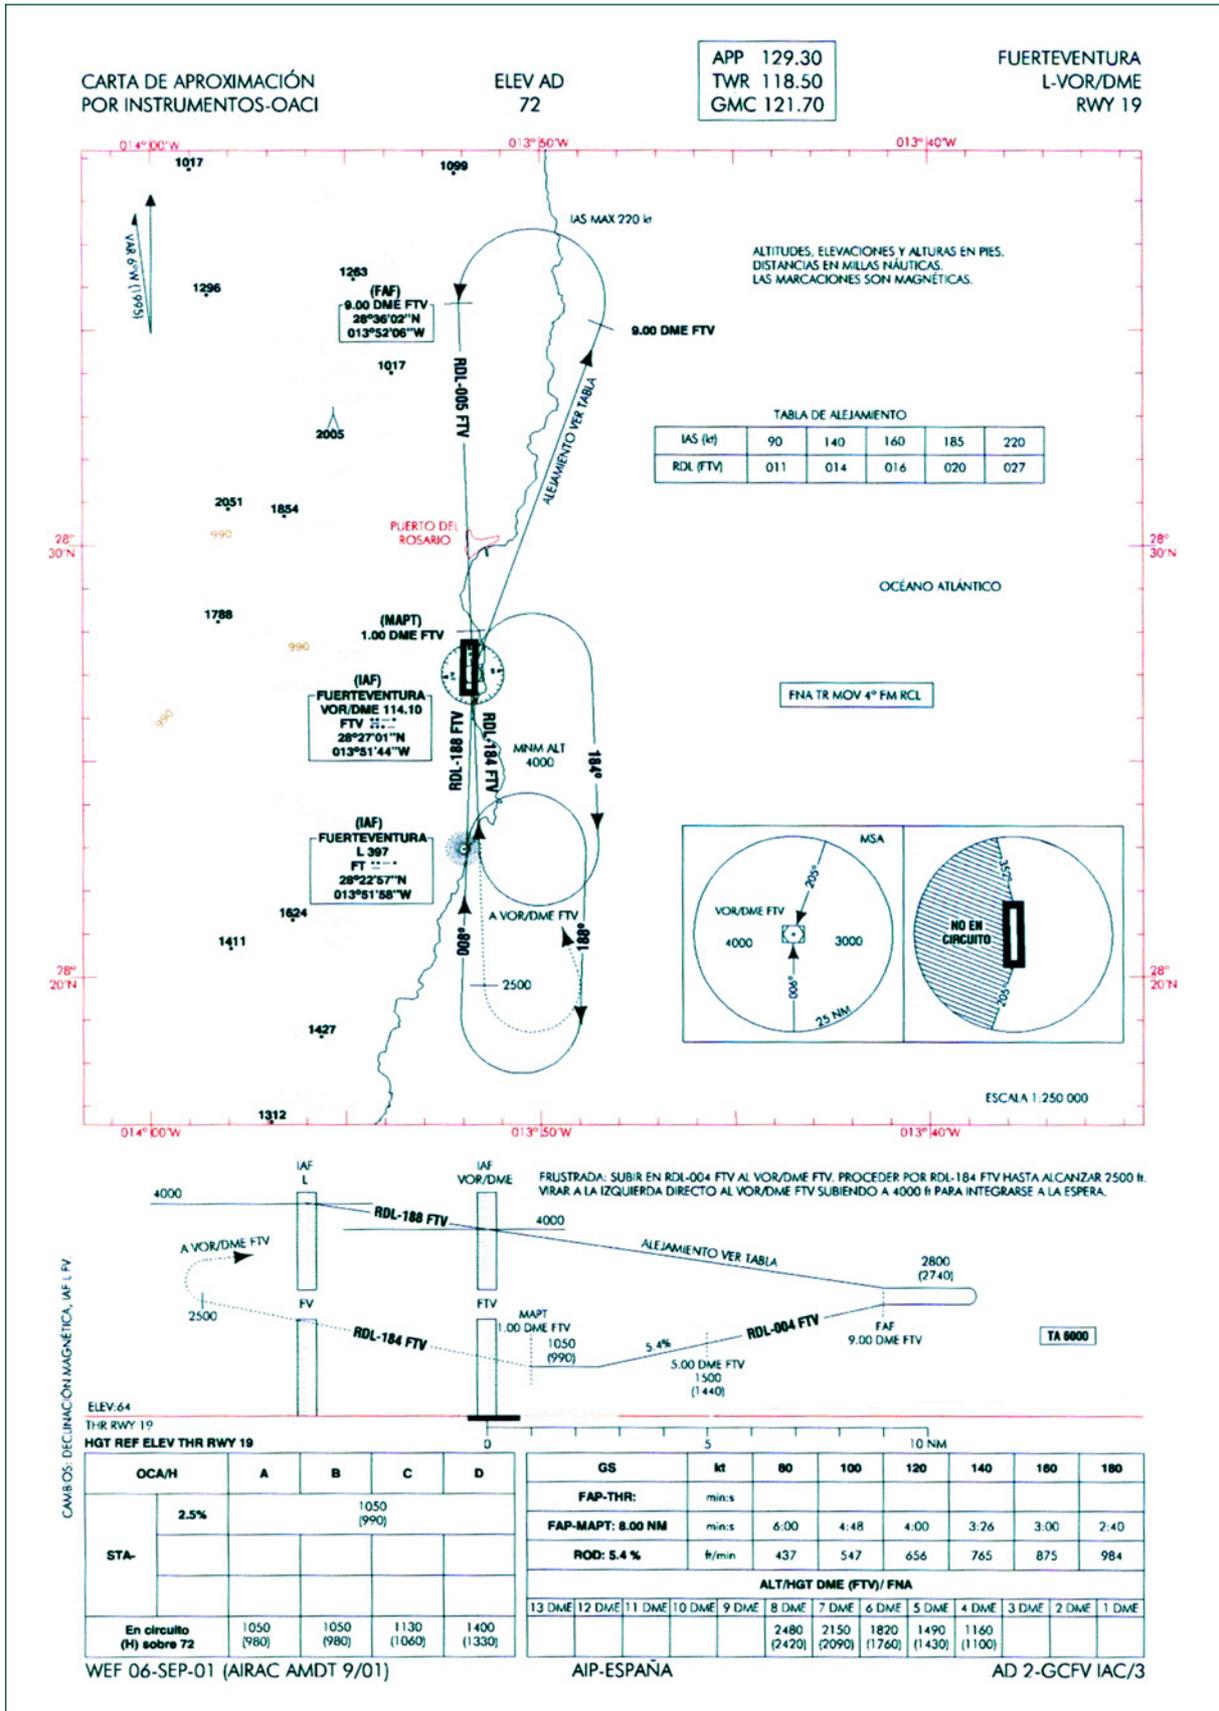
ANNEX A
VOR-DME approach chart
to Fuerteventura Airport

According the procedure described in approach chart to Fuerteventura that was in force at that date, once established in the point FAF (Final Approach Fix) in the 19 runway prolongation, at 9 NM, DME distance and 2800 ft altitude, a descent is initiated passing through an intermediate point in RWY CL extension at 5 NM-DME with an altitude of 1,500 ft. Final descent continues until MDA, 1,050 ft, when a decision is to be made, to land if the PIC see, distinguish and identify the runway (or a part of it, or light systems), continuing landing in visual contact or to initiate the go-around procedure. The point for the go-around is MAPT (Missed Approach Point) and is identified by its DME distance of 1 NM. (See Annex A-1).

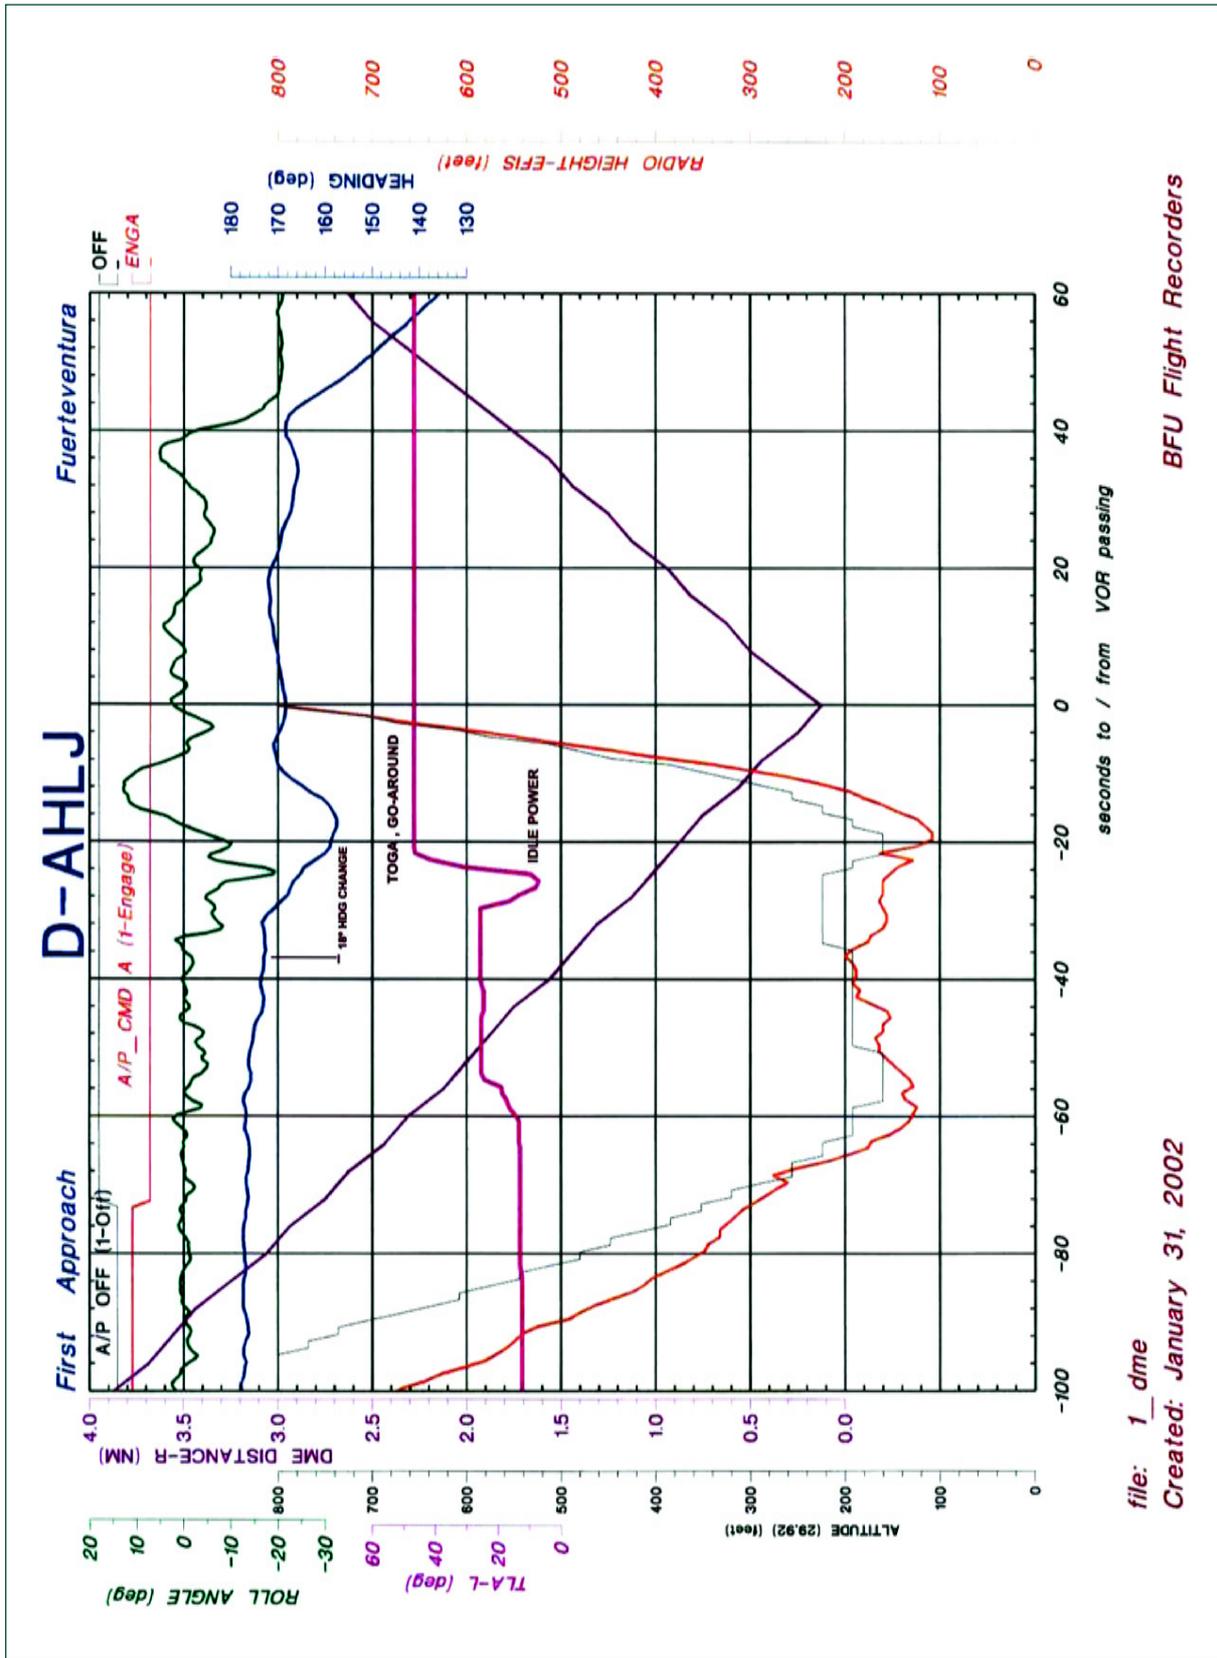
Annex B-1. Distance to/from VOR-DME. ALT, RH, Power, Heading and Roll angle

In graphic Annex B-1 a change of heading of 18° is noticed 10 seconds before go-around and bank 20° to the left, followed by a 12° heading change to the right. It is observed a descent to 105 ft radio height and the power increase for go-around.

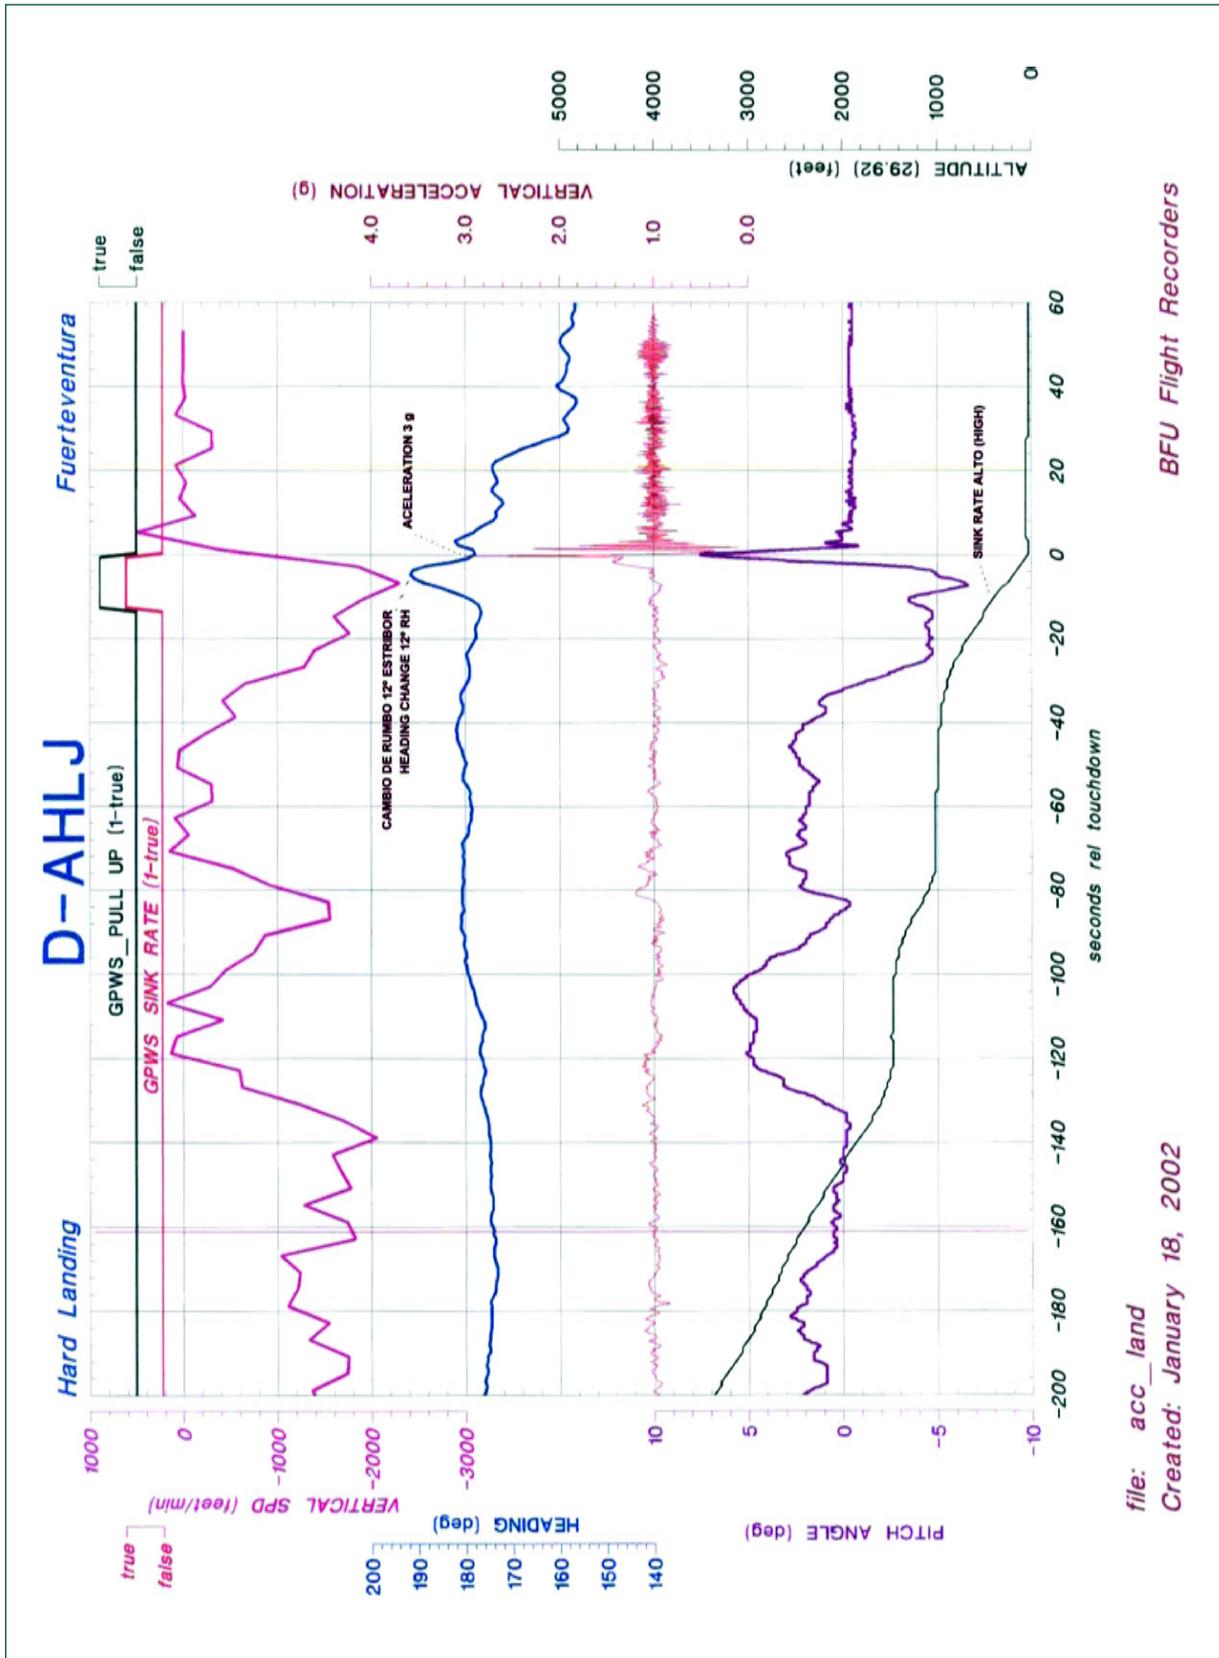
Annex B-3. Second approach and landing

In graph Annex B-3 it is clearly observable the instant ground contact was accomplished, when a 3 g's vertical acceleration was recorded. In the last 30 seconds in the glide path ROD was greater than 1,000 ft/min, reaching in some moments 2,200 ft/min.

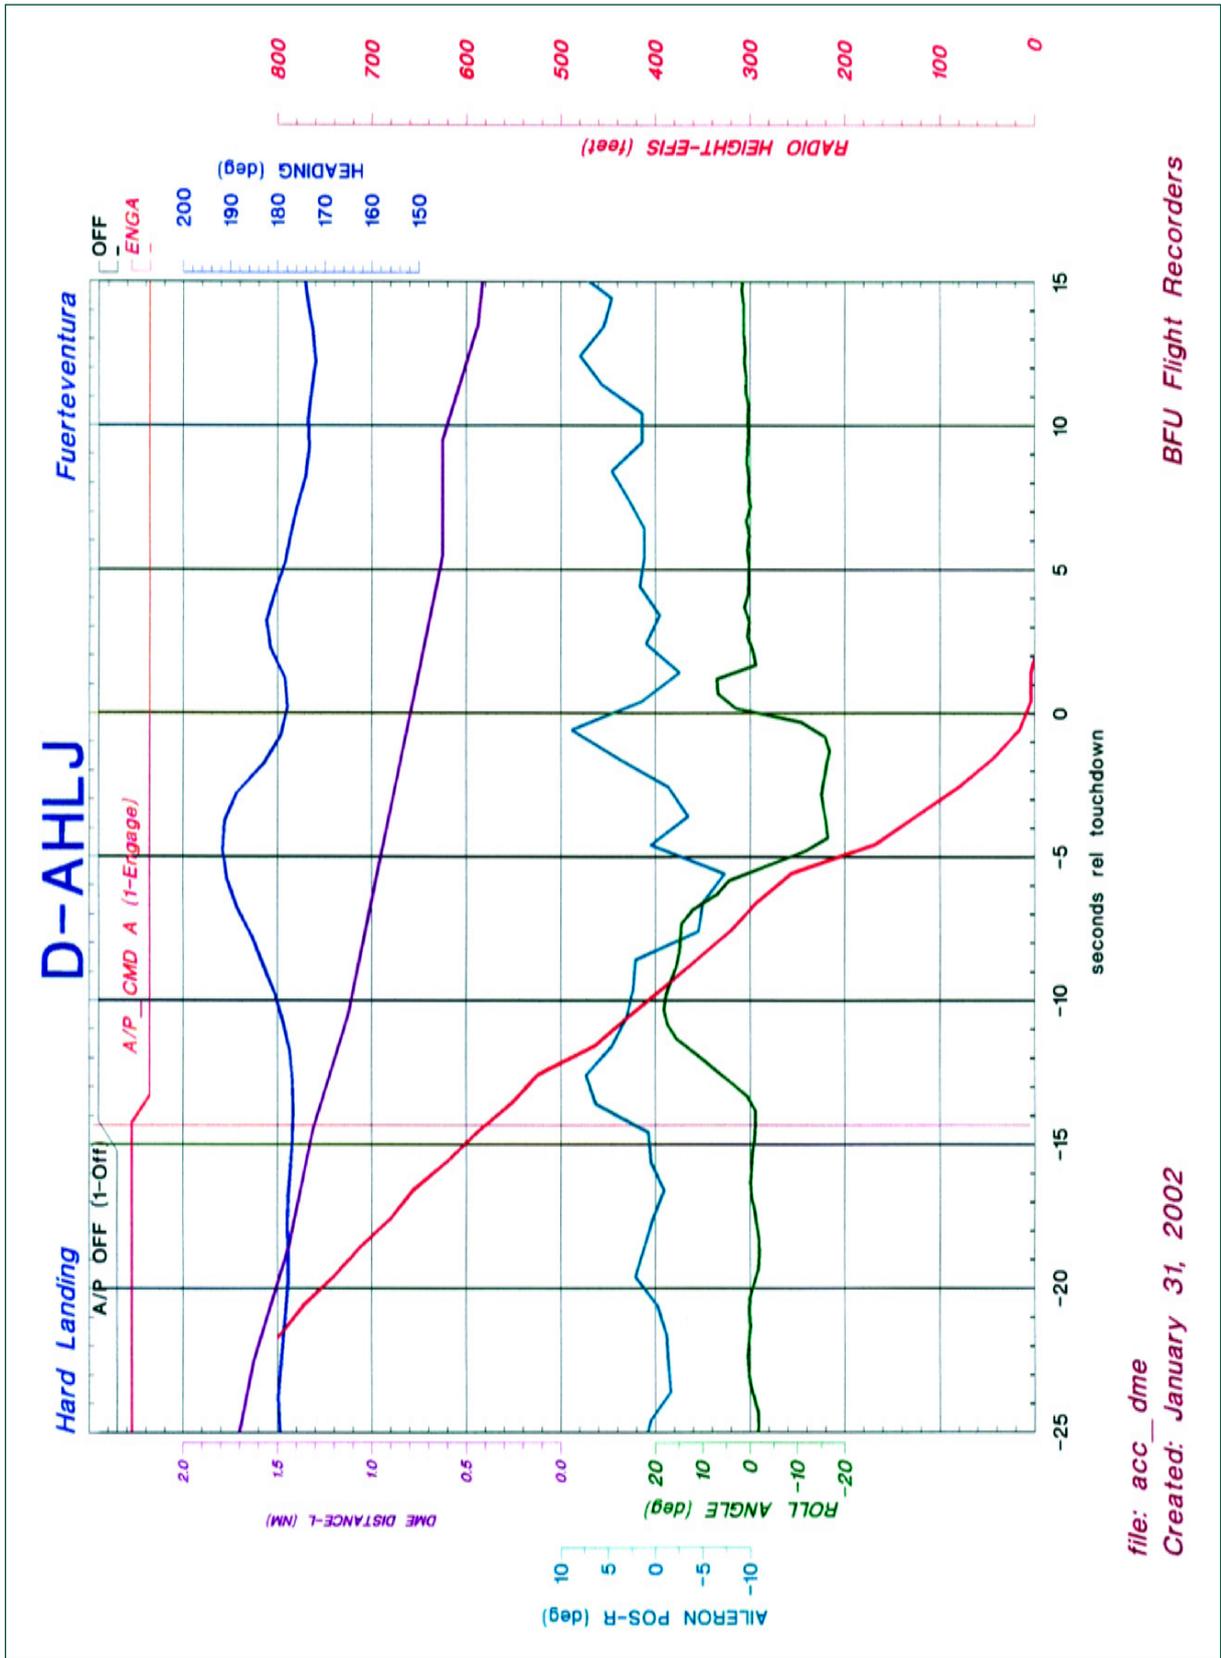
Annex B-4. Last seconds before touching down

In graph Annex B-4 a change in heading of 12° to the right can be seen, five seconds before touch-down when RH was 200 ft. Also aggressive use of aileron and bank angle can be observed a few seconds before touch-down.

DFDR readouts showed that the bank angle shortly before touch down was not caused by a gust of wind as the captain has stated. The bank angle was definitely caused by the captain's control input.

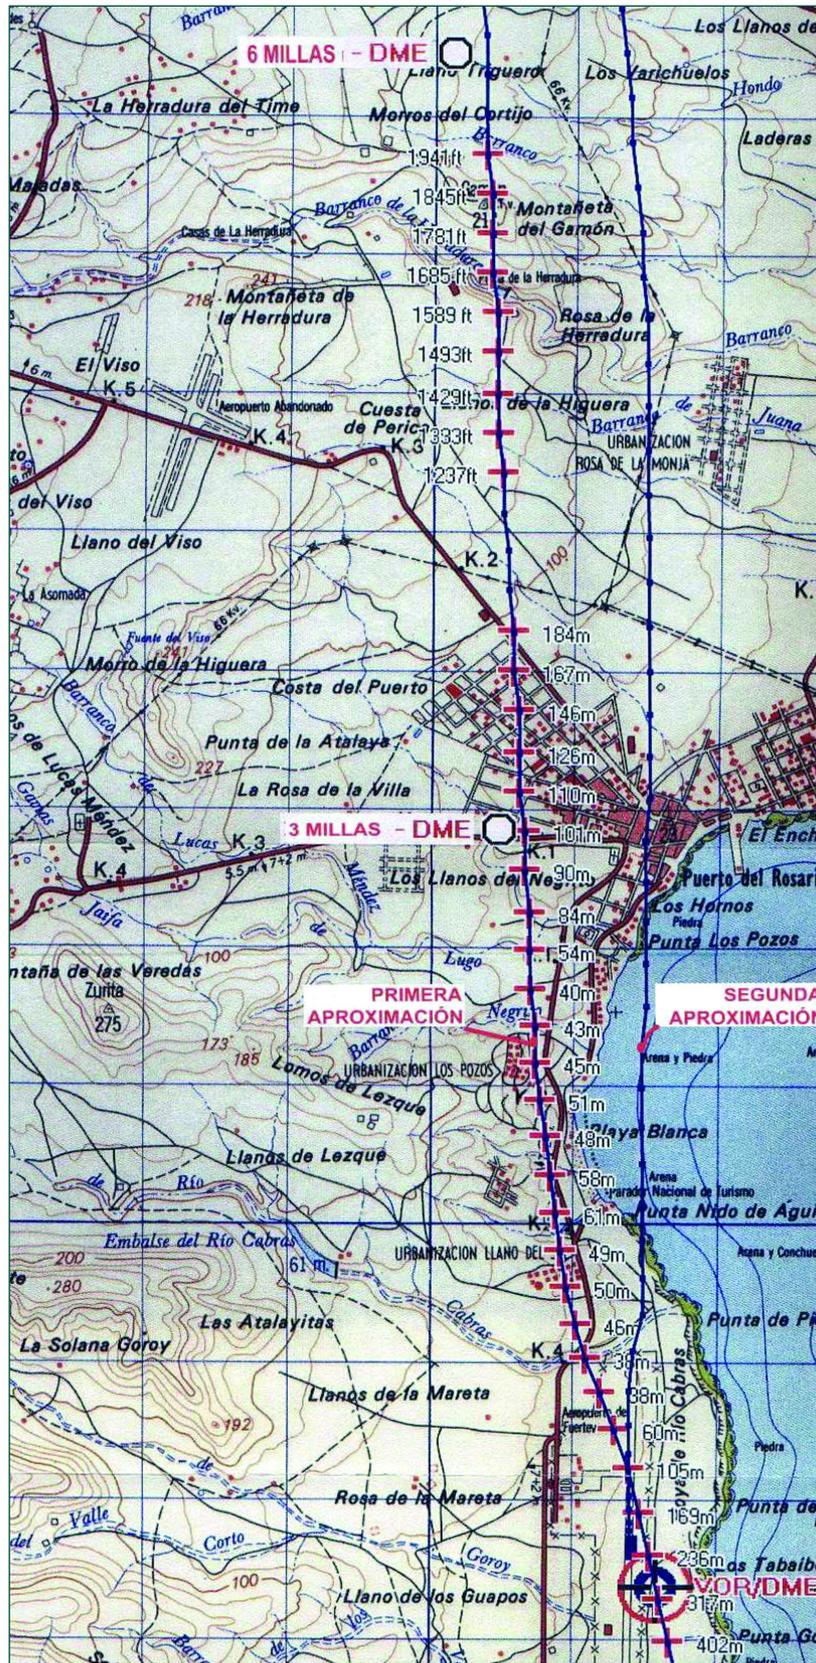
ANNEX C
Approach path followed
in the two approaches

In Annex C-1 a reconstruction of aircraft path on both approaches, —made by BFU from FDR data—, is shown.

Since the pilot flying conducted the approach on the wrong radial (188°)—184° would have been correct—the approach was offset parallel to the runway. Once the runway came into view the aircraft had to be piloted first to the right and then to the left towards the runway. This caused the high roll rate (18°/s) at touch down and led to the damage of the aircraft together with the rate of descent.
