TECHNICAL REPORT IN-021/2002

DATA SUMMARY

1.1.- Description of the event.

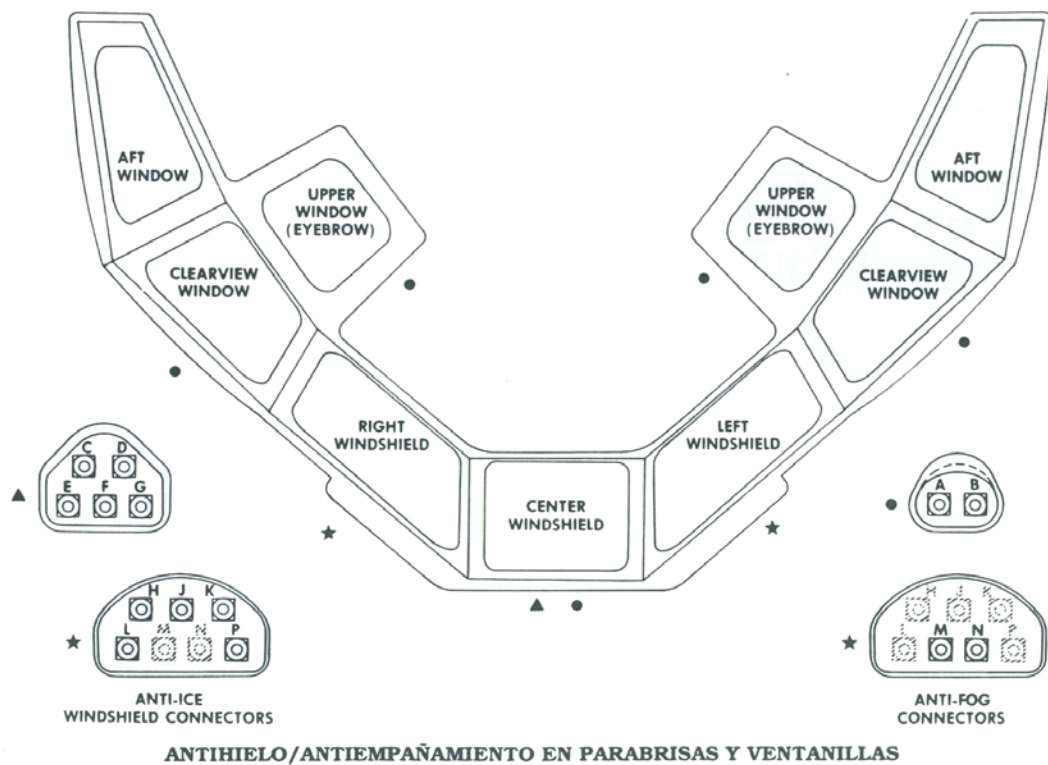
In both cases, current goes to the resistances that convert it into heat to deice or defog the windshield through electrical connectors kept together by a plastic material part (see in Figure 1 the type of connectors located in each windshield and windows).
