DATA SUMMARY

Date and time	24 june 2002; 17:45
Site	Ocaña airfield (Toledo)

Registration	PH-1204
Type and model	SCHLEICHER Ka 6 BR

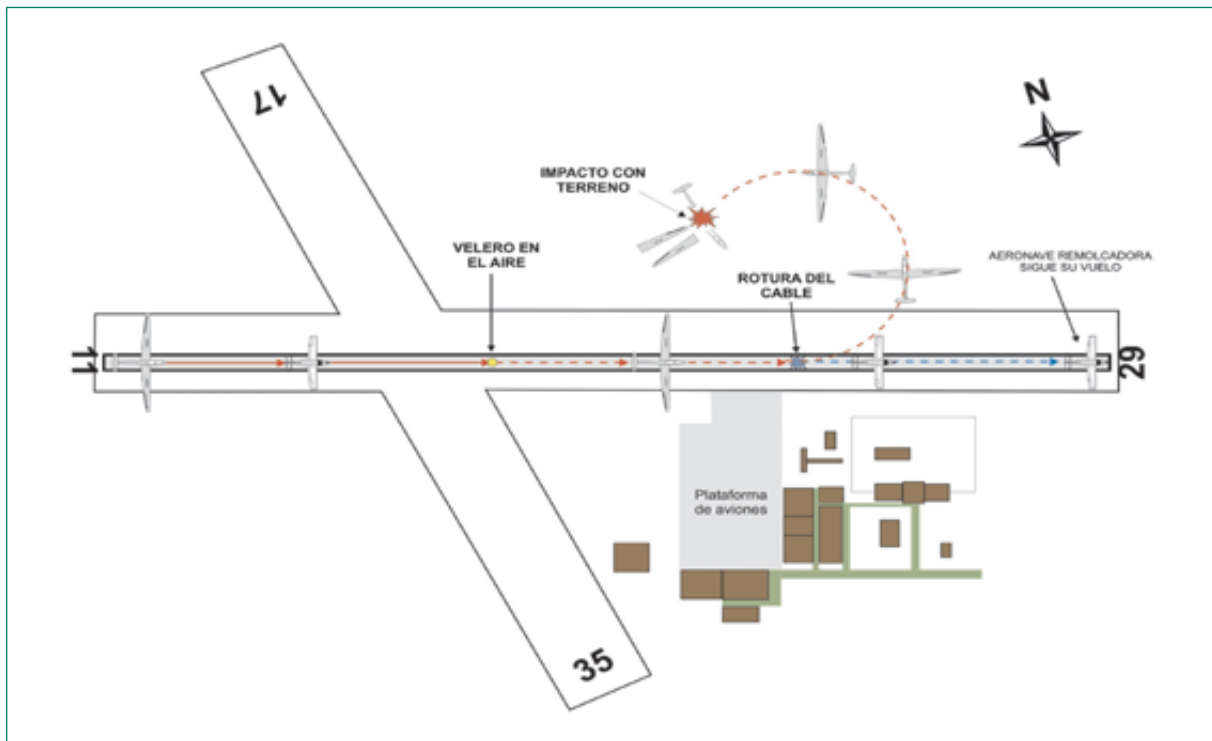
At approximately 17:43, local time, a Robin DR-400-180R aircraft, registration EC-BTN, began to tow a Schleicher Ka 6 BR glider, registration PH-1204, on runway 11 of the Ocaña aerodrome. The take off was carried out in a normal way, the glider lifted off first followed by the towing aircraft shortly afterwards. Seconds later, when both aircraft had travelled about three fourths of the 1200 metre-long runway (see diagram), the tow cable broke.

The towing aircraft continued on its route and the glider began a very shallow turn to the left, almost without banking, as if trying to return to the threshold from where it had departed. When it had turned more than 90° it increased the bank, and instants later the left wing descended abruptly and the aircraft began to descend quickly, until it crashed into the terrain.

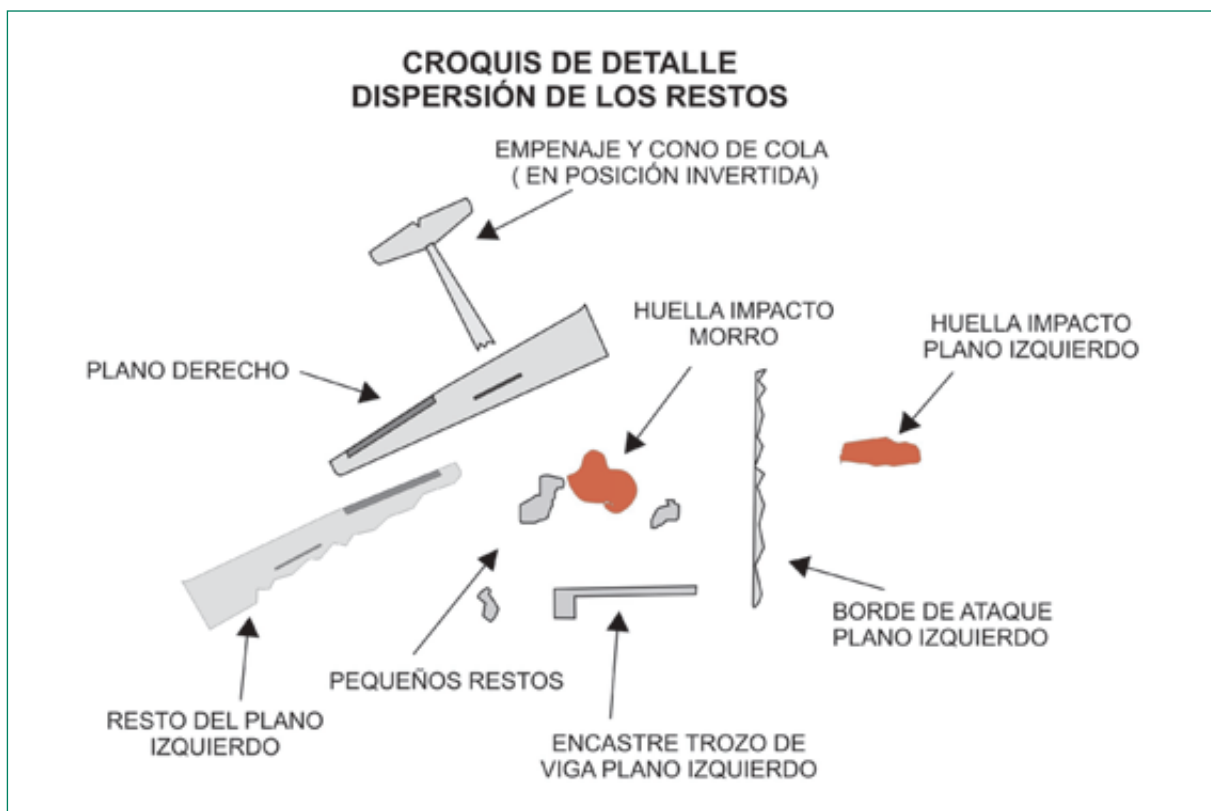
An impact mark was found on the ground, produced by the leading edge of the left wing, and to its left, the impact mark of the aircraft nose was noticed.

The left wing was broken in three parts: the leading edge, located very close to the spot where the wing impacted, a beam fragment and the wing root area, located near the spot where the nose impacted, and the wing tip, located farther to the left.

The nose of the aircraft was completely destroyed up to the wing root. Its fragments were scattered about the area where the impact took place.

The right wing suffered little damage. Its location is indicated on the diagram.

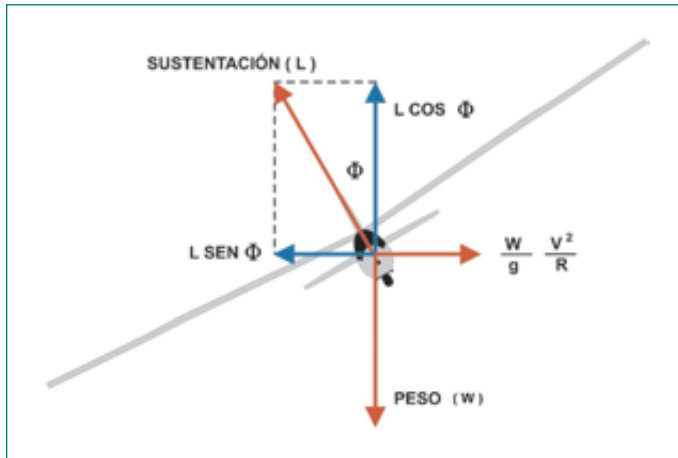
To facilitate the aircraft turning, it is necessary to bank it towards the desired side. In that position the lift forms an angle with the vertical, so that its horizontal component «pulls» the aircraft, causing it to turn. The weight of the aircraft must be balanced by the vertical component of the lift (L), whose value is equal to the lift multiplied by the

cosine of the angle formed with the vertical (ϕ), that is to say $L \cdot \cos \phi$. Since this value is smaller than L , in order to keep the aircraft from descending, the lift should be increased by increasing the angle of attack. This causes an increase in the induced drag and in the stall speed, i.e. that an aircraft stalls at a higher speed if it is turning than if it were in a straight and level flight.

In the present case, taking into account the large span of this kind of aircraft, the low speed, low height turn initiated by the glider made the left wing tip to descend and to lose speed until stall occurred on that side of the wing, and eventually produced the fall of the glider and the impact into the ground.

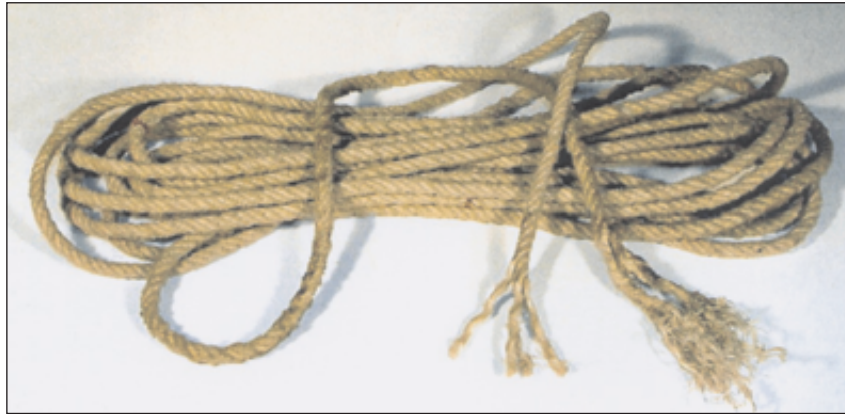
The tow cable is composed of four rope strands, having a total diameter of approximately 9 mm. It could be observed that one of its ends was broken. With regards to its appearance, it was noted that the external surface showed signs of severe wearing caused by being repeatedly dragged across the ground during the glider towing process.
