## **TECHNICAL REPORT**

**A-054/2002**

Accident to aircraft  
GROB G-103 «Twin Astir»,  
registration D-8736,  
at Aerodrome of Santa  
Cilia de Jaca (Huesca),  
on 18 August 2002

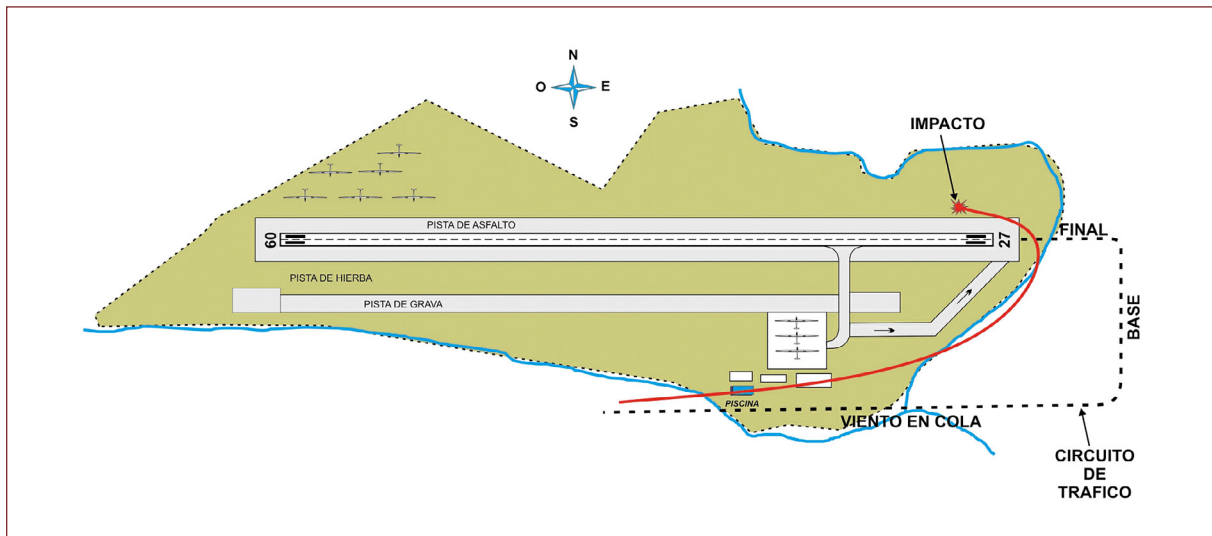
The impact occurred (see Figure 1) to the right of the runway threshold, after it had been overshoot in the direction of the flight. The figure includes a drawing of the aerodrome of Santa Cilia de Jaca, the estimated path of the last stage of the flight, reconstructed on the basis of the statements of witnesses and the injured crew member, and the aerodrome traffic circuit, with identification of the down wind, base and final legs.

Figure 1. Map of aerodrome, estimated aircraft path and traffic circuit. «Pista de asfalto»: Asphalt runway. «Pista de hierba»: Grass runway. «Pista de grava»: Gravel runway.

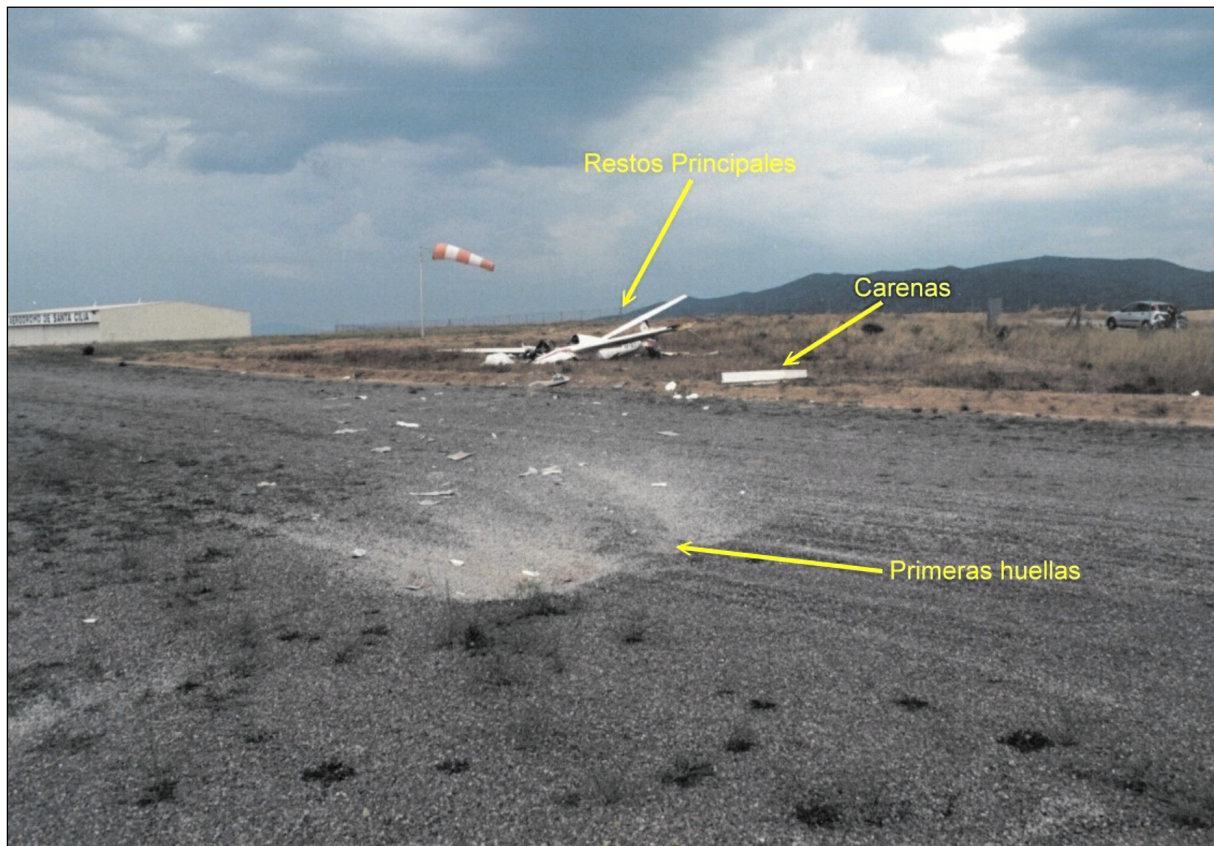
The position and distribution of the wreckage, as it was found are shown in the photograph of Figure 2, which was taken looking forward in the direction of flight, from the position of the first impact. The dragging marks left by the aircraft can be identified.

The first marks can be seen in the foreground of the figure (small fragments and remains of paint), resulting from the aircraft scraping against the top of the side slope, approximately 1.5 m high, located to the right of the threshold of runway 27 and parallel to it. In the photograph this paved runway would be located behind the camera with which it was taken and would run practically from right to left, in the same direction as the lines which cross the figure.

Some fairings and other minor wreckage at the next raised edge, some 30 cm high, can be seen in the middle of the figure.

The main aircraft wreckage, which was some 12 m from the mentioned raised edge, can be identified in the background.

Figure 2. Position and distribution of the wreckage. «Primeras huellas»: First marks. «Carenas»: Fairings. «Restos principales»: Main wreckage.

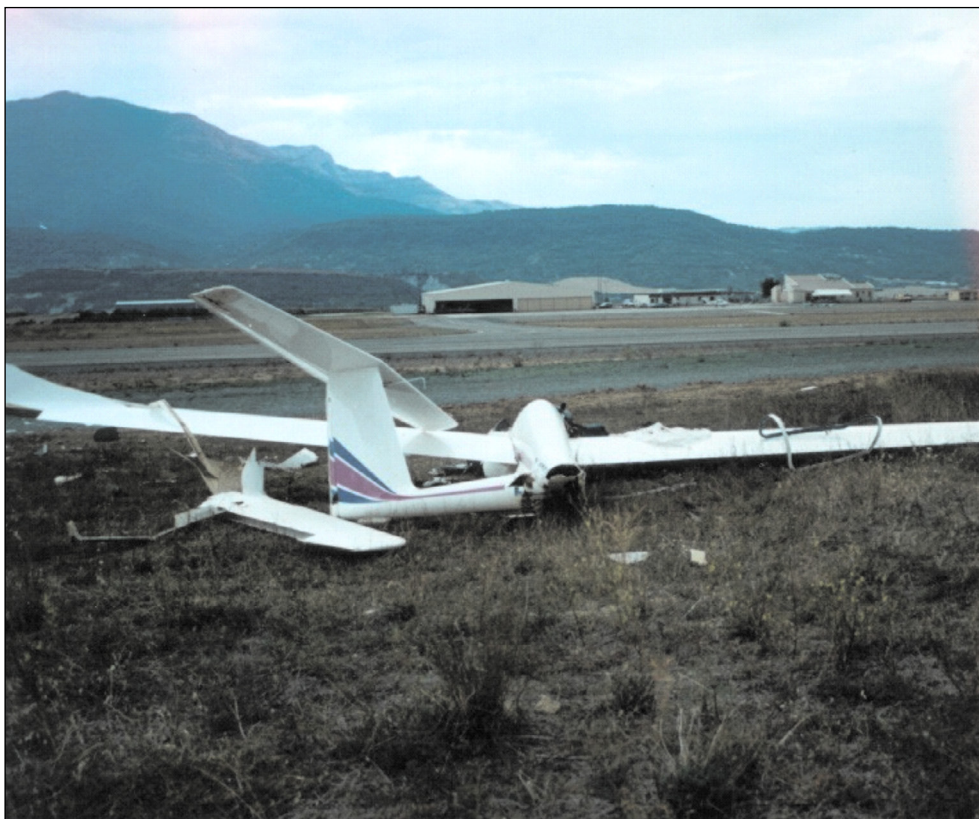
Figure 3 is a photograph showing the wreckage seen from the rear part of the fuselage and in a direction approximately perpendicular to the trajectory. As can be seen in the figure, in the accident the aircraft dragged laterally towards the outside of the turn it was making. It came to a stop pointing to the aerodrome's buildings and hangars, that is, with a heading perpendicular to its final course.

In this figure, the final position of the left outer wing and the fuselage breakage can be identified. The mentioned outer wing broke and shifted in a counter-clockwise direction, whereas the fuselage breakage appeared as though it occurred in the opposite sense, i.e. in a clockwise direction. Figure 4 shows details of this breakage.

Figure 3. Main wreckage

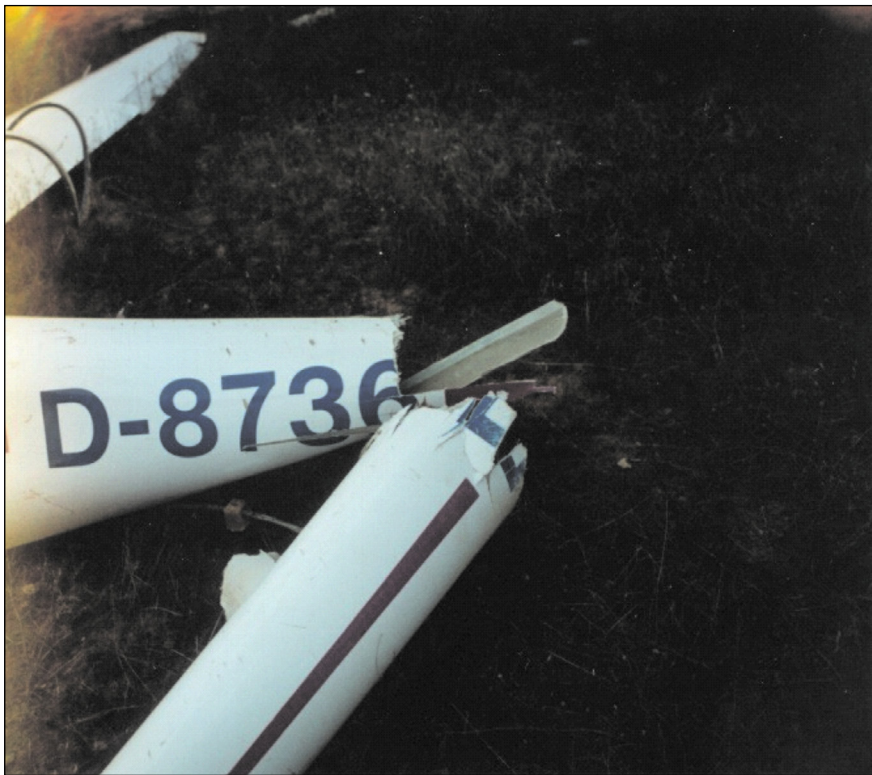
Figure 4. Detail of fuselage breakage

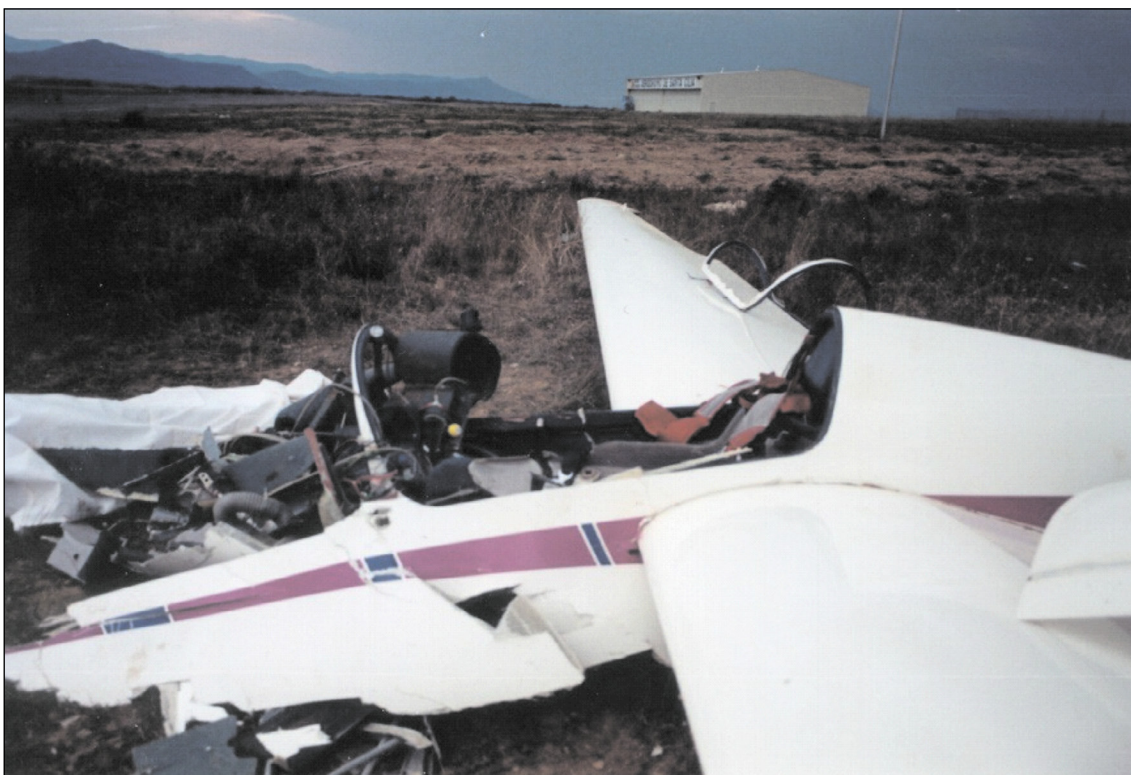
The most damaged part of the aircraft in the accident was the front fuselage (see Figure 5), particularly the front cockpit, occupied by the deceased pilot. The impact angle was estimated at more than 20°.

Figure 5. Front fuselage and cockpit wreckage
