CIAIAC

TECHNICAL REPORT

IN-069/2002

**Incident involving BOEING
B-747-300 aircraft,
registration TF-ATH, at
Madrid-Barajas Airport on 14
September 2002**

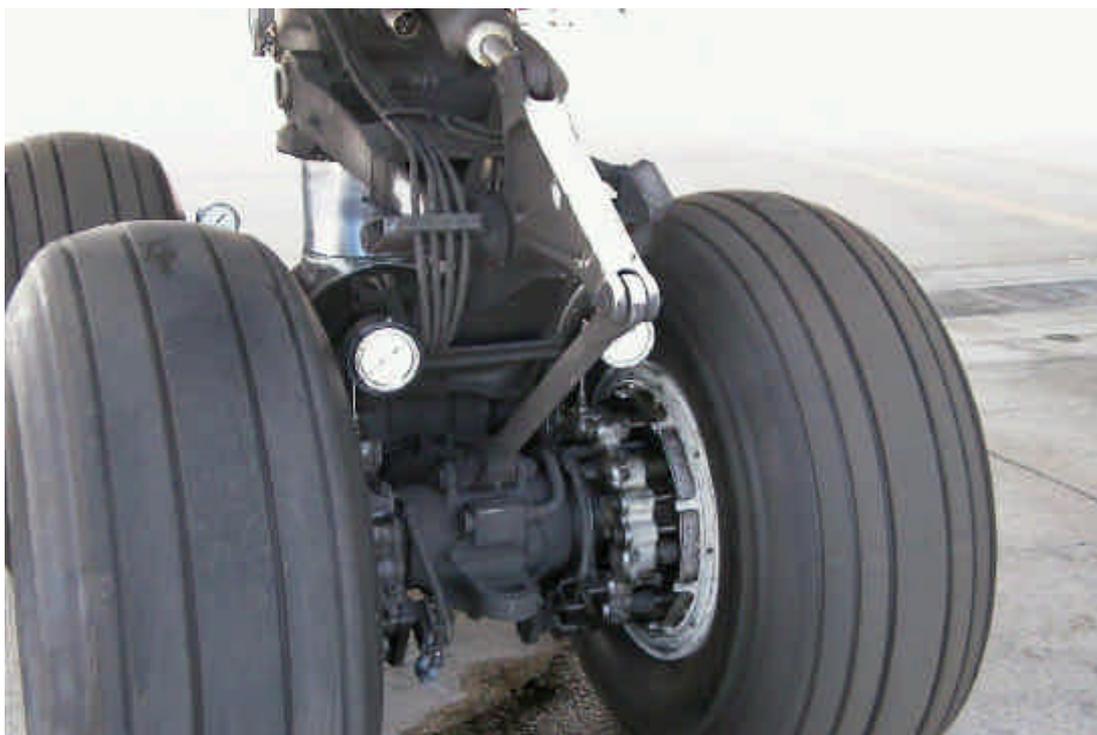
Gauges installed on the brakes of TF-ATH

The results of the test were satisfactory according to the PASS criteria of the maintenance manual. The conclusion was that the system worked all right and therefore it was fully operative.

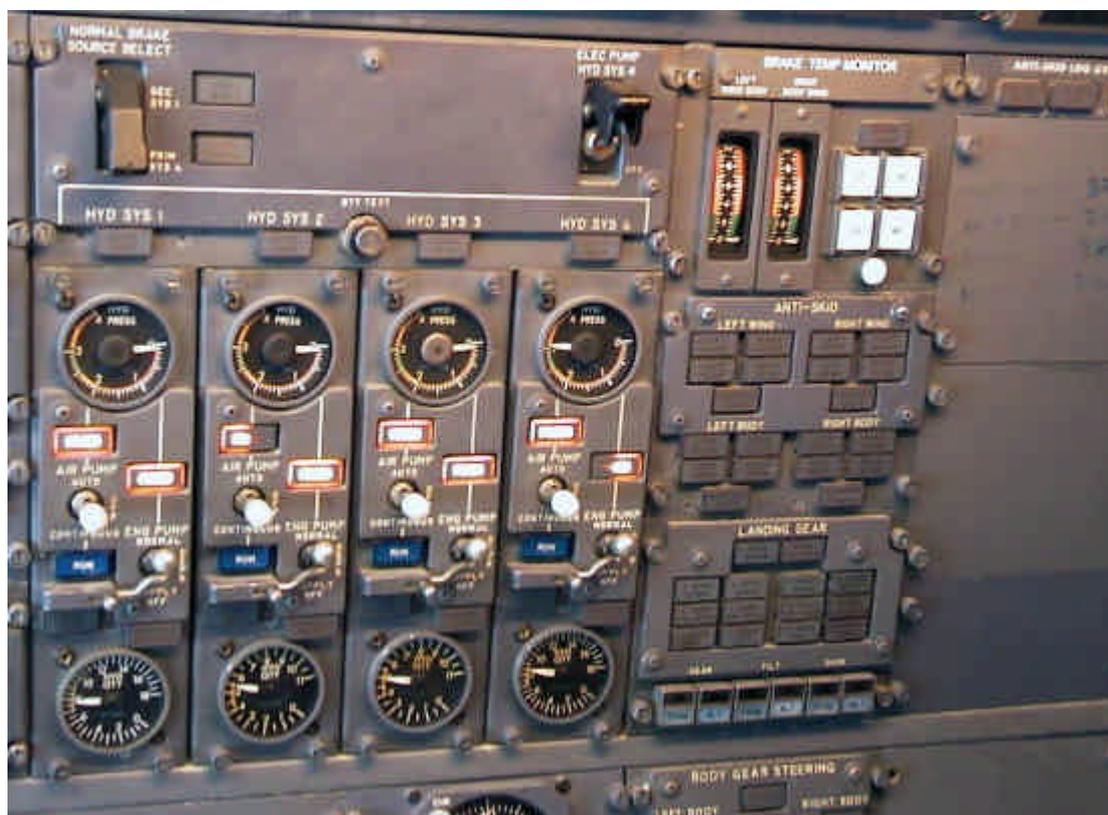
CM-3 Panel. ACP switch (labeled "ELEC PUMP HYD SYS 4", cover lifted) noted. Pressure gauge of Hyd. System No. 4 shows 3100 PSI.

Additionally, it was noted that the electrical pump (ACP) was immediately and automatically disconnected at the very first crank of engine four.
