**DATA SUMMARY**

Date and time	<b>Tuesday, 18 November 2002; 16:45 hours</b>
Site	<b>Airport of Sabadell</b>

Registration	<b>F-BRDL</b>
Type and model	<b>SOCATA RALLYE 180</b>

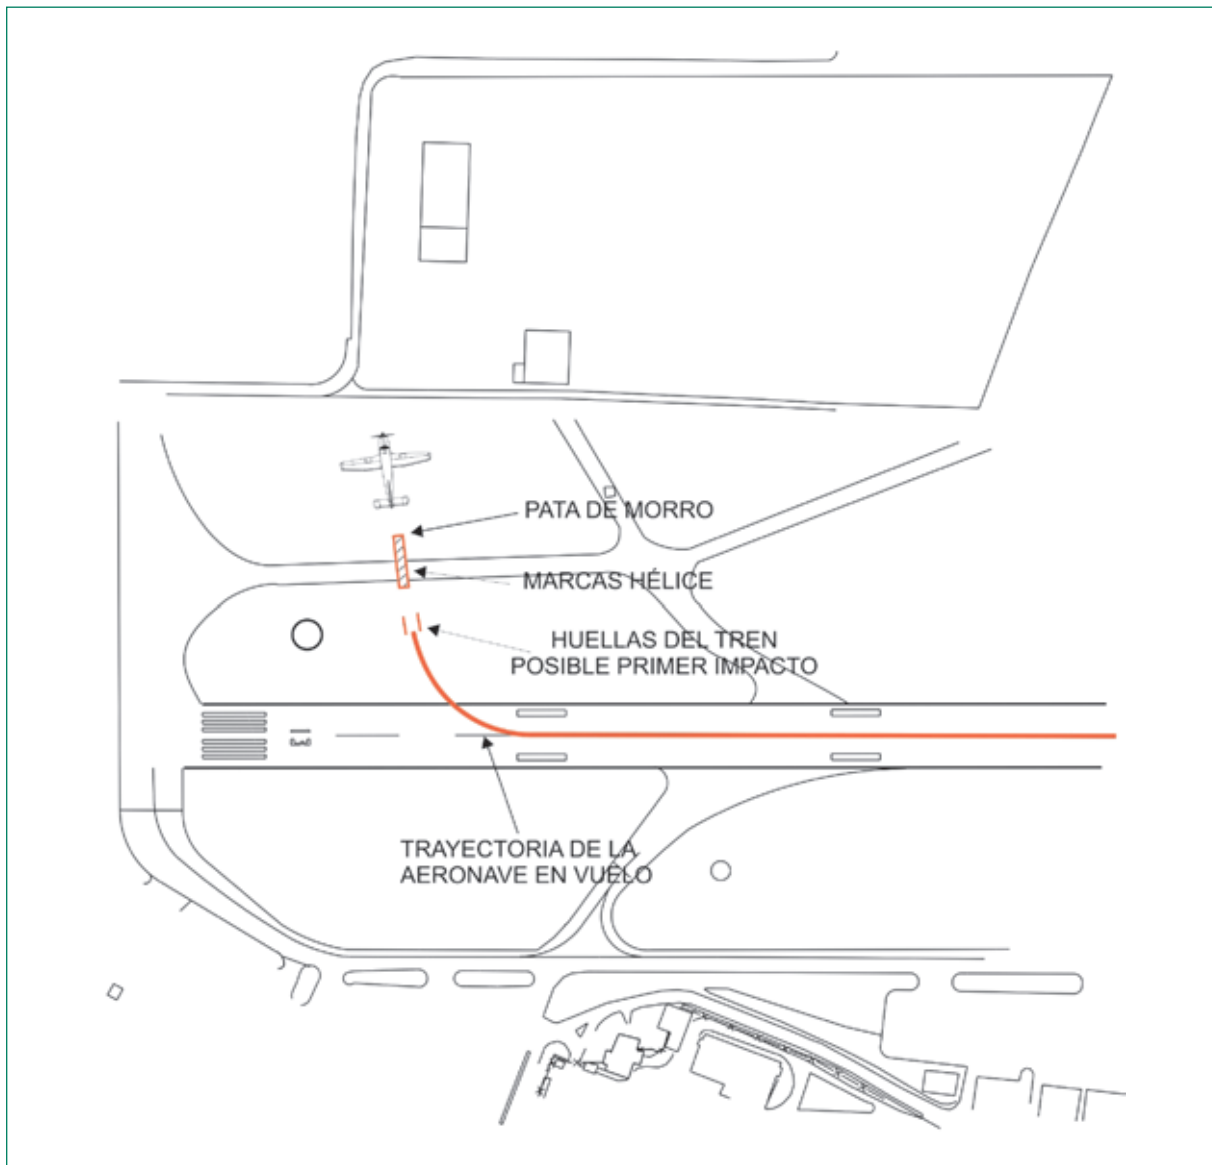
The aircraft suffered damage to its nose landing gear, propeller and engine.

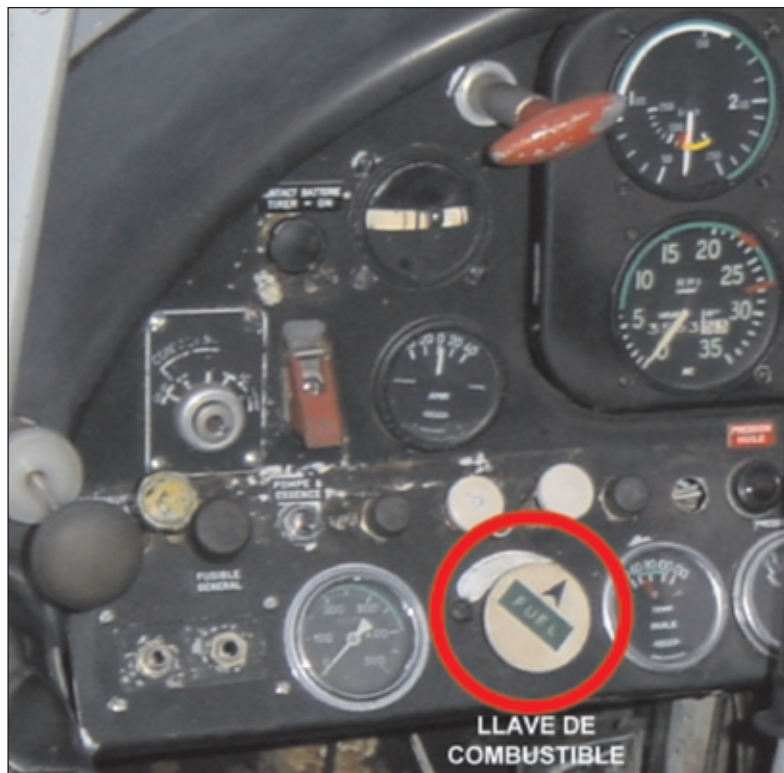
The fuel switch on this aircraft (see photograph) has two positions: open and closed. In the photograph, the switch is in the closed position. The switch is moved to the open position by turning it about 90 degrees to the left, until it reaches the limit.

In both positions, closed and open, the switch is locked into position, but this will not happen if the switch is in any intermediate position between the open and closed positions.

The loss of power of the engine was due to fuel starvation caused by the closure of the fuel switch.

This suggests that before initiating the takeoff run, the fuel switch was already in a position very close to «closed». The pilot did probably not notice this circumstance, due to the fact that the pre-flight check was not carried out in its entirety.
