TECHNICAL REPORT

A-002/2003

**Accident of aircraft FOKKER 50,
registration PH-FZE, at Melilla Airport (Spain),
on 17 January 2003**

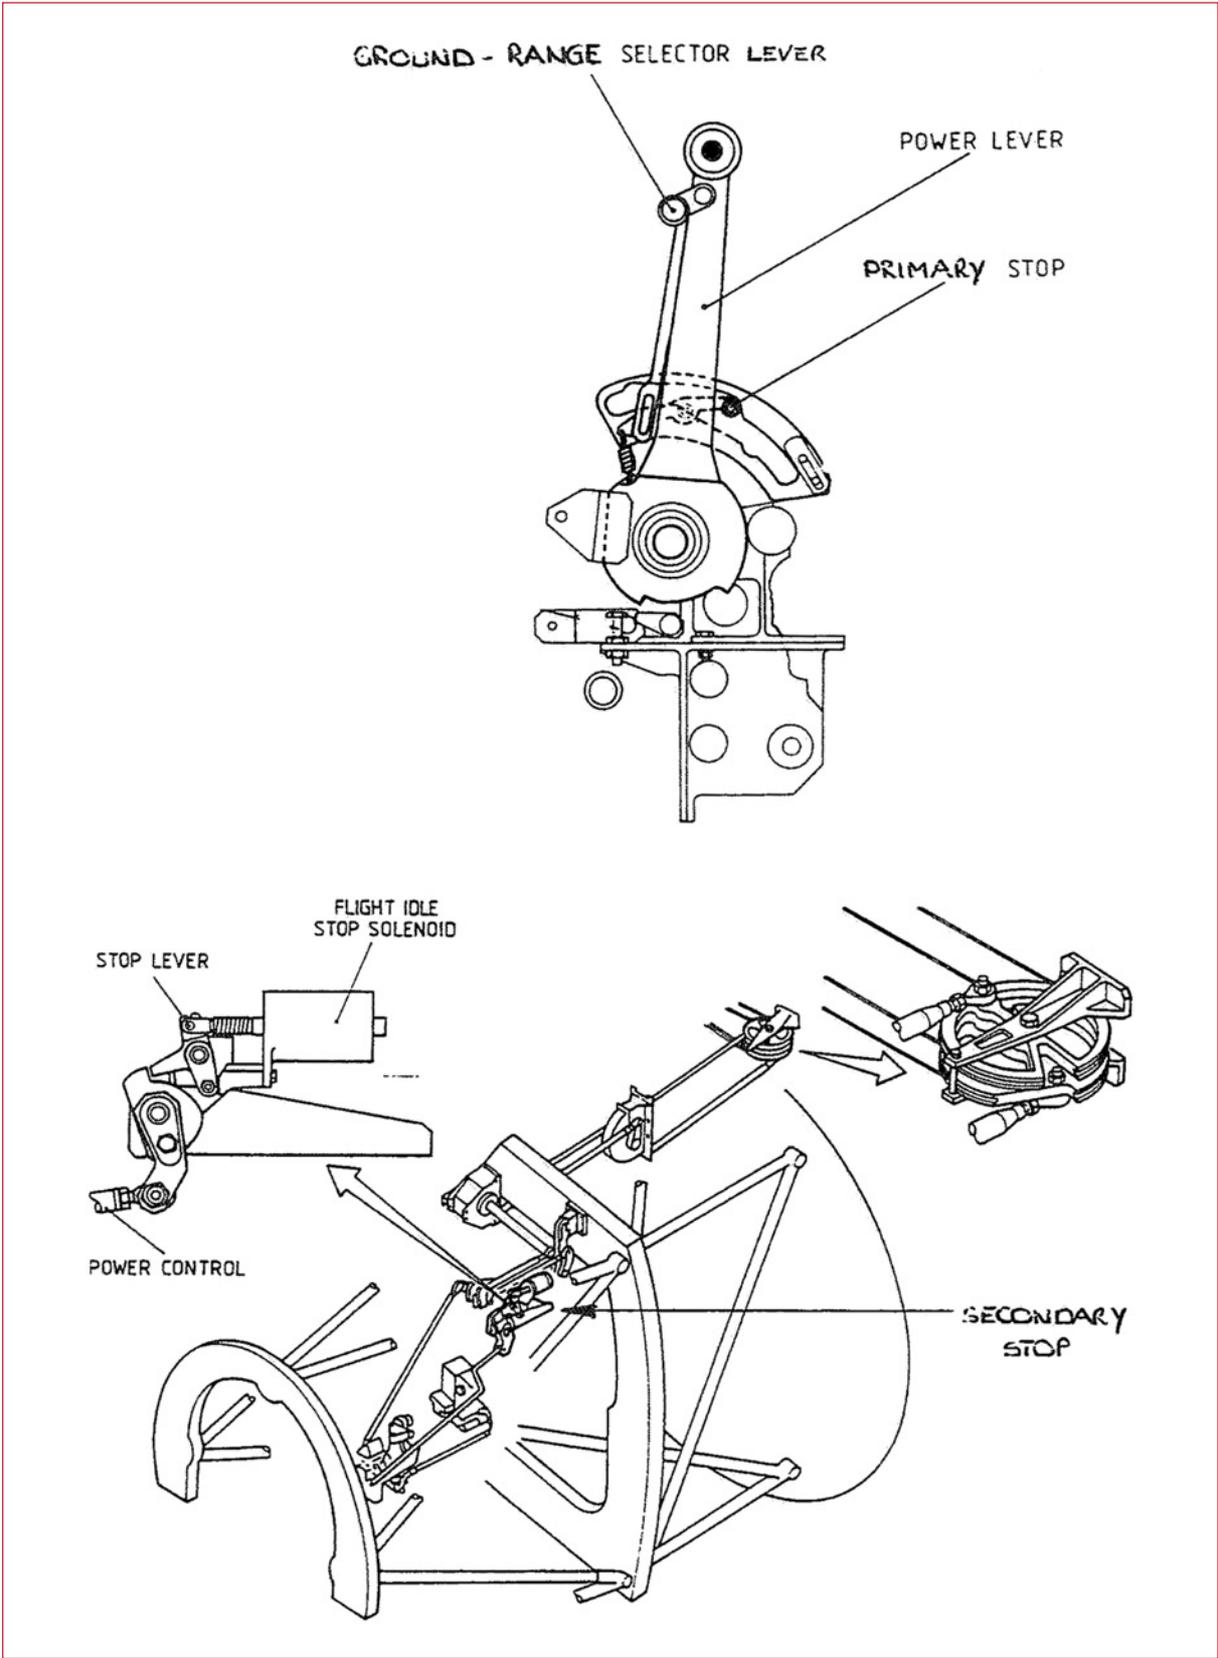
Figure 1.6.3.2. Detail of the automatic flight idle stop assembly (from Fokker SL 137)

However, the contrary is also true: if certain failures happen, and the solenoid is not energized on the ground, the automatic flight idle stop is not removed and ground idle or thrust reverse cannot be selected when desired by the pilot. There is no «override» feature on the cockpit to overcome this possible fault.

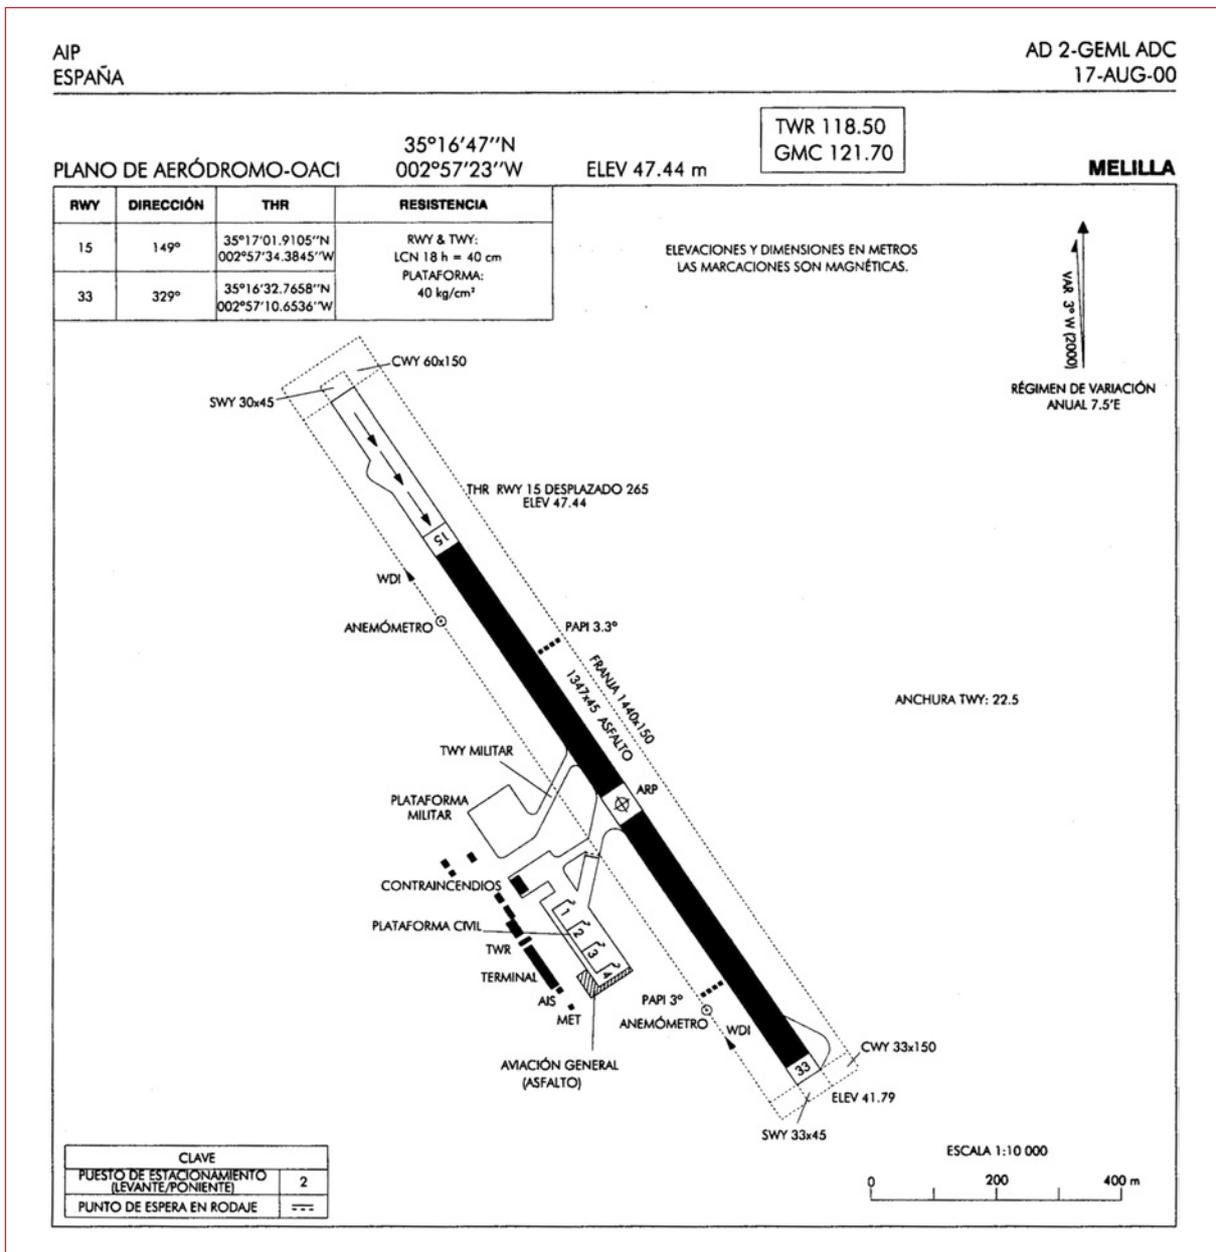
According to the AIP dated 17-8-00 (see Figure 1.10.1), since this runway had a stopway, it would mean that there was no strip available at the end of runway 15.

Figure 1.10.1. AIP revised in year 2000. At the end of Runway 15 there is a stopway of 33 m × 45 m

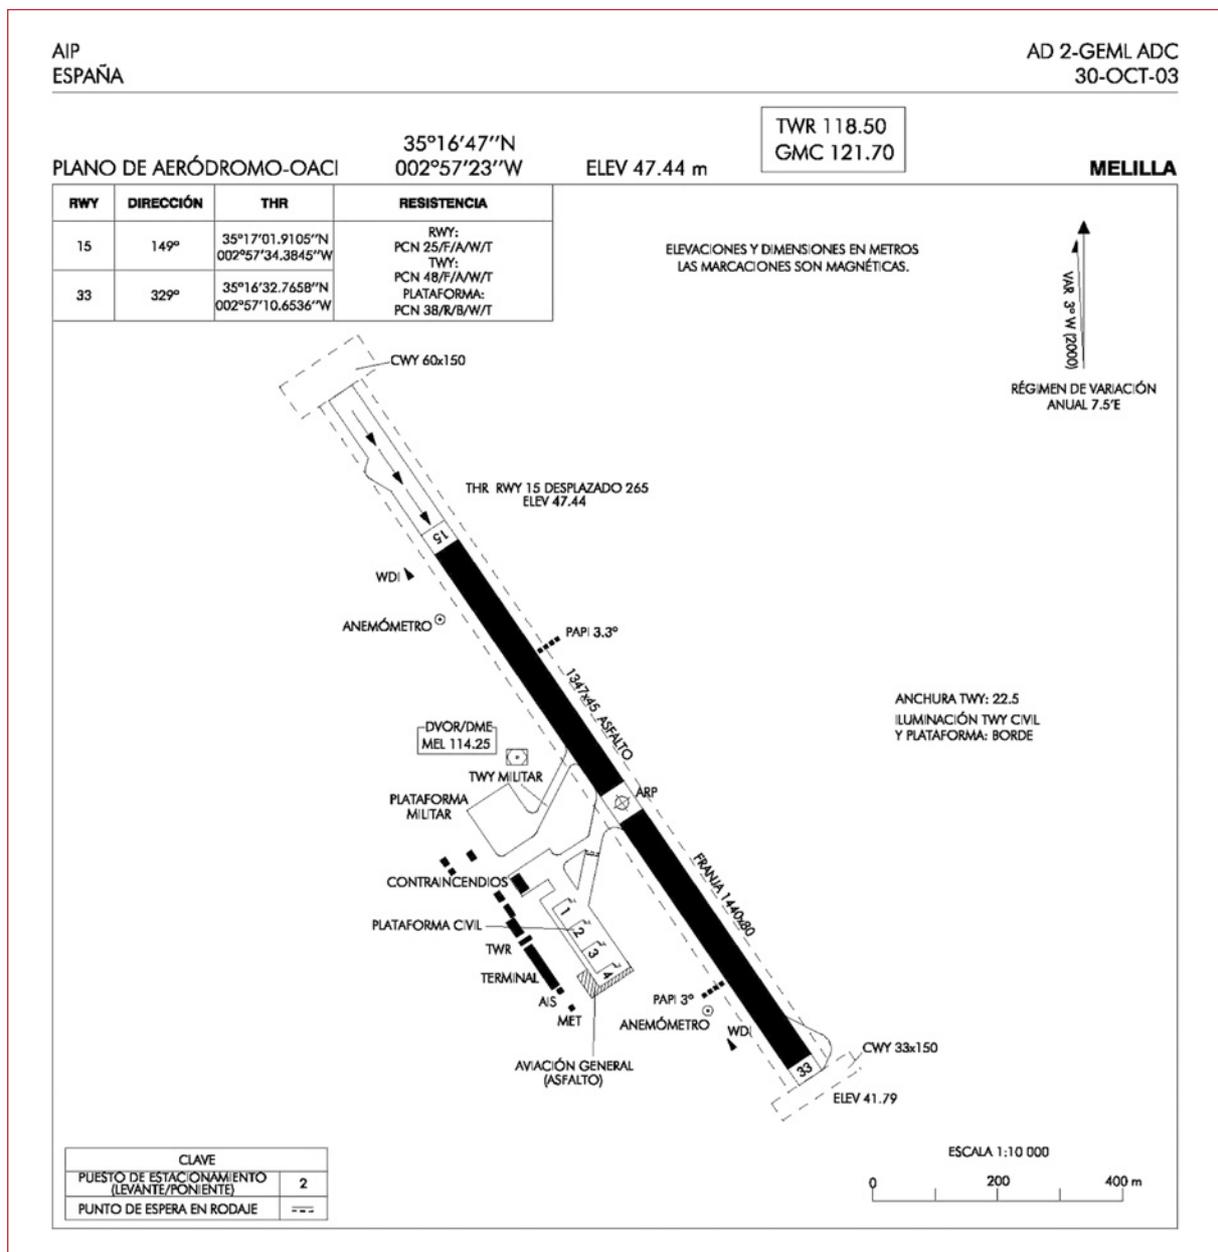
Some inquiries were made regarding the suitability of the strip at Melilla Airport and in October 2003, the AIP was amended and any reference to a stopway in runway 15 was deleted. It was stated that the runway strip extended 33 m × 80 m beyond the end of runway 15. However, this strip did not yet comply with the recommendations of Annex 14 of ICAO, which required a strip of 60 m of length and recommended 150 m of minimum width for such a strip (see attached Figure 1.10.2).

Figure 1.10.2. AIP revised in October 2003. At the end of Runway 15 there is no stopway

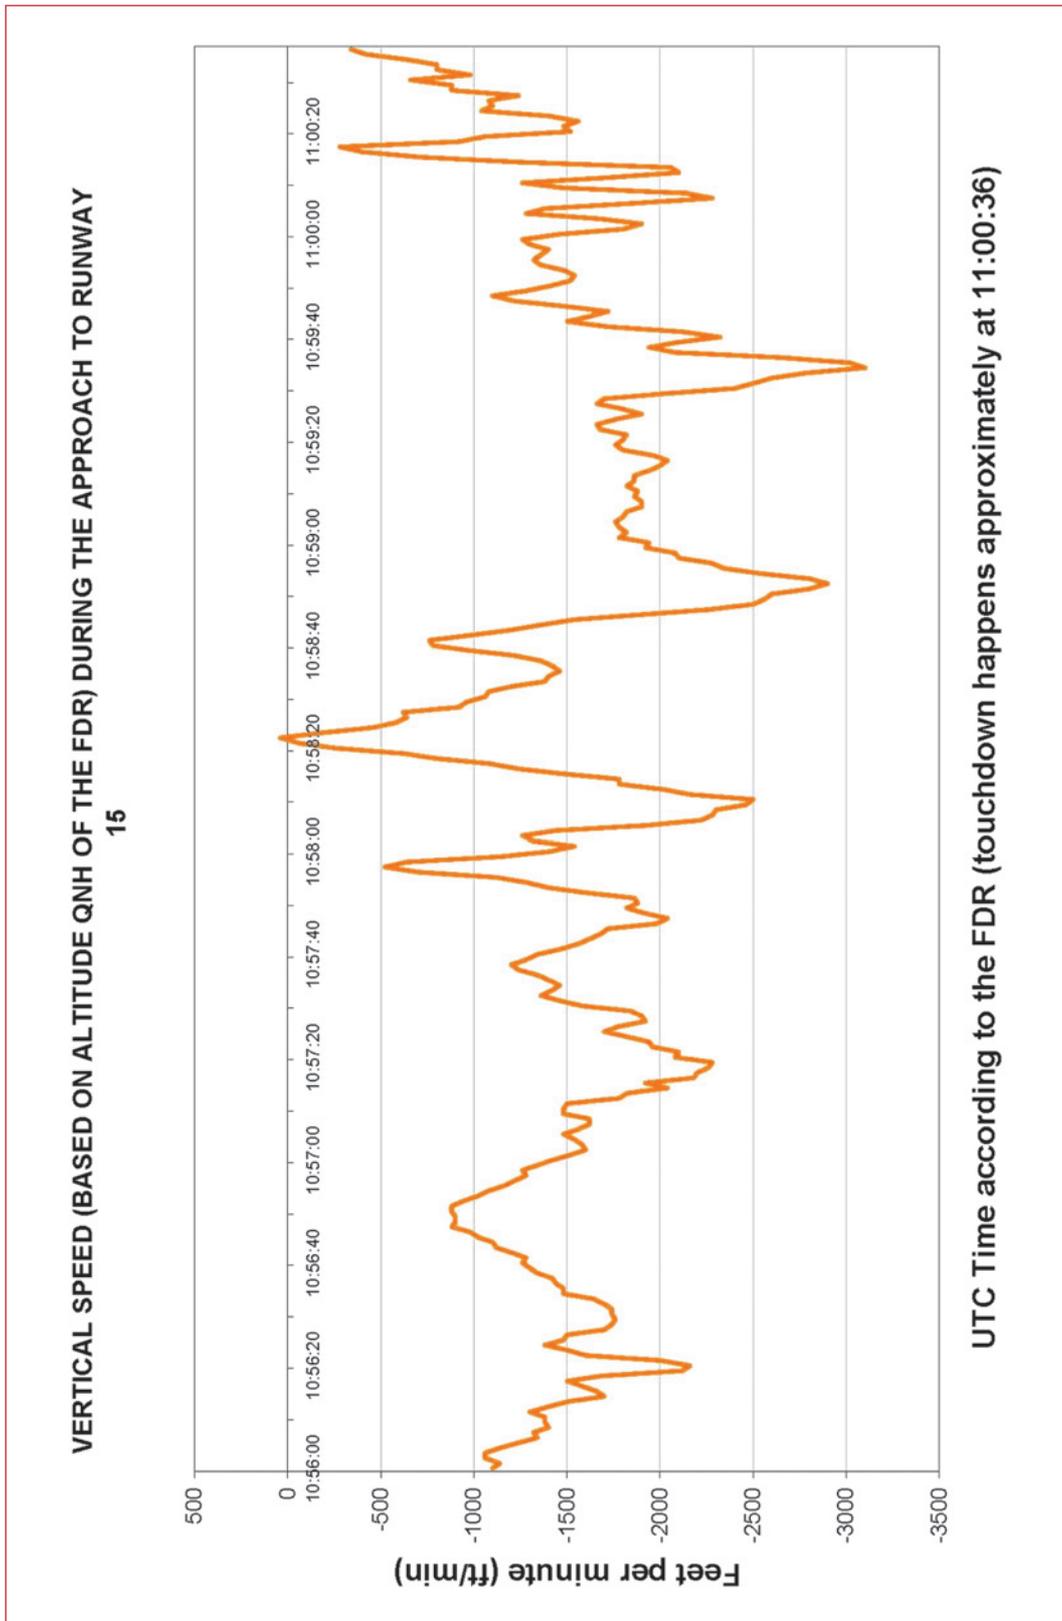
Figure 1.11.2.2.1. Vertical speed. Around 15 seconds before touchdown the vertical speed was between 1,500 and 1,000 fpm

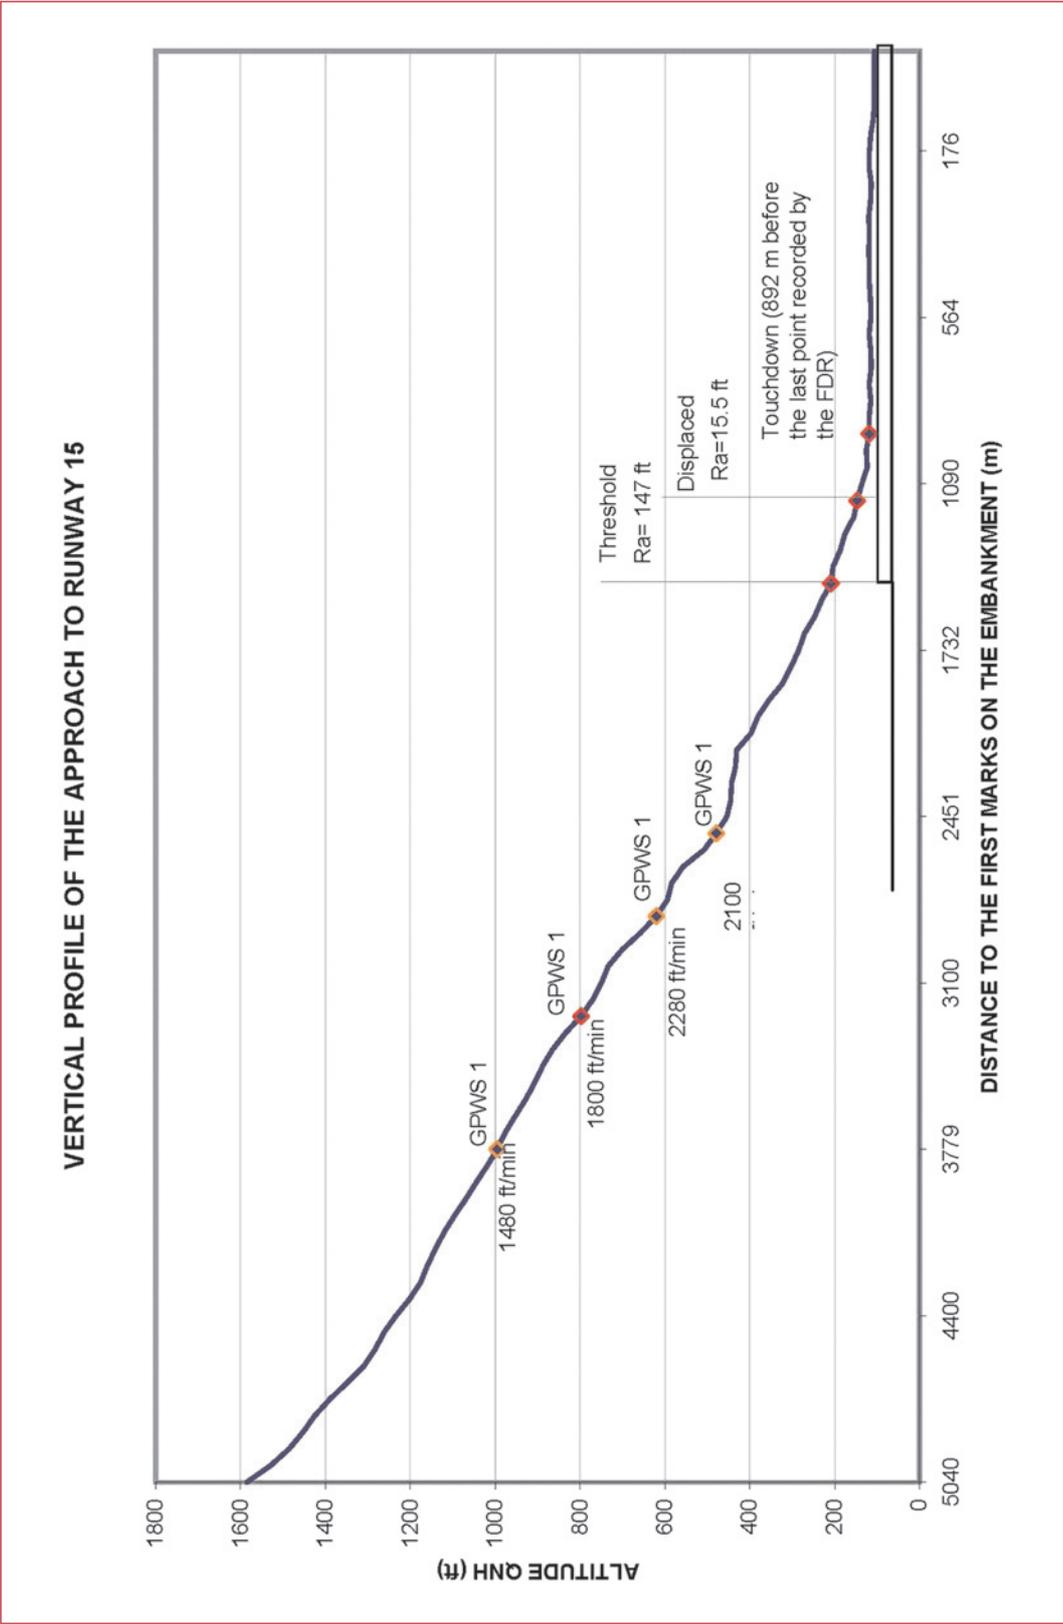
Figure 1.11.2.3.1. Vertical profile and landing rollout. The aircraft ran around 892 m from touchdown up to the end of the recording (impact with the terrain of the embankment)

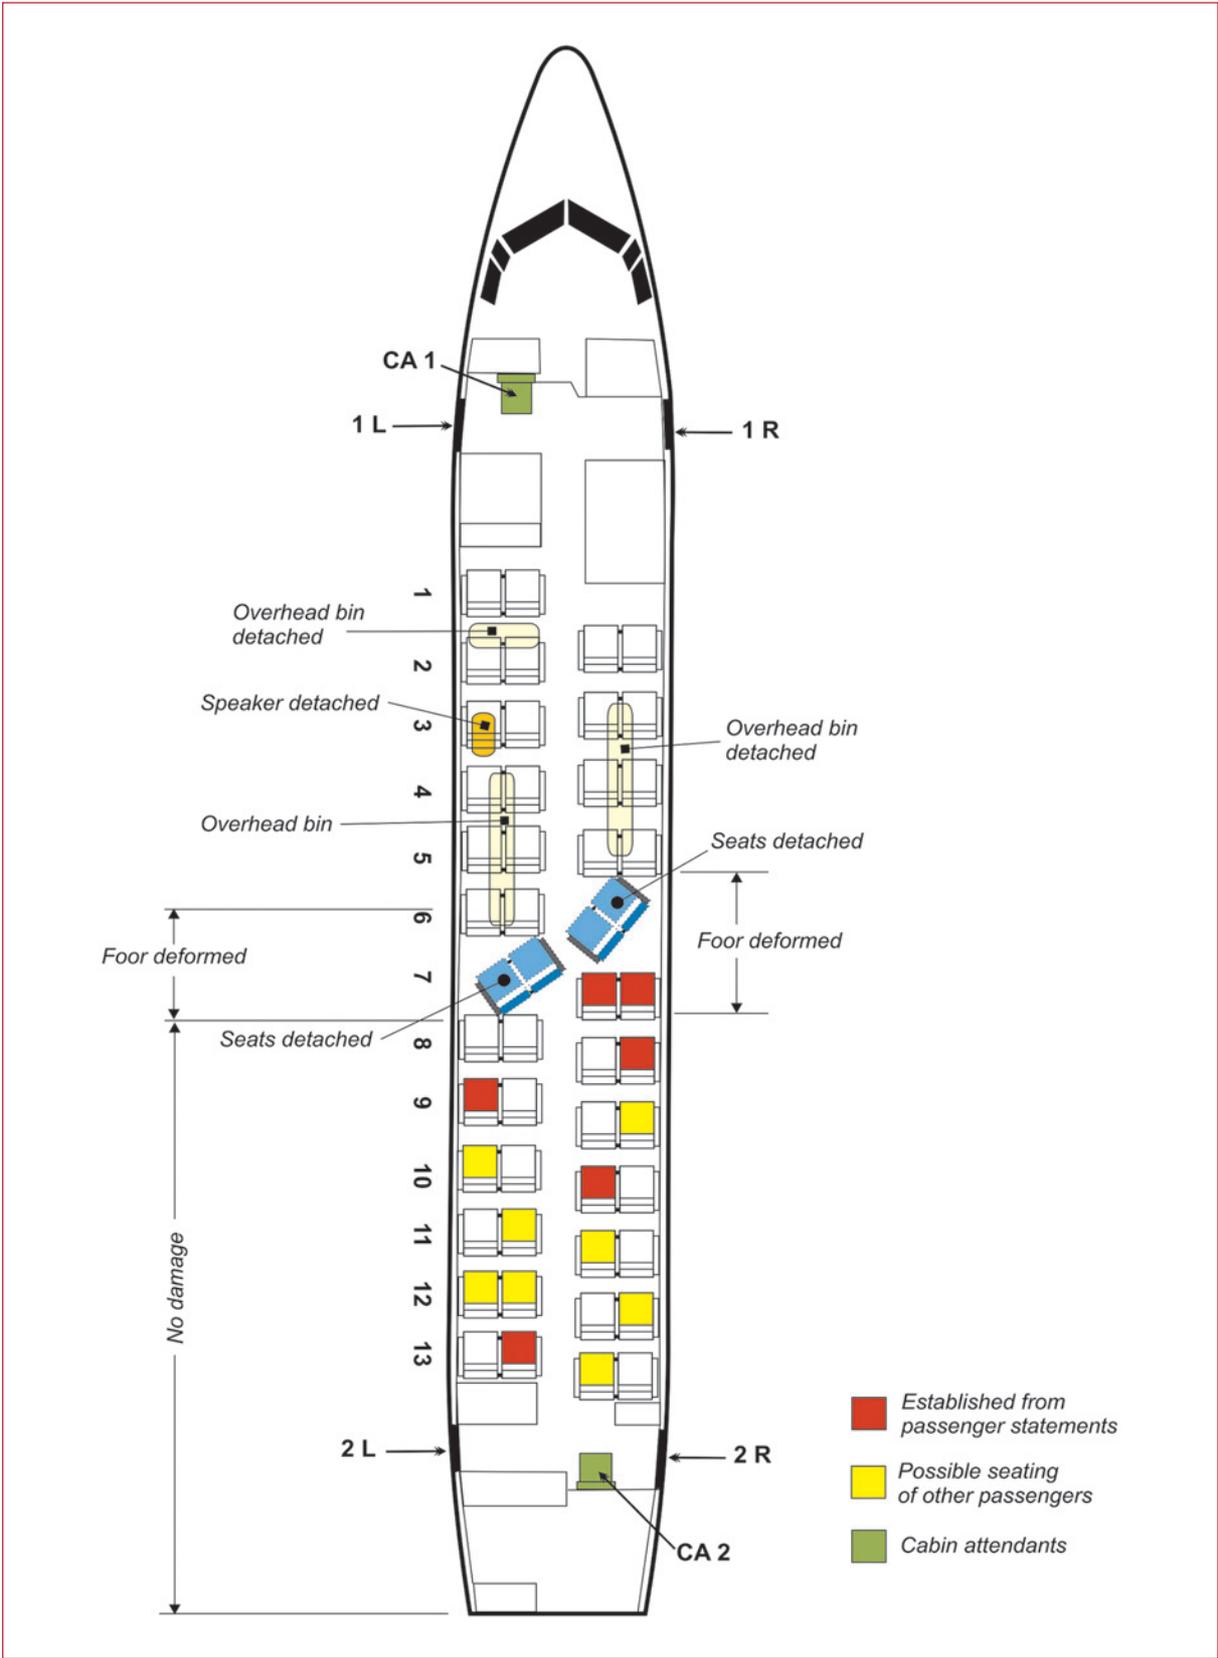
Figure 1.15.1. Drawing of the passenger cabin damage

As a result of the impacts when the aircraft jumped through the slope (the highest and latest recorded value of vertical acceleration was 5 g), the passenger cabin suffered important damage in its central part, where the wing was detached from the fuselage. The four seats of row 7 were detached and 2 overhead bins detached and fell towards the seats (see Figure 1.15.1). However, there was no noticeable damage to the seats, overhead bins or floor from row 8 towards the tail of the aircraft.

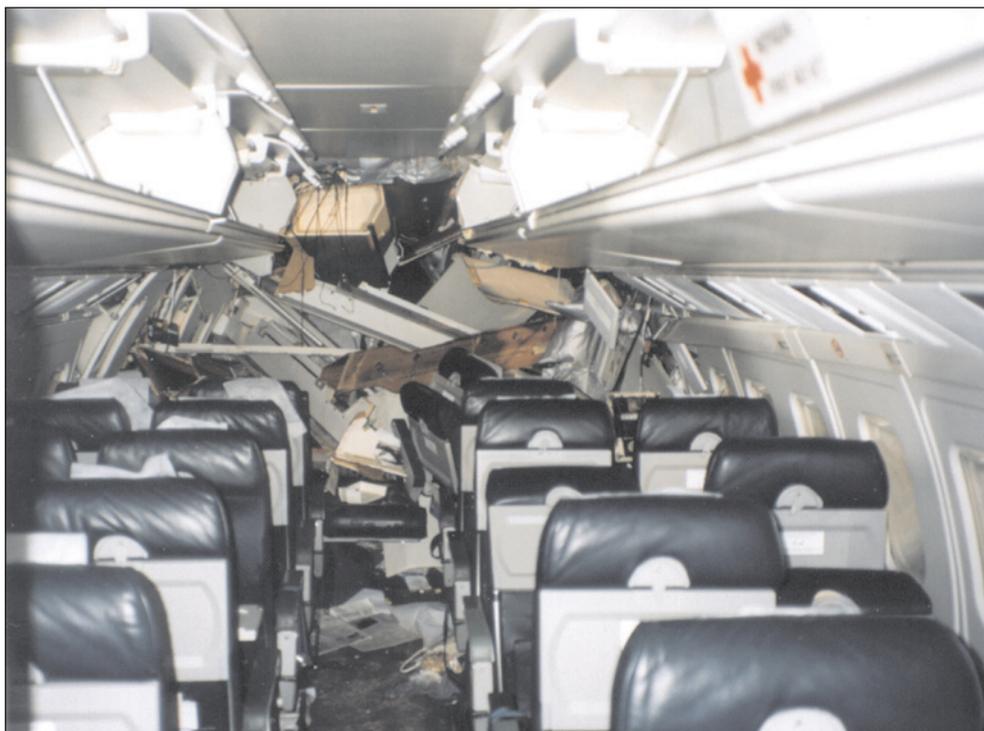
Figure 1.15.2. View of the damage from the rear part of the cabin

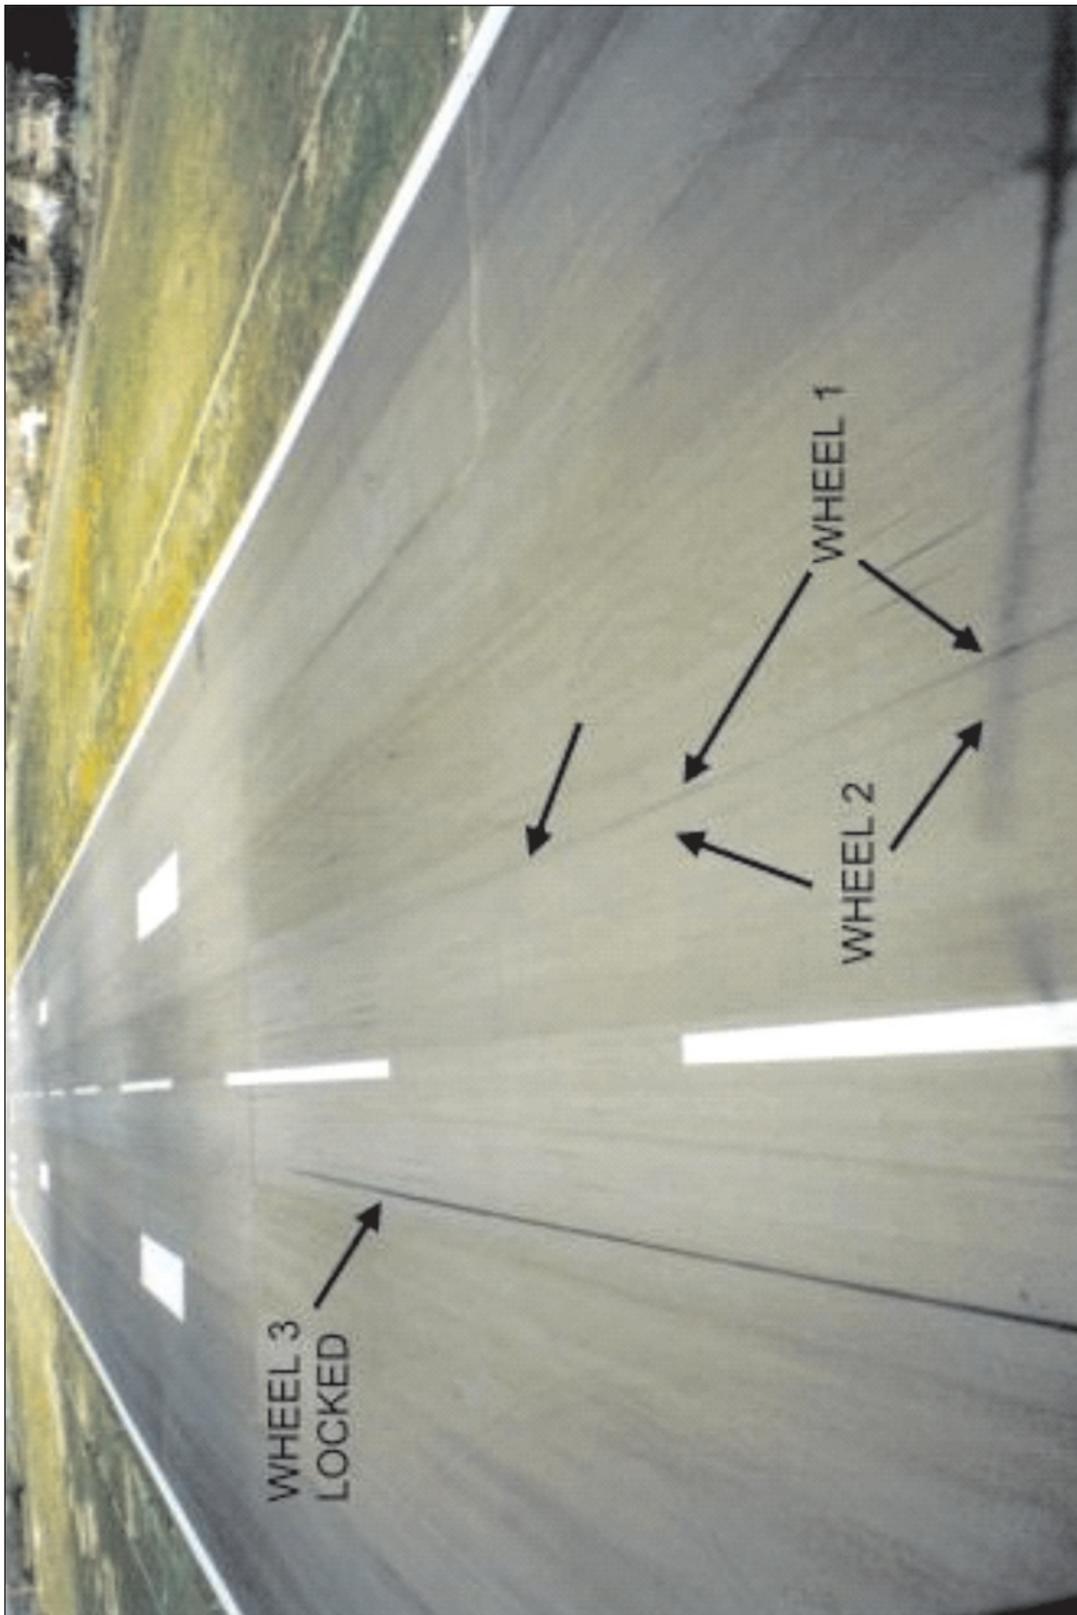
Photo 1. View towards runway 15 threshold (i.e., in the sense contrary to the landing roll). Track of wheel 3 clearly marked and showing signs of tire lock

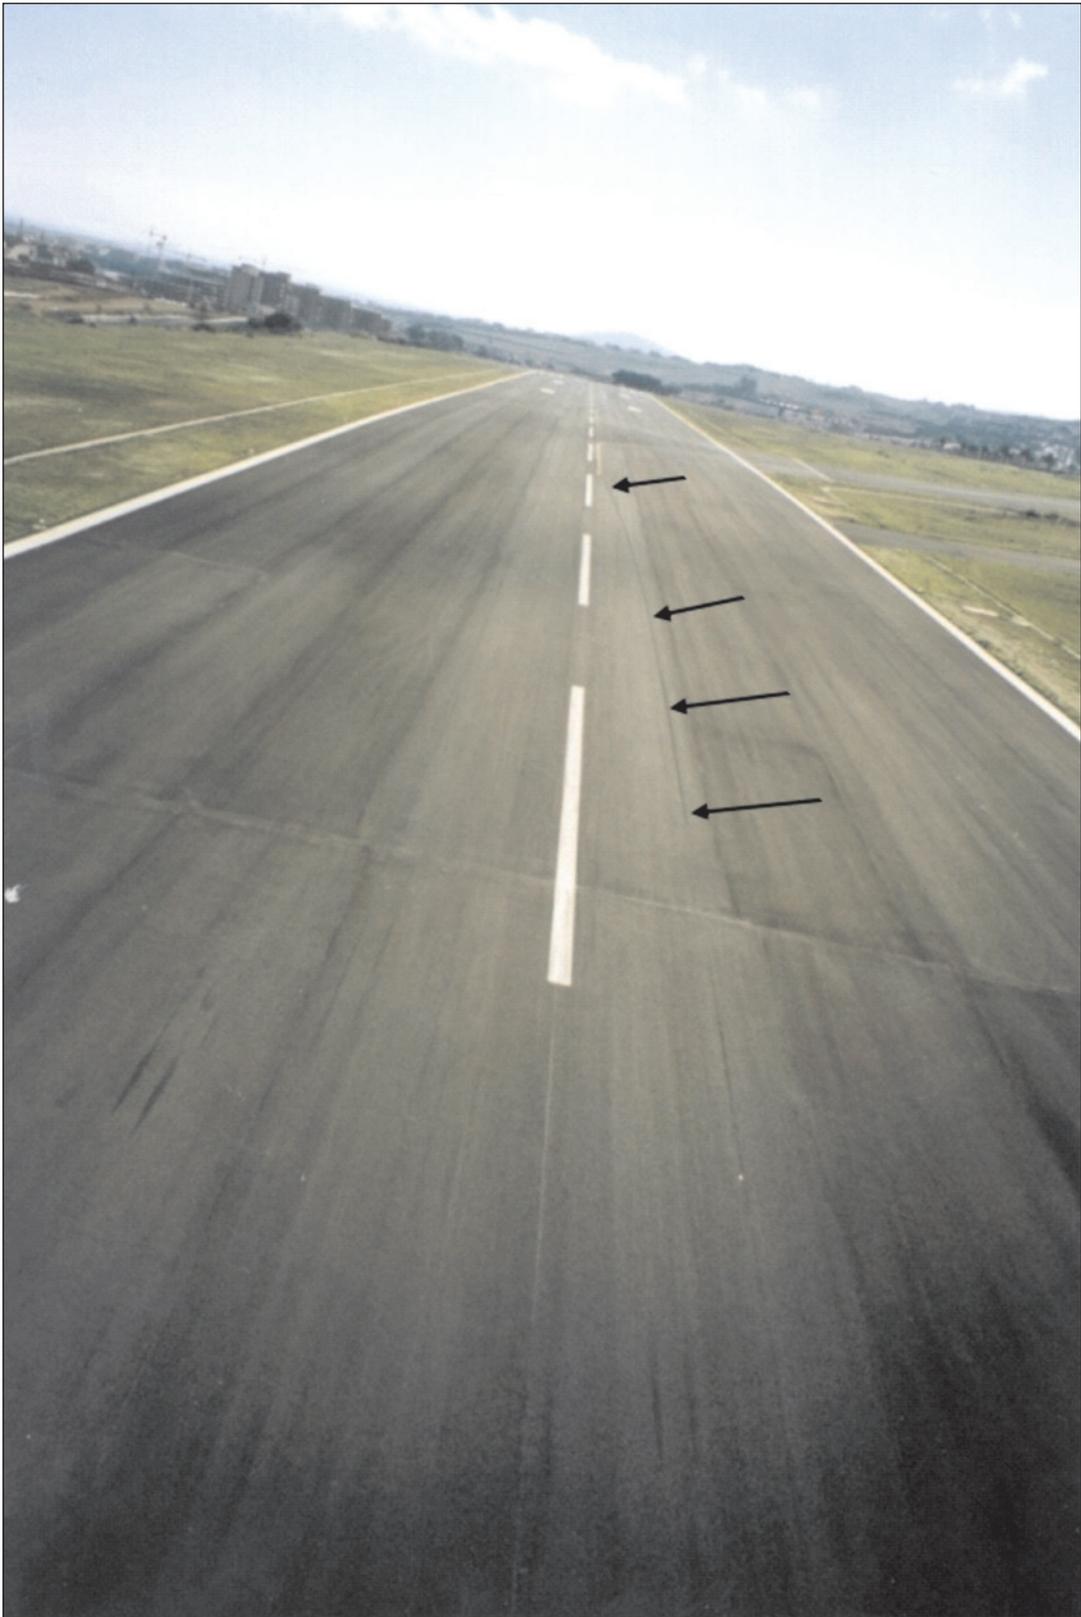
Photo 2. *View in the sense of the landing roll. Track of wheel 3 crosses the runway axis*

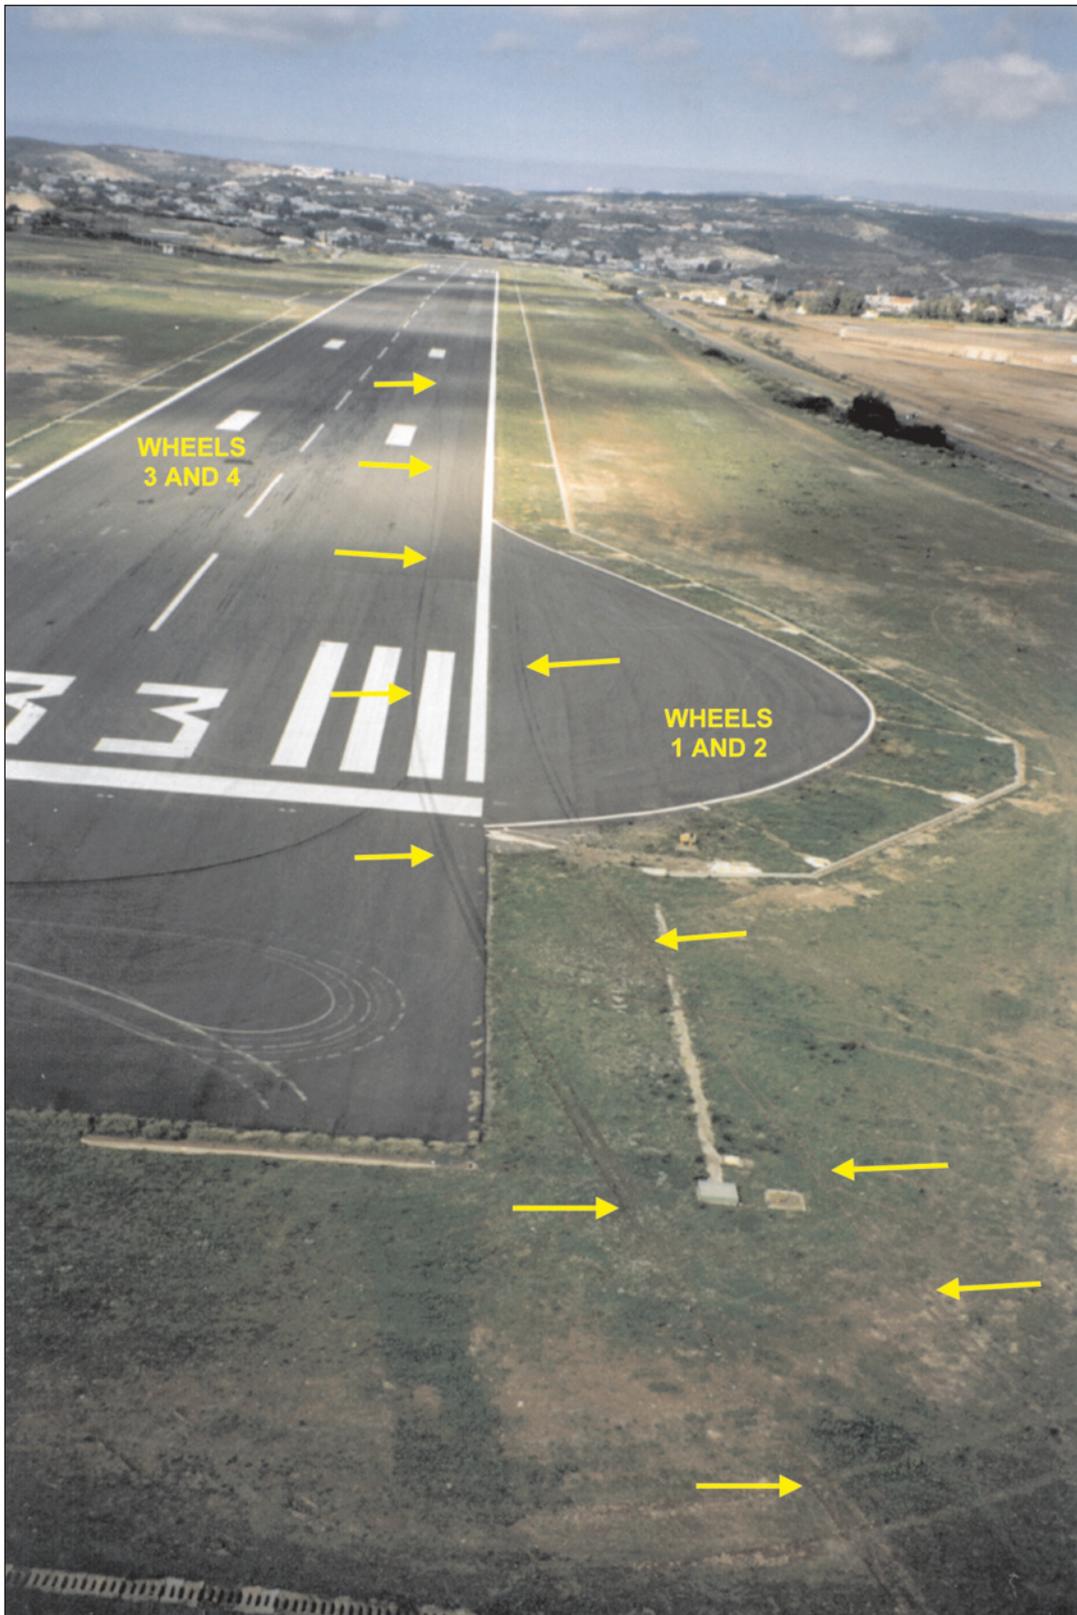
Photo 3. View in the sense contrary to the landing roll. Tracks of wheels 1 and 2 outside the runway

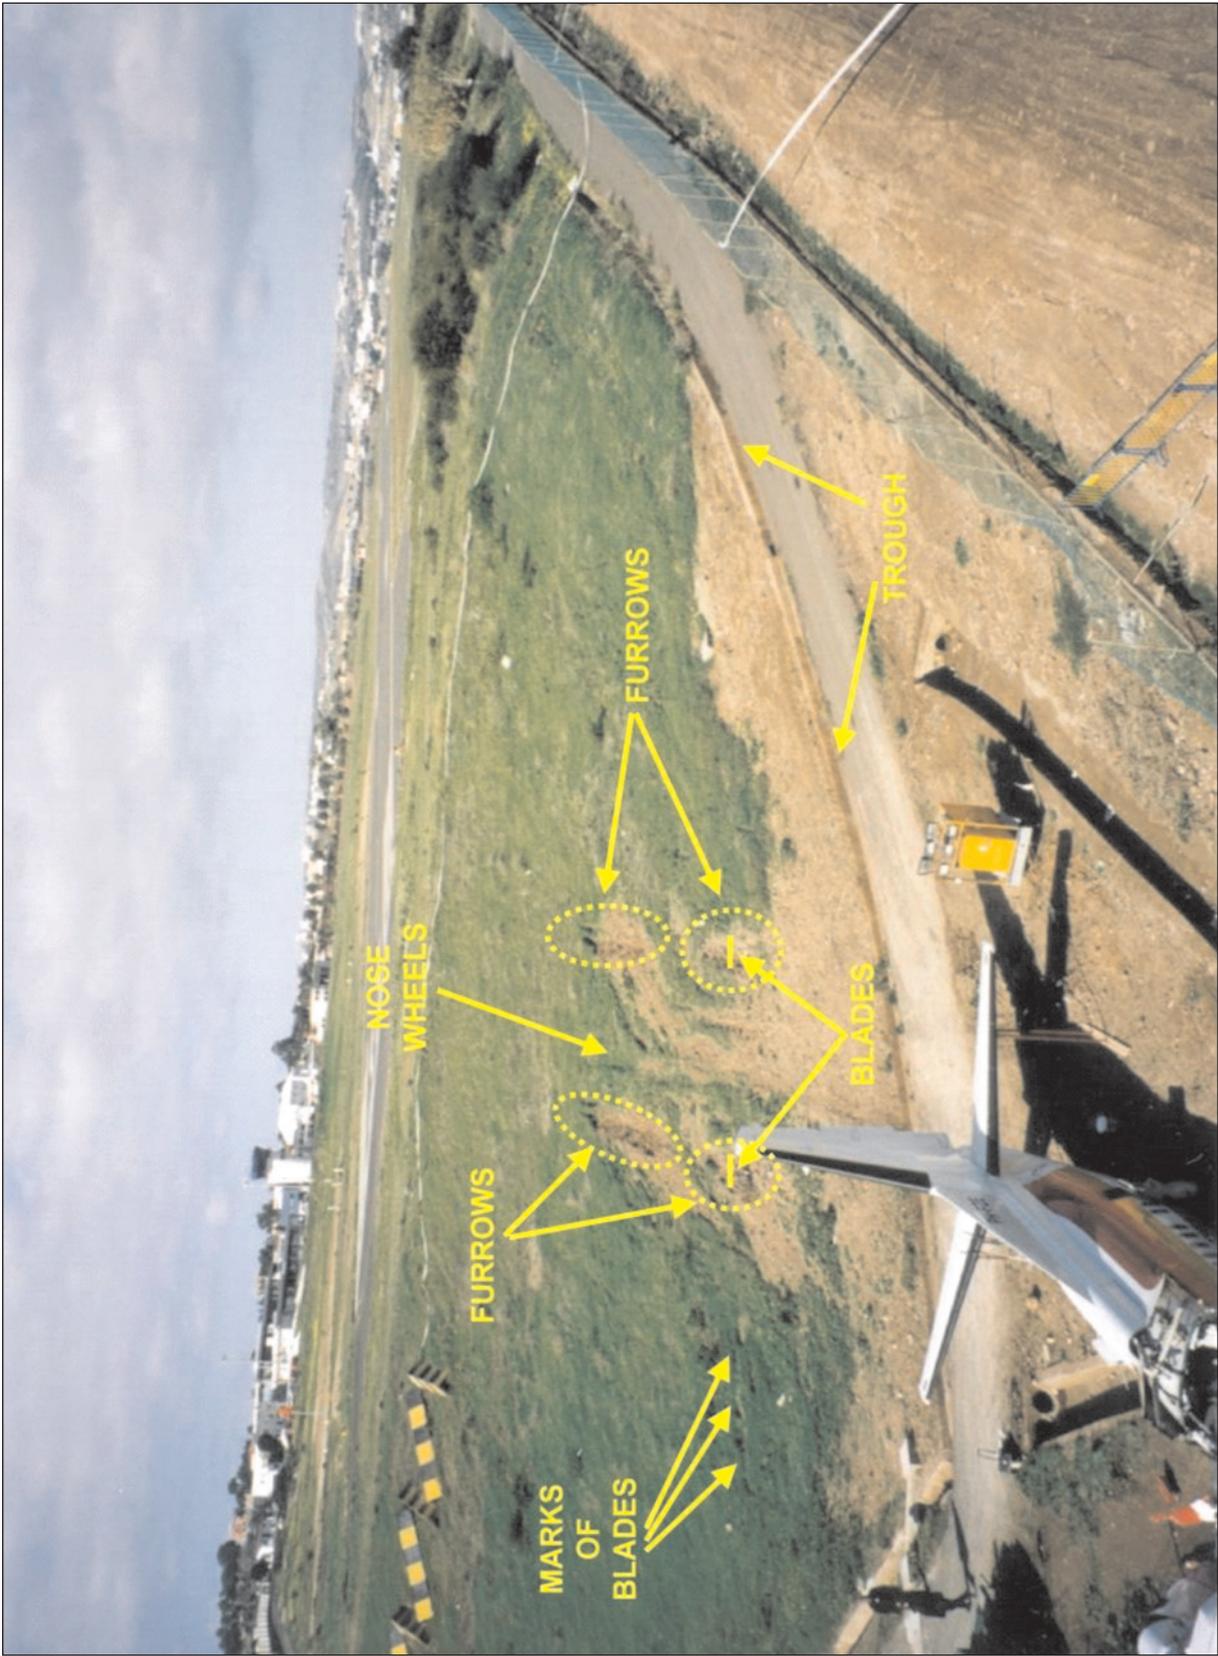
Photo 4. Final position of the aircraft and marks on the terrain of the embankment
