TECHNICAL REPORT

A-033/2003

Accident to aircraft
SOCATA TB-20
«Trinidad», registration
D-EKBI, at Alto de
Cobata-Sierra Salvada,
Amurrio (Álava-Spain),
on 27 June 2003

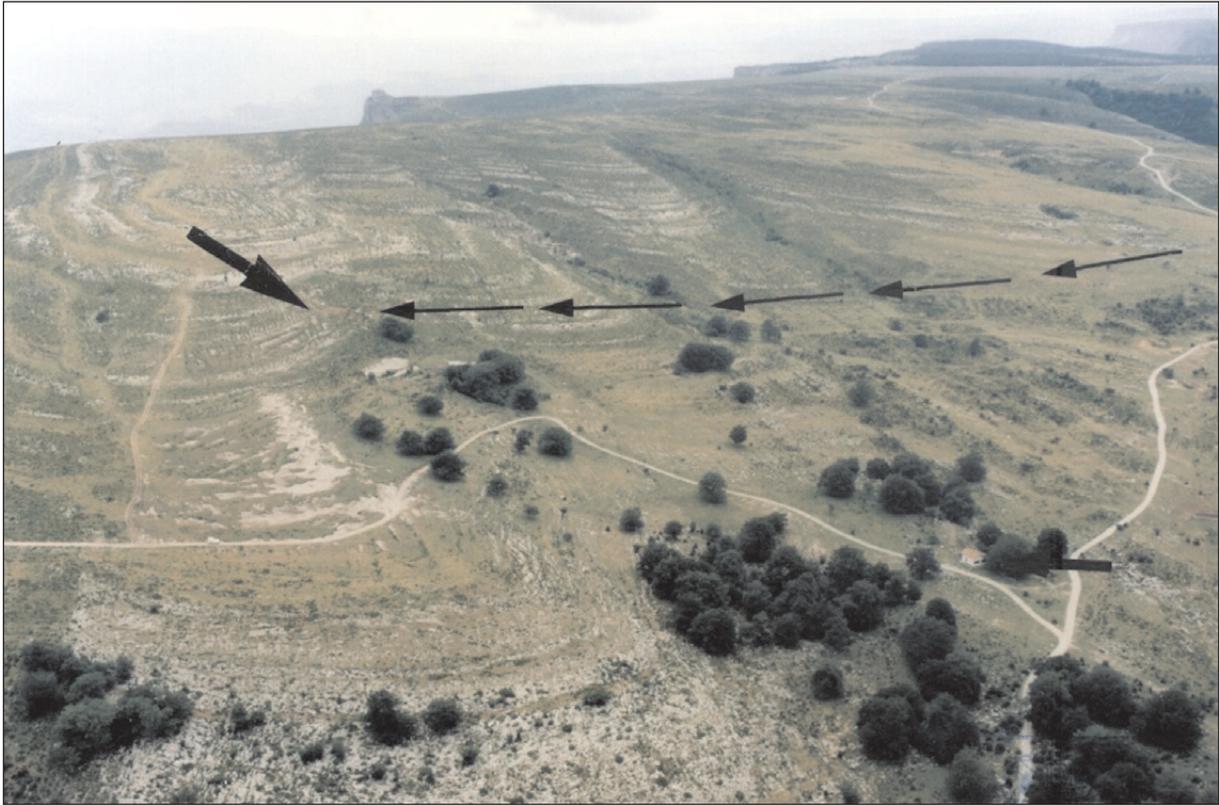
Figure A-6. *General view of the site of the accident with an indication of the impact point and the flight's probable path before the accident*

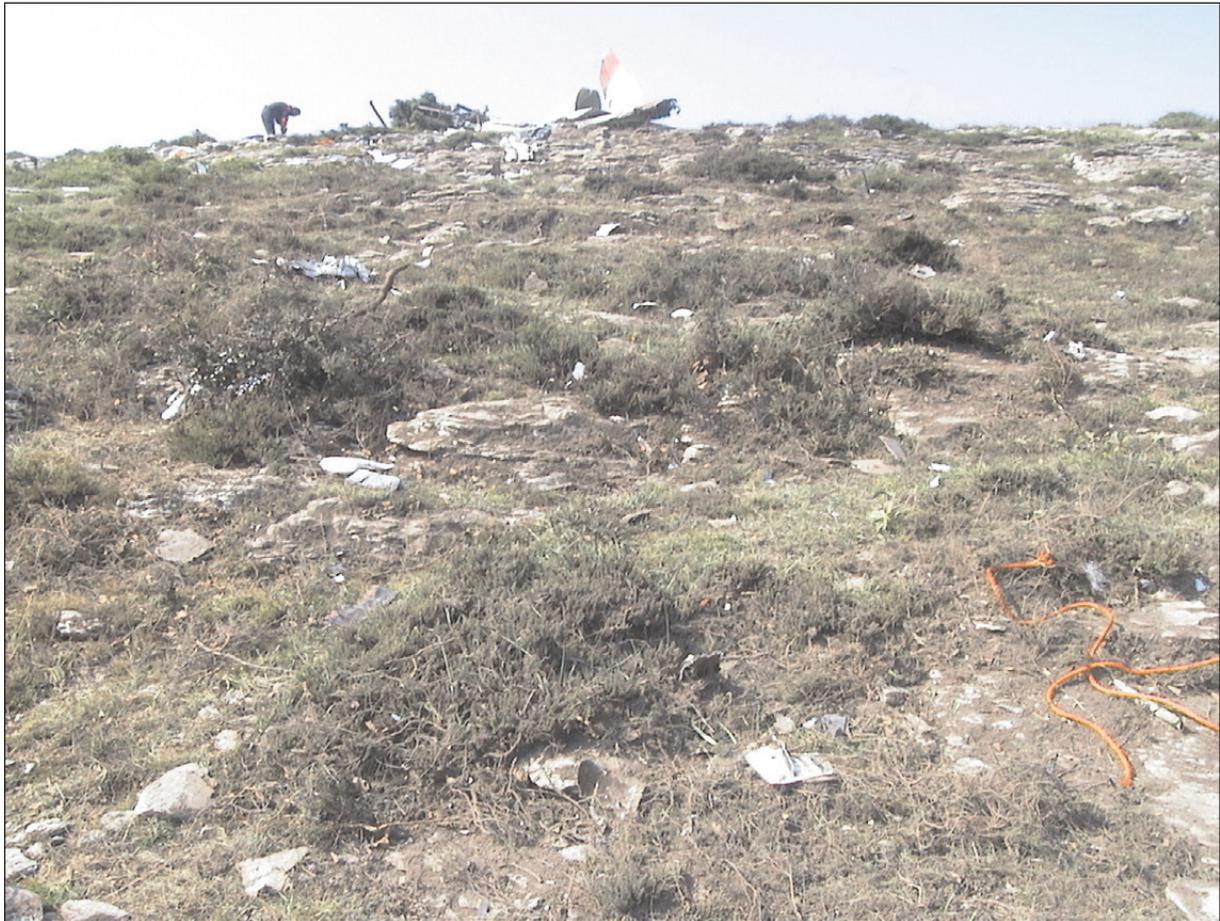
Figure A-7. *View of the point of impact in the direction of the flight, S-N*

The area of the first impact, slightly churned up, the marks of the skidding and the loose wreckage scattered about in the area can be seen in the sketch in Figure C-1 of Appendix C and in photograph A-7. The main wreckage grouped together at the end of the run can be seen in the photograph in Figure C-2).

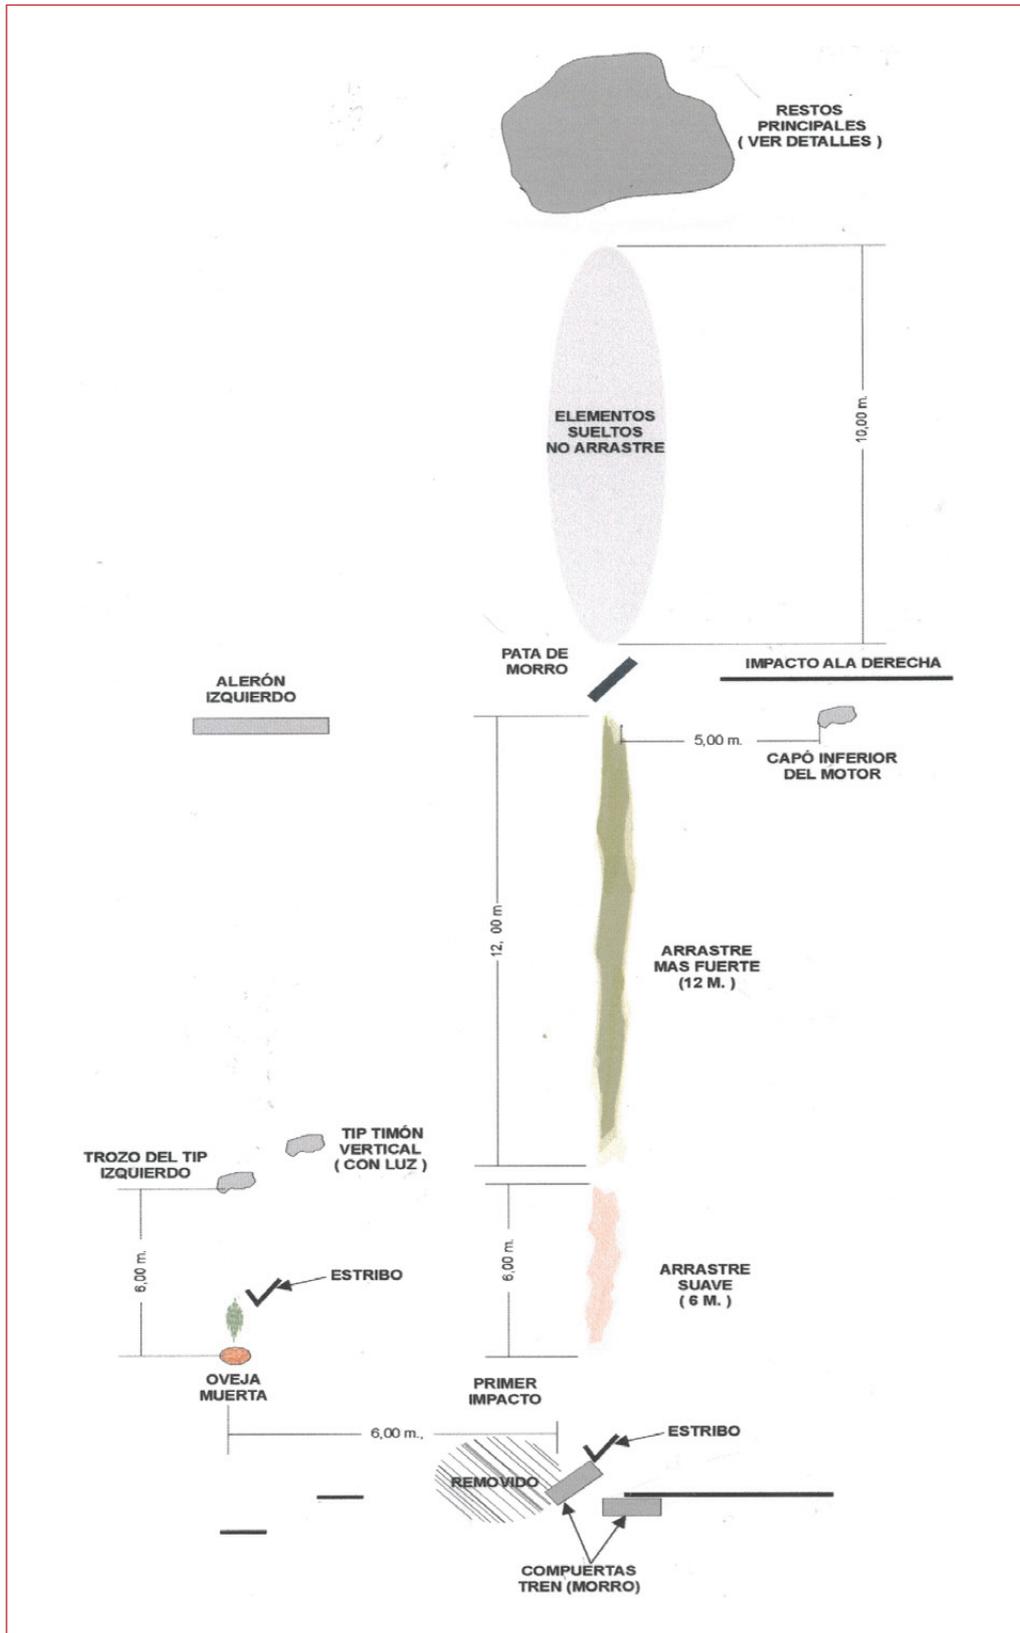
Figure C-1. *Distribution of wreckage*

The marks of the aircraft's impact and dragging along the mountain slope show a south-north direction. A first crash of the aircraft's underbelly, which churned up the terrain and tore off the nose assembly doors, followed by minor bumps in which parts of the flight controls, stirrups and structure, nose assembly, etc. on both sides of the aircraft came off, could be observed. During dragging and up to the final impact the aircraft traveled 47 m and ascended 18 m up the mountain slope.

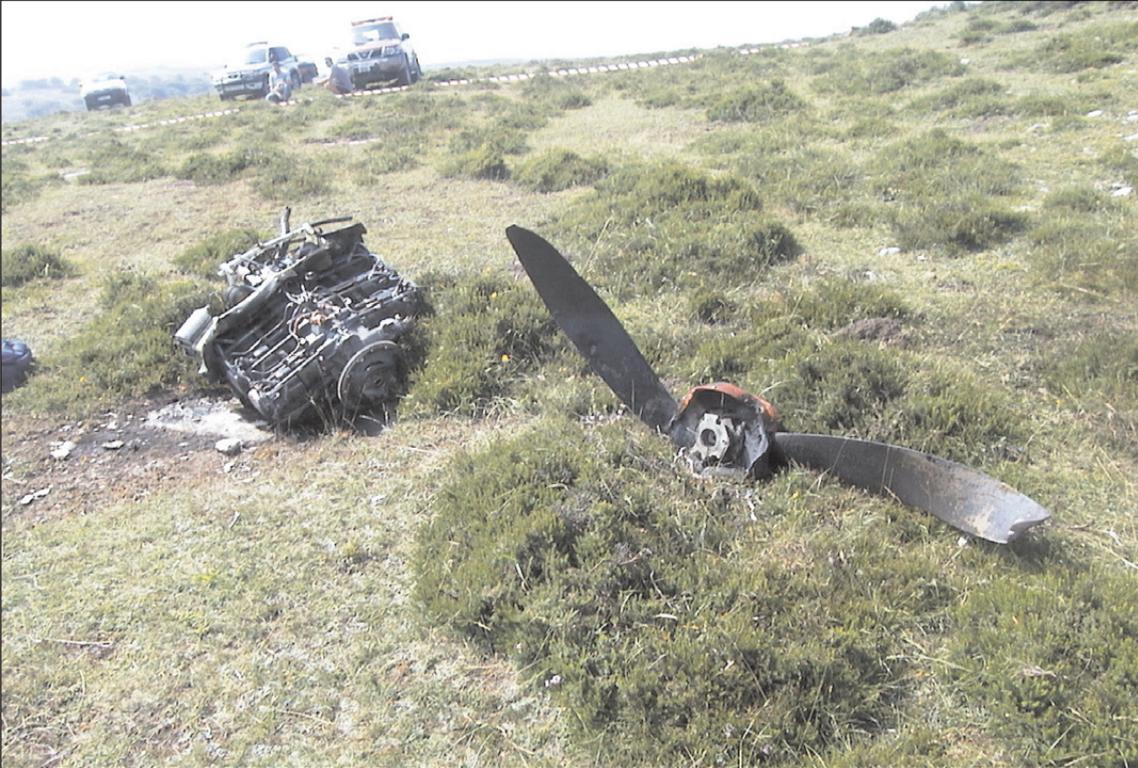
Figure C-3. *Detached engine and propeller*
