DATA SUMMARY

Registration	OY-NXS
Type and model	SCHEMPP-HIRTH VENTUS 2CM
Operator	Private

REPORT

Date of approval	28 September 2005
------------------	--------------------------

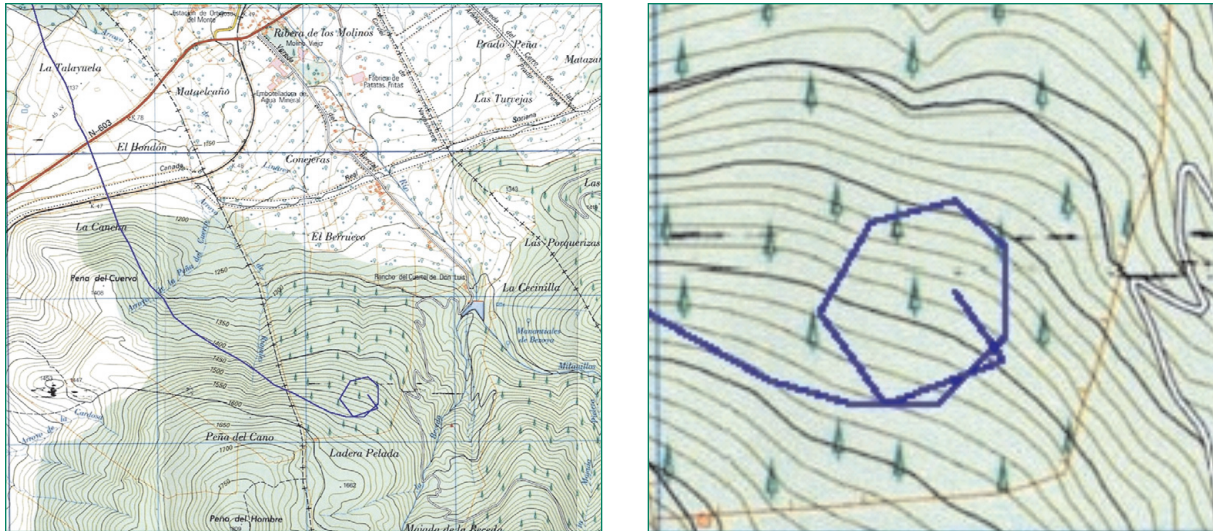
Figure 1. Airplane trajectory and detail of last seconds of flight

The site of the impact (see figure 1) ($40^{\circ} 48.498'$ north, $004^{\circ} 09.422'$ west) is situated at a height of 1,520 m (GPS measurements) on a wooded hillside facing practically east. The slope at the accident site varies between 15 and 30 degrees, but a few metres higher up the slope it increases to values of between 30 and 45 degrees. The summit of this slope is some 150 m above the impact site.

The wreckage and the marks of the impact extended in an approximately straight line running west to east (curving slightly to the left in the direction of movement of the aircraft) and over a distance of approximately 60 m.

A first impact was observed on a branch of a tree some 9 m from the ground. At the foot of this tree the end of the left wingtip was found (a piece some 50 cm long of the bottom surface). Some 7 m from the foot of the tree was the start of a groove approximately 6 m long that was traced by the left wingtip (the rest of the wingtip lay at the end of the groove). Eight metres from the end of the groove was the mark left by the

impact of the nose of the aircraft. This distance is very approximately the distance from the wingtip to the nose. The aircraft had the feature of allowing the wingtips to be adjusted for two different wingspans (15 and 18 m); at the moment of the accident it was configured for 15 m.

The duration of the flight was a little under 10 min. From the departure aerodrome to the accident site, the aircraft followed an almost constant course to the south-east.

From the horizontal groundspeeds recorded, and taking into account the usual indicated airspeed in climbing under engine power, it is deduced that the aircraft probably had a tail wind of some 20 kilometres per hour. The wind was therefore probably from the north-west: this coincides with the information set out in section 1.6 and would mean that the accident site was probably on the leeward side of the hill into which the aircraft crashed.

It is noted that the engine stopped moments before the accident, coinciding with a turn to the left. The aircraft was quite close to the ground when this manoeuvre was performed.

Some thirty seconds before the impact, the recorded groundspeeds fall below the stalling speed and finish practically at zero, and at the same time sharp increases are observed in the vertical descent speed, to a final recorded value of 6.4 metres per second. The changes of course indicate a very tight turn to the left.
