TECHNICAL REPORT

A-045/2003

Accident to
aircraft ROBIN,
model ATL «Club»,
registration F-GFNB,
in the vicinity of the
Rinlo coastline (Lugo),
on 8 August 2003

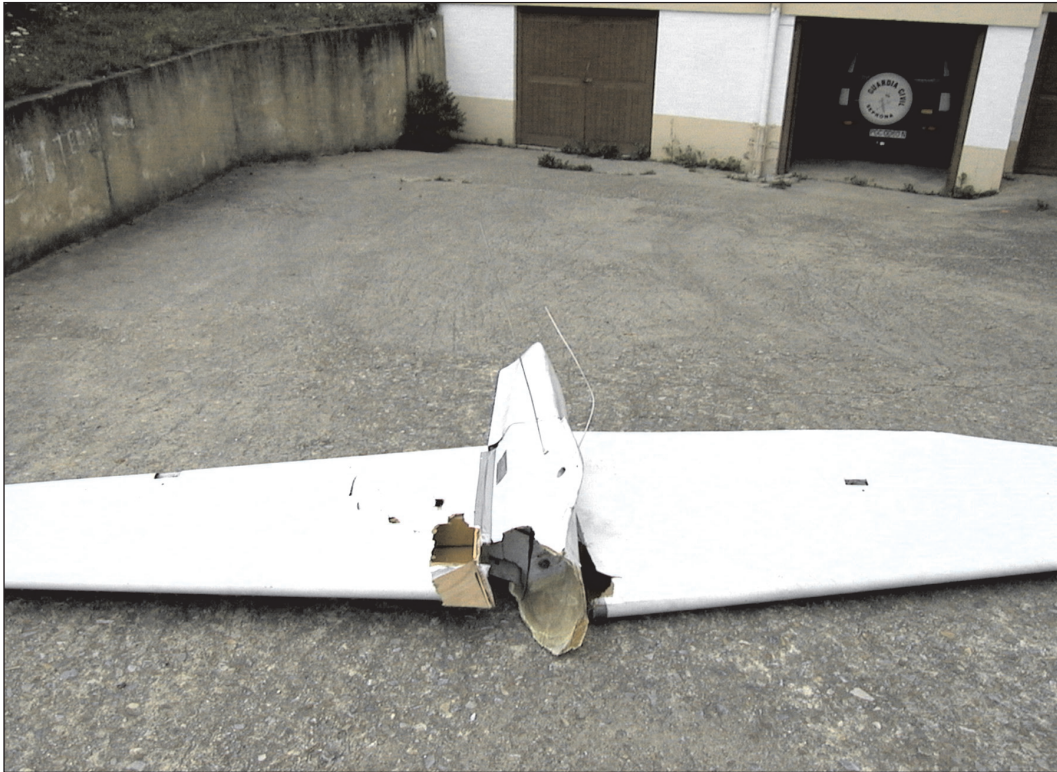
Aside from the corpses, the most significant remains recovered, all of them badly damaged, were two stabilizers (figure B-1, Appendix B), the left wing (figure B-2, Appendix B), broken at approximately 60 cm from the tip, fragments of the seats, a bag with several objects and a wheel.

Photo B-1. *Stabilizers wreckage*

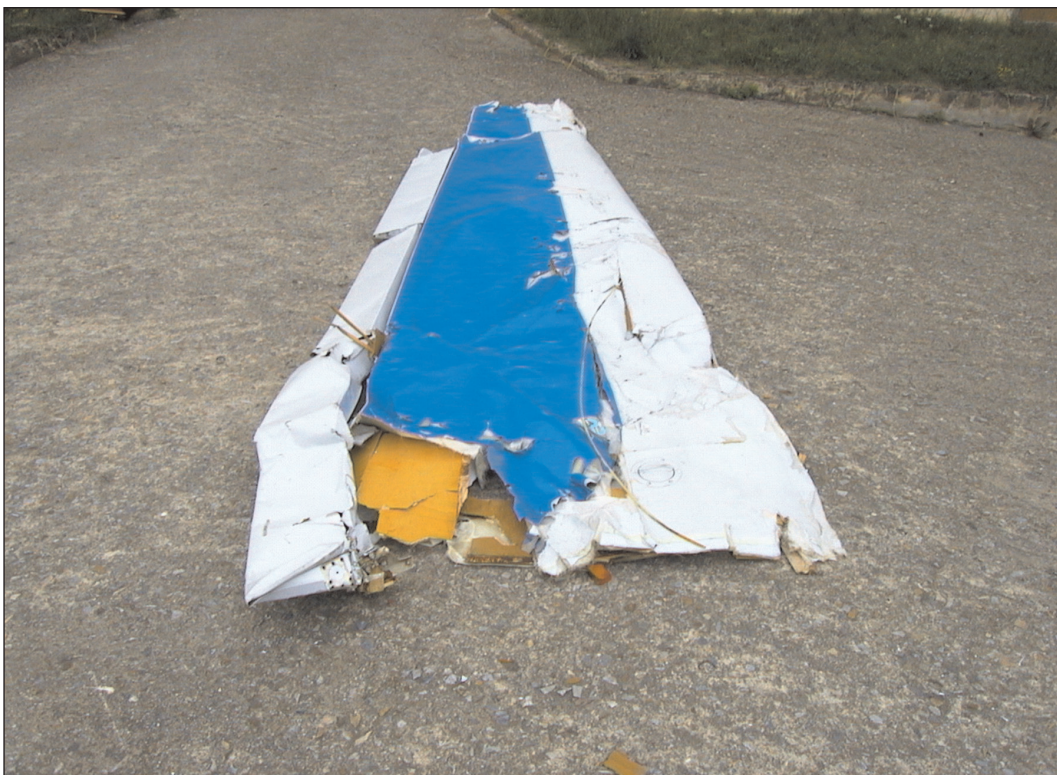
From the analysis of the recovered wreckage, especially the breakage of the left wing at 60 cm from the tip, it can be concluded that the left side of the aircraft impacted first, coincident with the actual sense of the turn being carried out, and that the impact happened at a relatively high speed.

Photo B-2. *Left wing wreckage*
