## TECHNICAL REPORT A-055/2003

Date and time	<b>Friday, 5 September 2003; 10:00 h local</b>
Site	<b>Renedo de Esgueva (Valladolid)</b>

Registration	<b>N3574M</b>
Type and model	<b>Aerostar (Raven) RX-7, s/n RX7-3203</b>

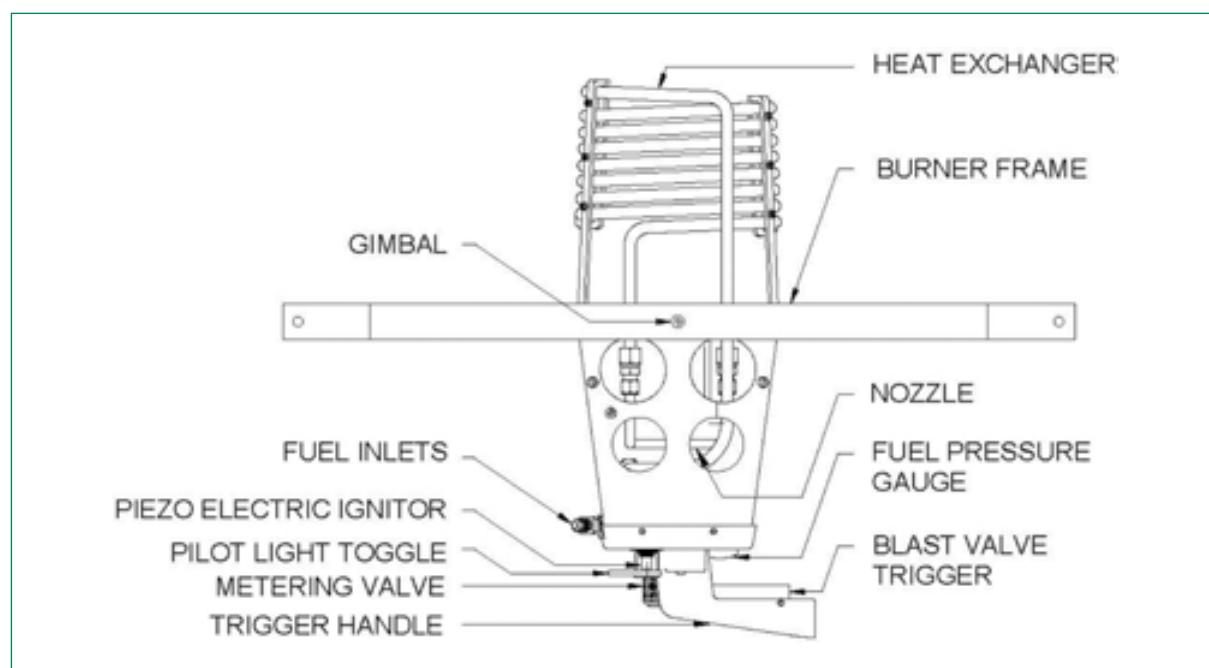
The «dual inlet» burner had two inlets of liquid propane. Those inlets were fed by hoses from the propane bottles on board that were used as fuel of the balloon. The hoses were fitted to the burner inlets through nuts that were threaded and then wrench tightened with a tool carried on board during the balloon assembly before every flight.

The «pilot light» is fed by liquid propane from the main fuel line. The propane is then converted to a gaseous state in a brass regulator just below the pilot light head (see Figure 1). The second fuel line carries liquid propane as a redundant fuel source or back up, in the event that the main fuel system malfunctions and needs to be shut down. In this event, the burner can be operated through the use of the metering valve.

Figure 1. Drawing of a burner similar to the one on board the accident balloon. The fuel hoses fittings are wrench tightened to the bottom of the burner

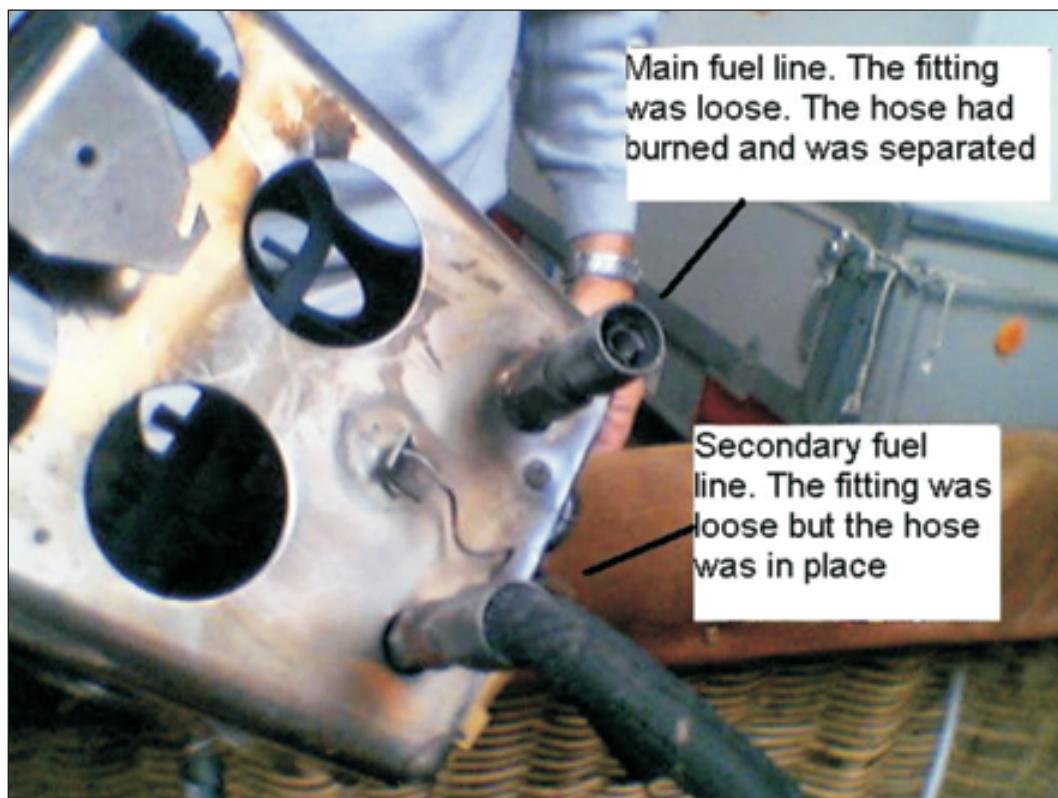
Figure 2. View of the burner after the accident

The burner and its frame were taken with the intention of assembling it again in the basket, simulating a preflight task. The right hand hose (the main line, that feeds propane to be converted to a gaseous state) was burnt and detached from its fitting, while the fitting itself was still threaded to the burner inlet. The other hose was attached to its fitting and it was threaded to the inlet (see Figure 2).

It was tried to loosen the fittings and it was noticed that the first one (the main line) could easily be loosened by hand. The other fitting (corresponding to the secondary line) was also loose. The wrench was not found among the balloon wreckage. The pilot stated later on that she had the wrench on her pocket at the time of the accident.

It was concluded that the fire was initiated in the hose whose fitting was loose the most (the main fuel line). The pilot grabbed the burning hose and took it outside the basket, which would explain why it appeared burnt from outside.

After the accident, it was noticed that both fittings were loose, specially the one of the main fuel line, and they could be removed by hand. This would not have been possible if the fittings would have been wrench tightened.

It is probable that the preflight tasks were carried out in a hurry, under the pressure of the competition. In that environment, it is possible that the task of applying torque with the wrench was omitted, and after some flight time a fire was initiated in the main inlet

due to a leak of fuel through the thread of the fitting. The hose could then have detached from the fitting, due to the high heat and to the own pressure of the fuel.
