DATA SUMMARY

Registration	G-STRO
Type and model	ROBINSON R22 Mariner II
Operator	Sloane Helicopter Limited

REPORT

Date of approval	25th April 2006
------------------	------------------------

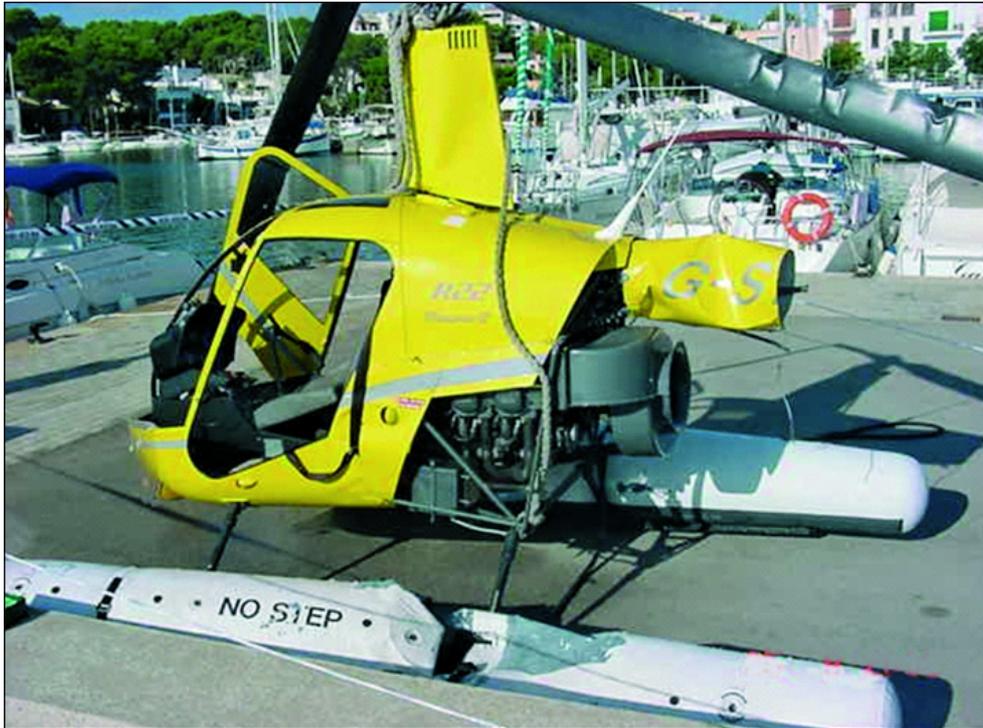
- The main rotor's blades struck the tailboom, cutting it and the power transmission axis to the tail rotor.
- The main rotor head assembly and the blades were bent.
- The float installed on the left ski was damaged.
- Beginnings of corrosion due to immersion in sea water.

The aircraft tipped up, with the cockpit and main rotor assembly in the water, floating on the water's surface due to the effect of one of the two floats.
