**COMISIÓN DE  
INVESTIGACIÓN  
DE ACCIDENTES  
E INCIDENTES DE  
AVIACIÓN CIVIL**

**Report  
IN-045/2004**

In-flight engine failure  
involving a McDonnell  
Douglas MD-83,  
registration EC-FTS,  
operated by Spanair,  
on 21 July 2004  
at Alicante Airport

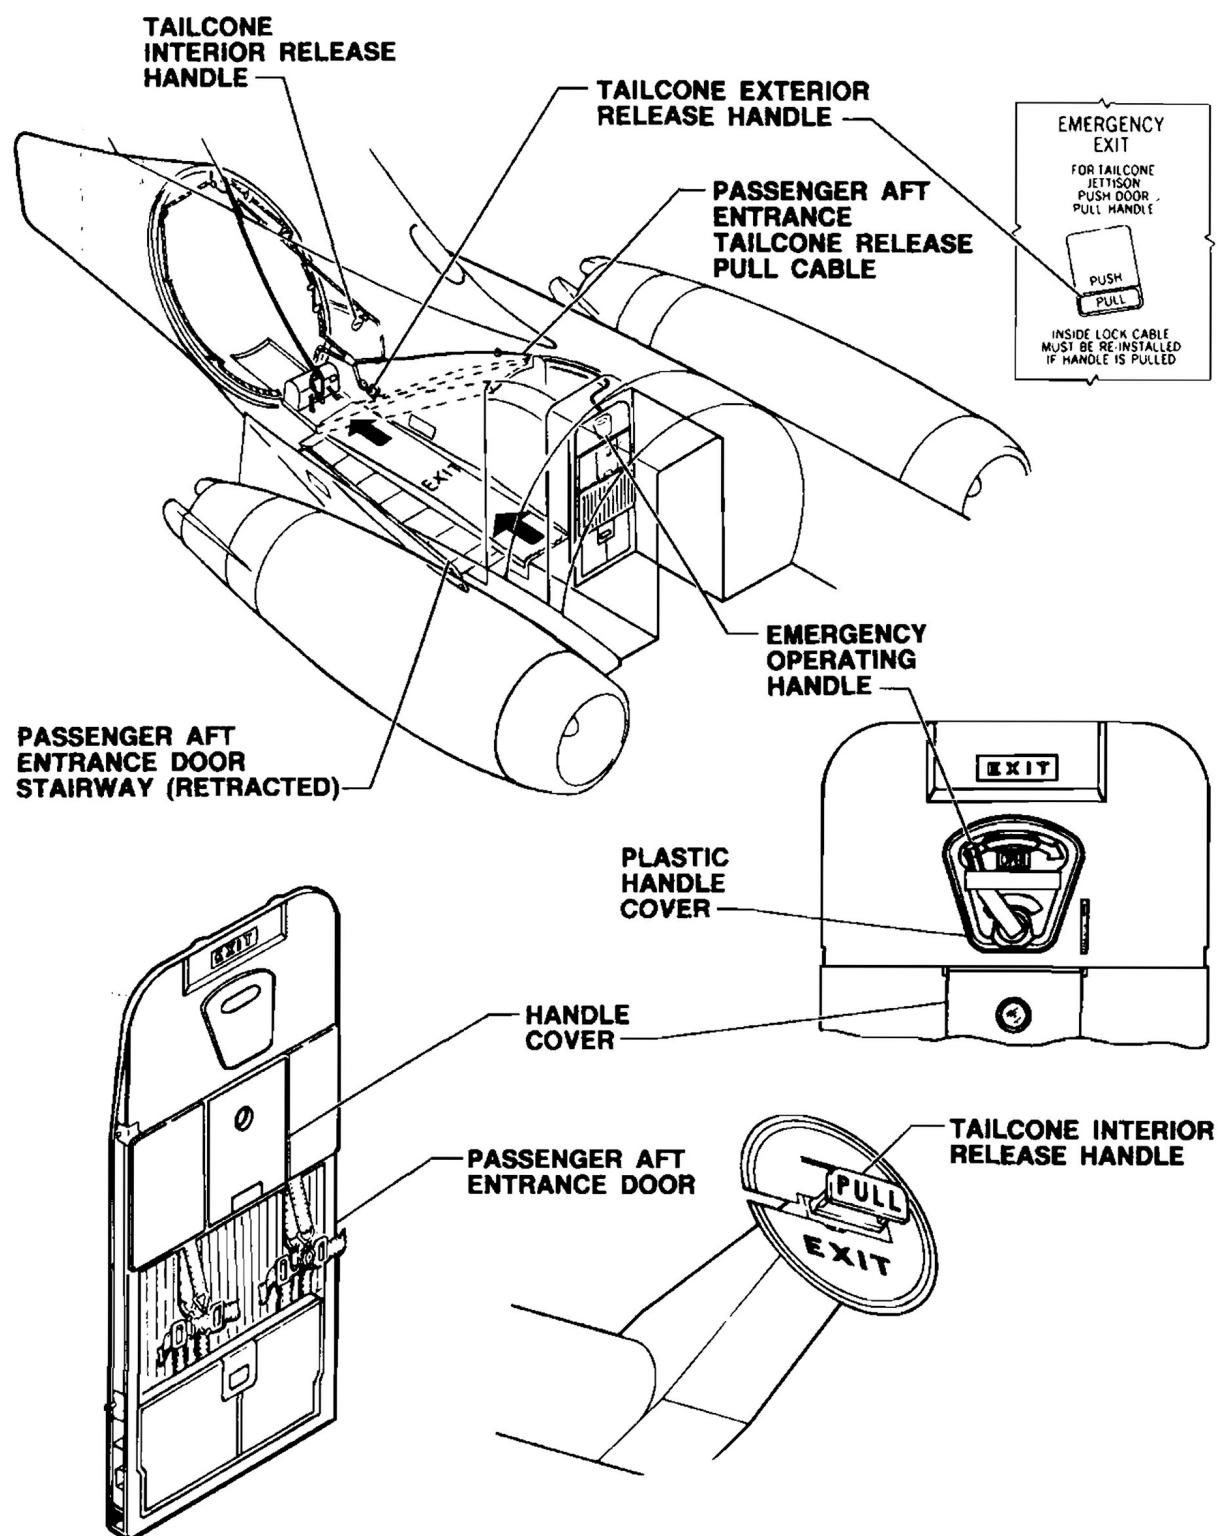
Figure 2. Tailcone jettison system

An inspection of the tailcone slide did not reveal any defects. It was concluded that an improper installation had kept it from deploying.

According to the inspection, the tailcone slide failed to deploy because of an improperly installed actuating device. Fortunately on this occasion, the type of failure, namely a reported fire in the left engine, prompted the captain to specifically prohibit the aft section from being used during the evacuation, though the tailcone was still released.

Faced with this possibility, the company took the initiative of inspecting all the tailcone slides in its MD80 fleet without finding any discrepancies.

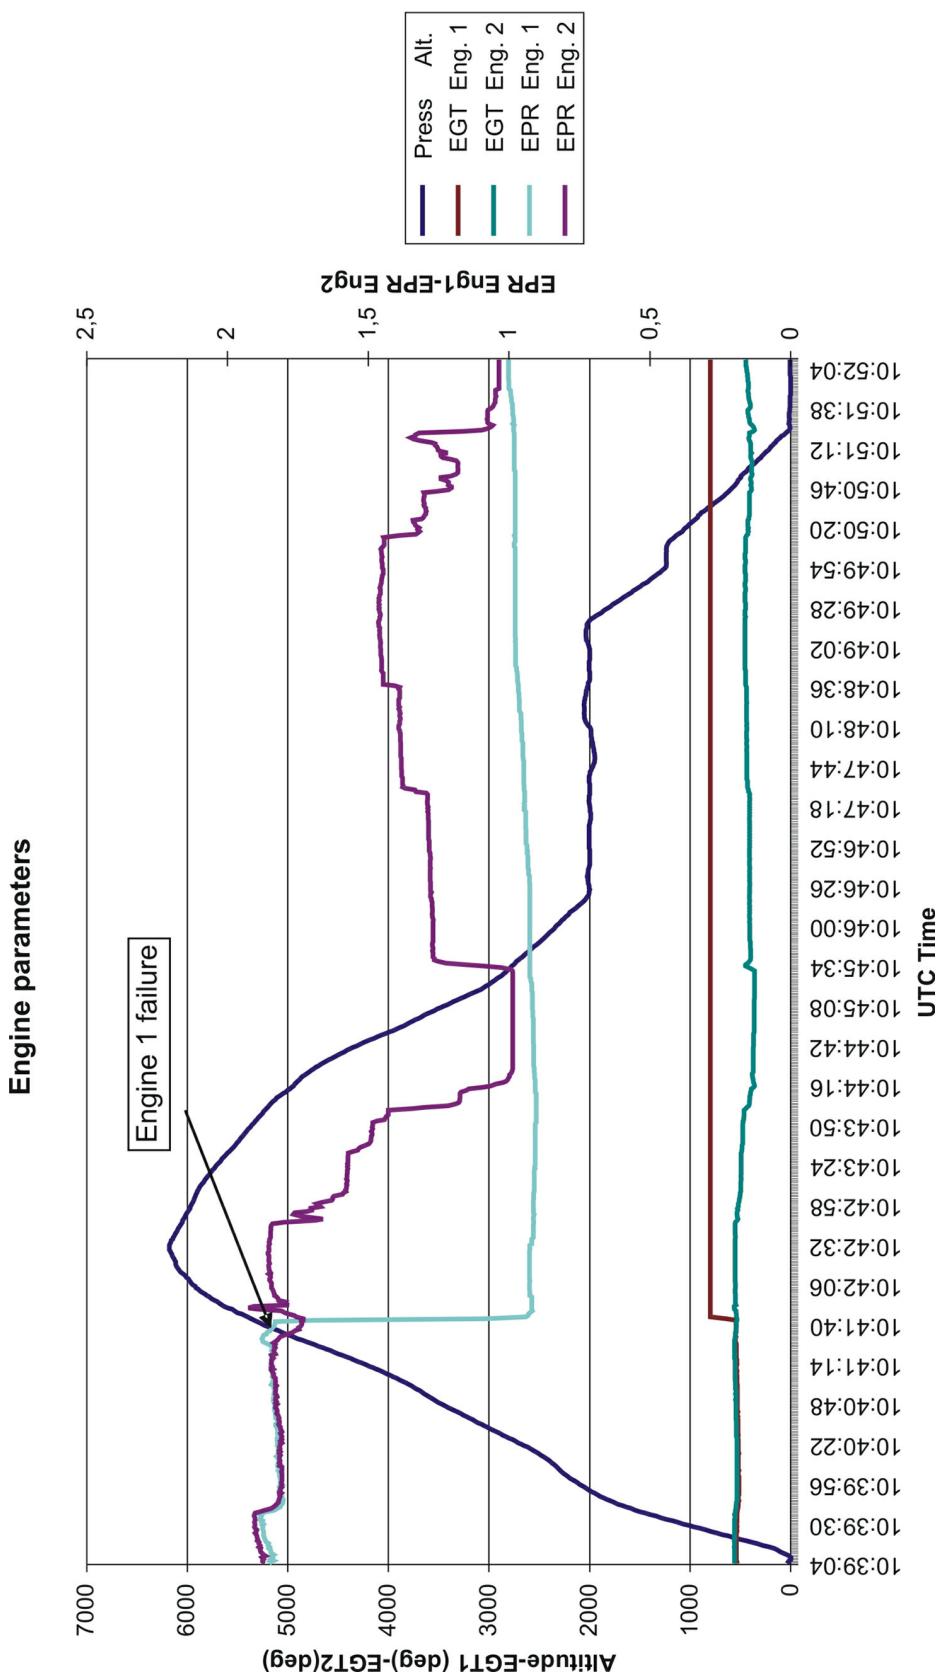
- 10:38:38: Takeoff run initiated, takeoff EPR selected.
- 10:41:39: Left engine fails. EPR falls to 1, N1 to 38% and N2 to 75%. Highest temperature logged is 638 °C before recorder goes off scale.
- 10:42:22: Left engine rpm's drop to 17% (N1) and 37% (N2).
- 10:42:44: Number 2 engine EPR dropped to 1.7.
- 10:51:20: Right engine EPR fell to 1.1, possibly during the landing flare.
- 10:51:27: Aircraft landed. No reverse thrusters deployed on either engine to stop the landing run.
- 10:52:07 : Last data point.

Figure 5. Progression of the exhaust temperature and EPR for both engines during the flight

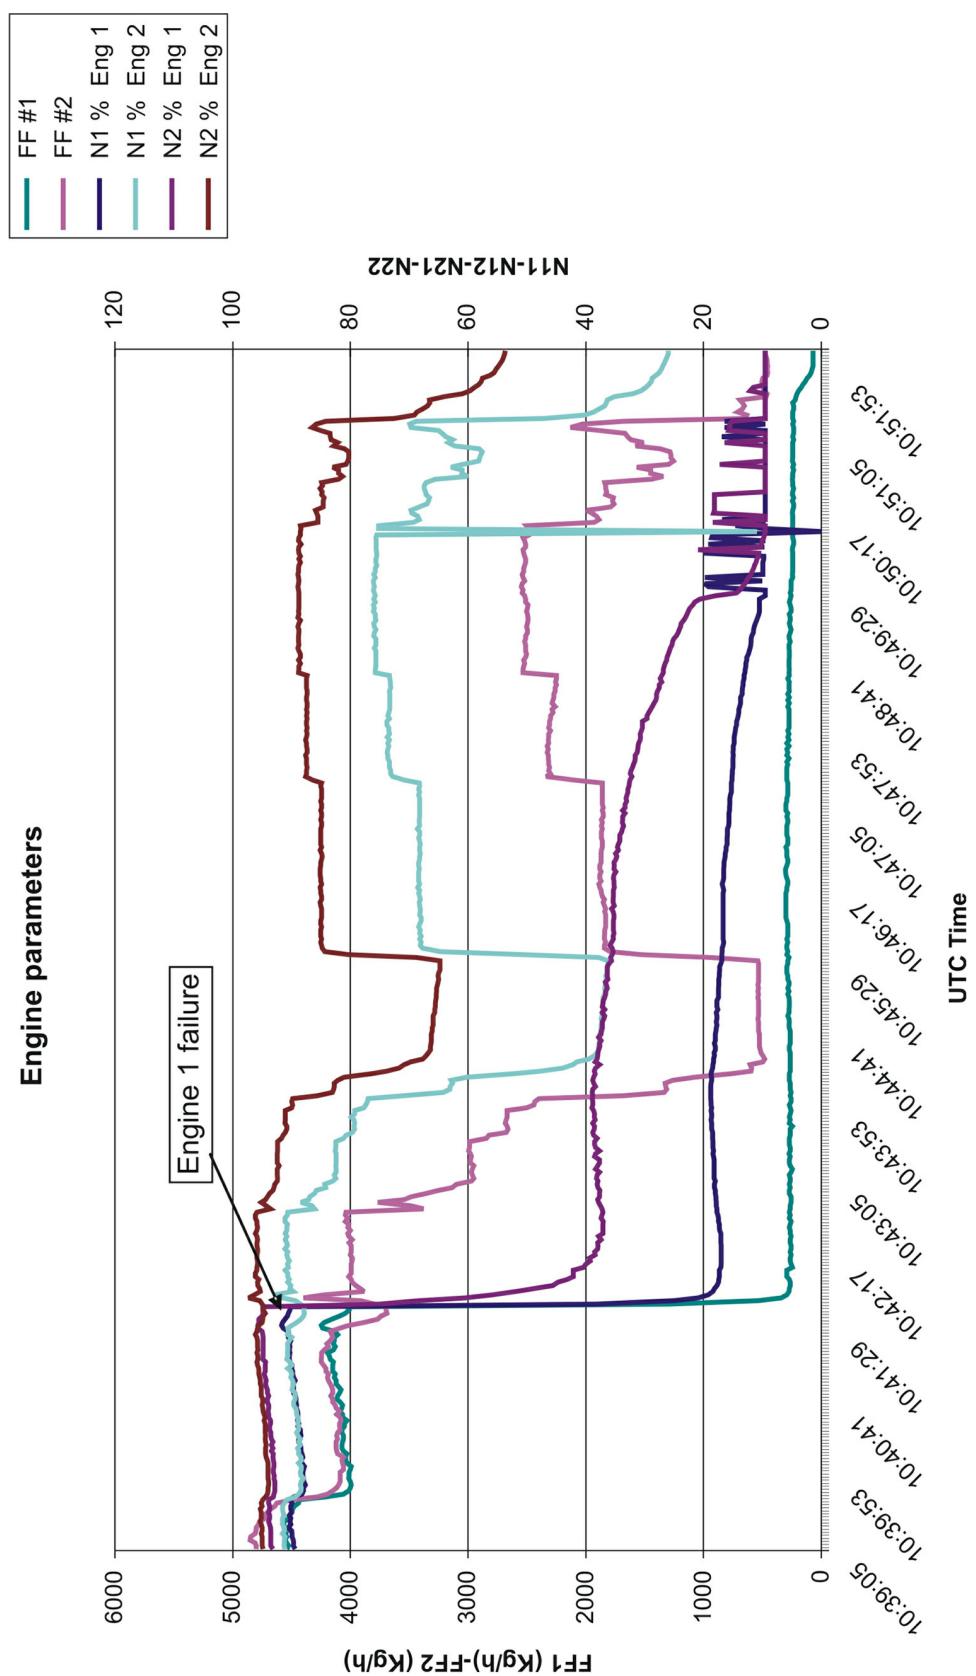
Figure 6. Progression of rpm's and fuel flow for both engines during the flight

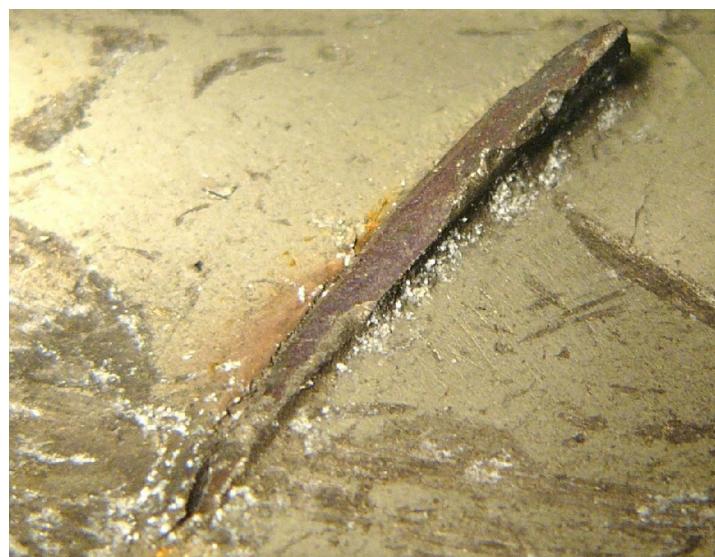
Six adjacent vanes detached from the 8th stage stator. All the remaining blades in stator 8 were damaged, especially along their trailing edges.

**Figure 9.** Fatigue failure of the vane

When the first two vanes in the 8th stage stator detached, they left a stub in the outer shroud which was consistent with a known failure mode. The failure start in High Cycle Fatigue at the trailing edge braze joint with the outer shroud and propagates towards the leading edge, leaving an about 5 mm stub at the leading edge.

In light of the damage, it is believed that the engine failure resulted from the simultaneous or near simultaneous release of two vanes on the 8th stage stator as a result of High Cycle Fatigue cracking, which led to the breakage of 4 other vanes on the 8th stage stator. Downstream damage then occurred in stages 9 to 13. The general failure of the compressor caused successive increase in turbine entry temperature and eventually turbine overheating to the point of melting turbine airfoils.

It became apparent during the left engine disassembly that the initial fault was the high-cycle fatigue failure of two stator vanes on the 8th stage. The engine had accumulated 10,642 flying hours and 7,675 cycles since new, and only 1,673 flying hours and 895 cycles since the last workshop inspection of these stator vanes.

Later, on 6 May 2005, a Service Bulletin was issued (SBJT8D 6472, Engine-stator assembly, 8th stage compressor-conversion from a braze-repaired to a strap-welded configuration) which provide a modification which converts braze-repaired 8<sup>th</sup> and 9<sup>th</sup> stage compressor stator assemblies to the original strap welded configuration. The necessity and convenience of its implementation was left to the operators' discretion depending on their situation.

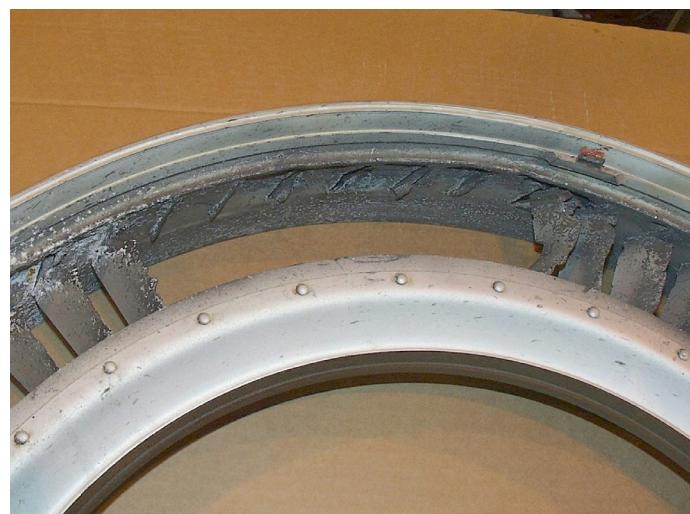
Figure 10. HPC 8th stage stator

Another vane from the 8th stage stator showed a trailing edge crack originating at the outer end braze.

The released vanes led to the breakage of four other vanes in the same stator (8th), as well as minor damage to the 7th stage. The released components triggered a cascade of failures in later stages of the compressor which were compounded by the imbalance of rotating elements. The imbalance was obviously a result of the stage 8 stator failure, and not vice versa.
