DATA SUMMARY

Registration	D-KIYL
Type and model	DG FLUGZEUGBAU GMBH DG 800
Operator	Private

REPORT

1. FACTUAL INFORMATION

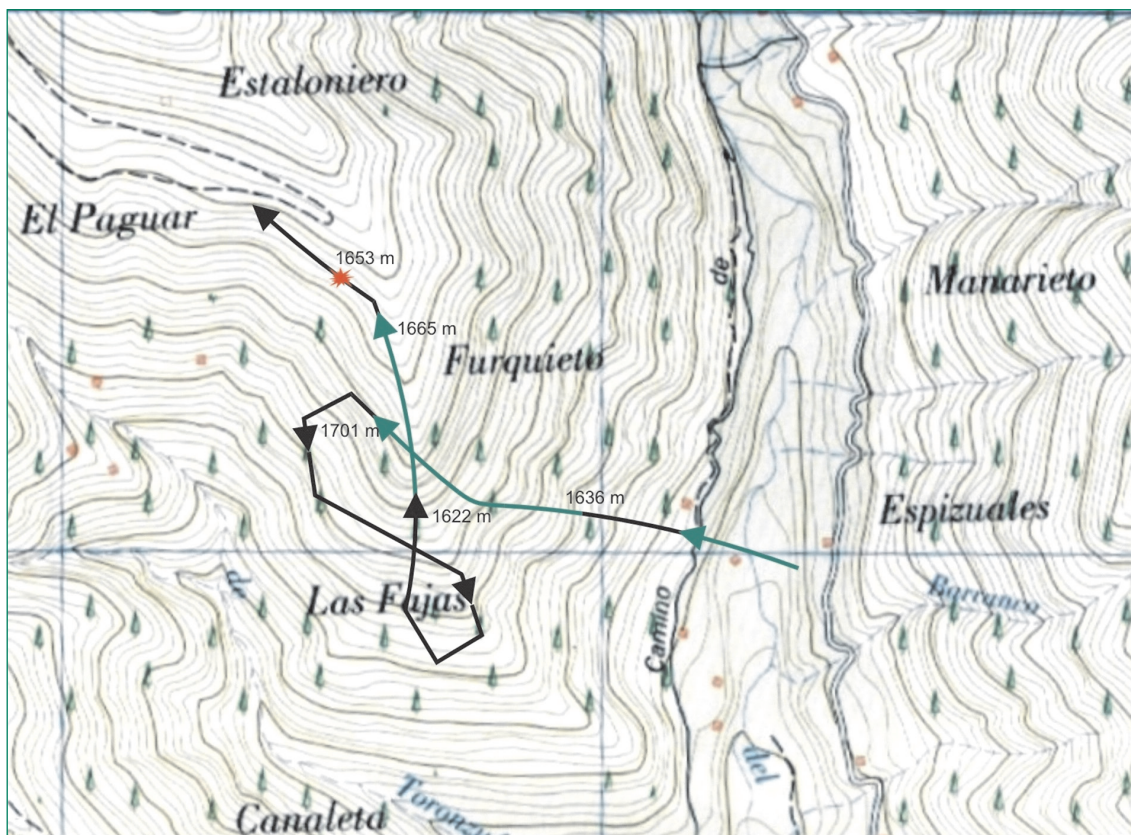
Figure 1. Track detail

Important flight data have been obtained from reading the aircraft's logger. Based on these data, it can be established that the aircraft had carried out a figure of eight in the

vicinity of the slope, at an altitude of between 1,622 and 1,701 m. In a first pass it gained height up to 1,701 m and then in what would be the longest part of the figure of eight run it descended to 1,622 m, when it again gained height to 1,665 m, subsequently descending for 8 seconds until it crashed into the ground. The last recorded data corresponding to the point of contact are: altitude 1,653 m, indicated airspeed 82 kph and vertical speed -3 m/s. The wind was blowing from 266° at a speed of 15 kph.
