DATA SUMMARY

Date and time	Thursday, 8 July 2004; 17:19 h UTC
Site	P. of Girona, en route from Girona to Paris Beauvois

Registration	EI-DAR
Type and model	BOEING B-737-800
Operator	Ryanair

Operation	Cial. air transport – Scheduled intern. passengers
Phase of flight	En route – Climb to cruising level

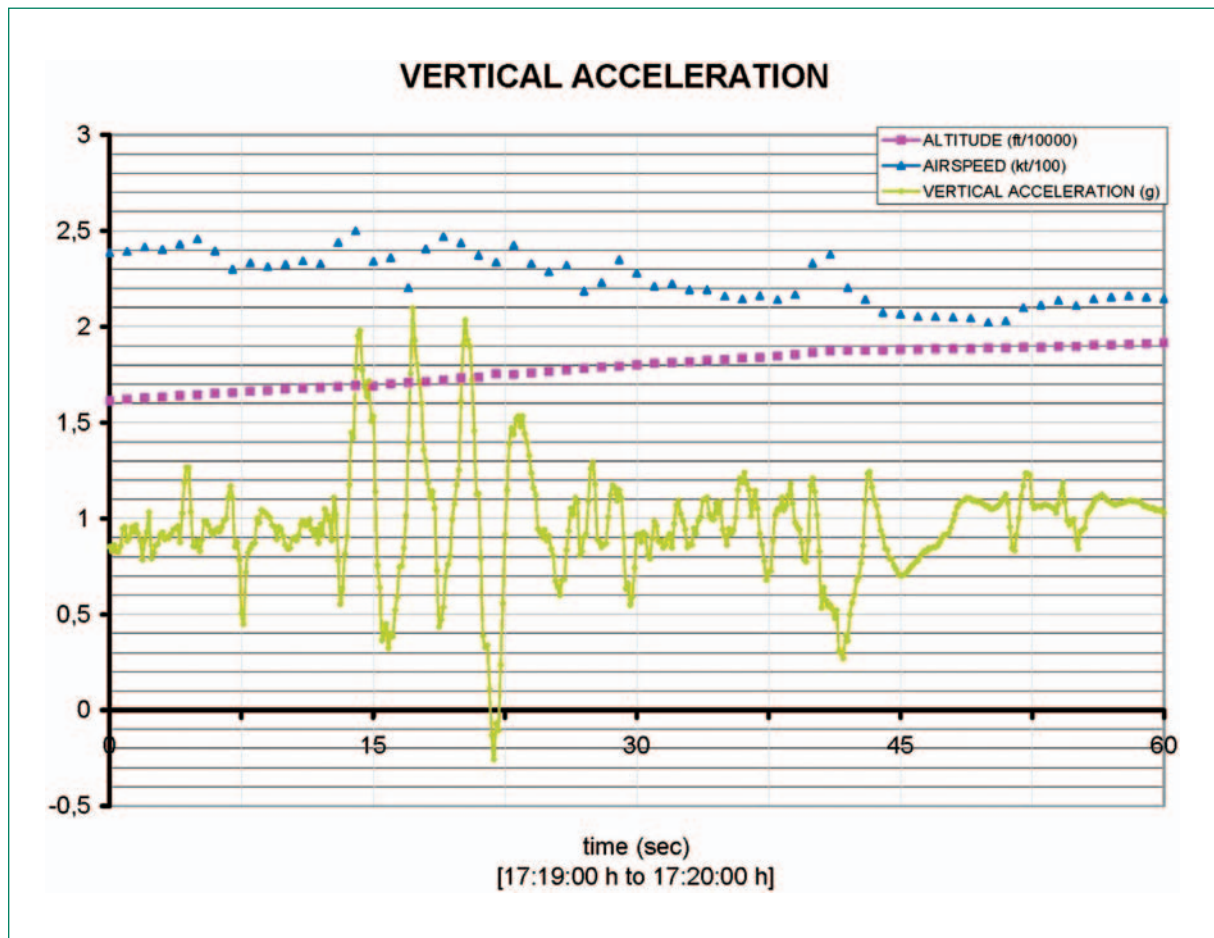
Figure 1

The aircraft was equipped with a cockpit voice recorder (CVR) and a digital flight data recorder (DFDR). When the incident was notified, the recorders were requested to be downloaded, but the CVR had already been over recorded. The operator provided a transcript of the DFDR. From the analysis of those data, it seems the strongest turbulence happened at the magnetic coordinates 42.098° N / 3.125° E (province of Girona) and it was determined that the aircraft suffered a maximum vertical acceleration of 2.096 g and a minimum vertical acceleration of -0.255 g when the altitude was around 17,000 ft. See a graph of the vertical acceleration on Figure 1. From an initial value of 230 kt of airspeed, it varied between 250 kt and 220 kt during the turbulence encounter. The horizontal and lateral accelerations also varied during the event (see Figure 2). The autopilot and autothrottle were engaged and remained engaged during the turbulence encounter and afterwards. There were large excursions of pitch and roll during the moments of maximum acceleration. The altitude did not suffer important changes, i.e. the aircraft continued its climb approximately with the rate of climb as before the encounter.

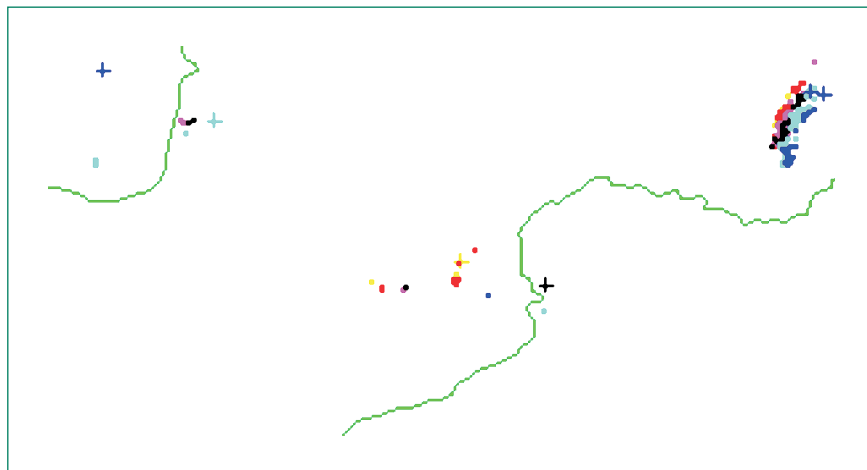
There had been some lightning activity close to the zone where the turbulence was encountered in the previous two hours (see attached map in Figure 3).

Figure 3. Map of lightning activity from 16:00 h to 18:00 h

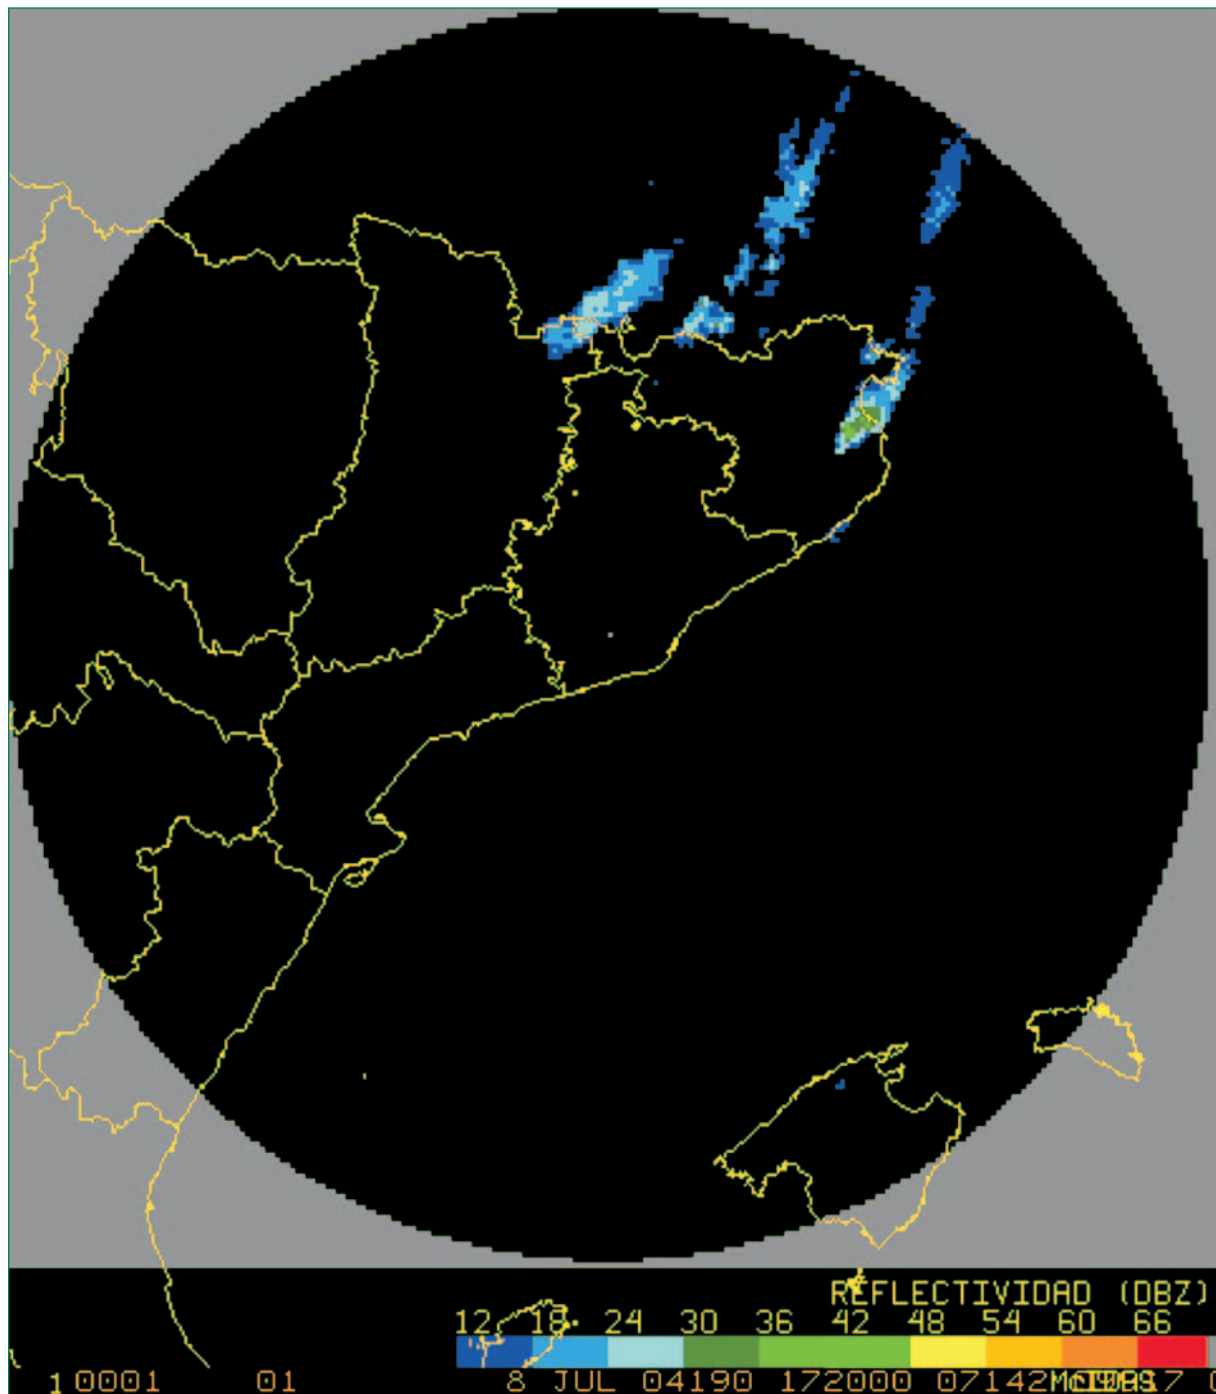
Figure 4 with the meteorological map at 17:20 h shows some cloud presence close to the Pyrenees Range (more reflectivity means more precipitation activity).

Figure 4. Weather radar map of the northeast of Spain on 8 July 2004, at 17:20 h

In any case, the pilot informed that nothing appeared on the weather radar. It is unknown the exact antenna tilt angle used, because given the cloud area showed in Figure 4, it is likely that at least some echoes should have appeared in the on board weather radar. Therefore, it is considered convenient to issue a safety recommendation to recommend that additional information on the effective use of the weather radar is distributed to flight crews.

- REC 11/05.** It is recommended to the operator of the aircraft that their operational procedures are amended to include the minimum conditions under which the cabin attendants may be released for passenger service when turbulence encounters are expected after takeoff.
- REC 12/05.** It is recommended to the operator of the aircraft that additional training is provided to flight crews regarding effective use of the weather radar and its limitations regarding detection of turbulence.

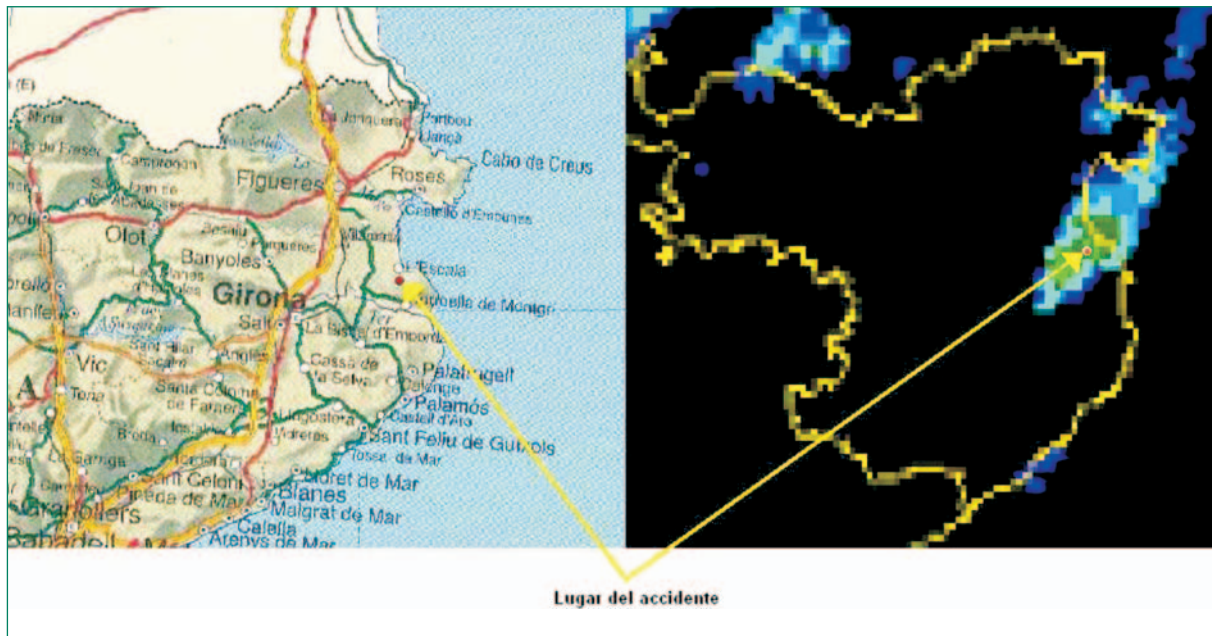
As it can be seen on Figure 5, the place of the accident was close to an area of some precipitation activity.

Figure 5. Place of the accident and detail of the weather radar map

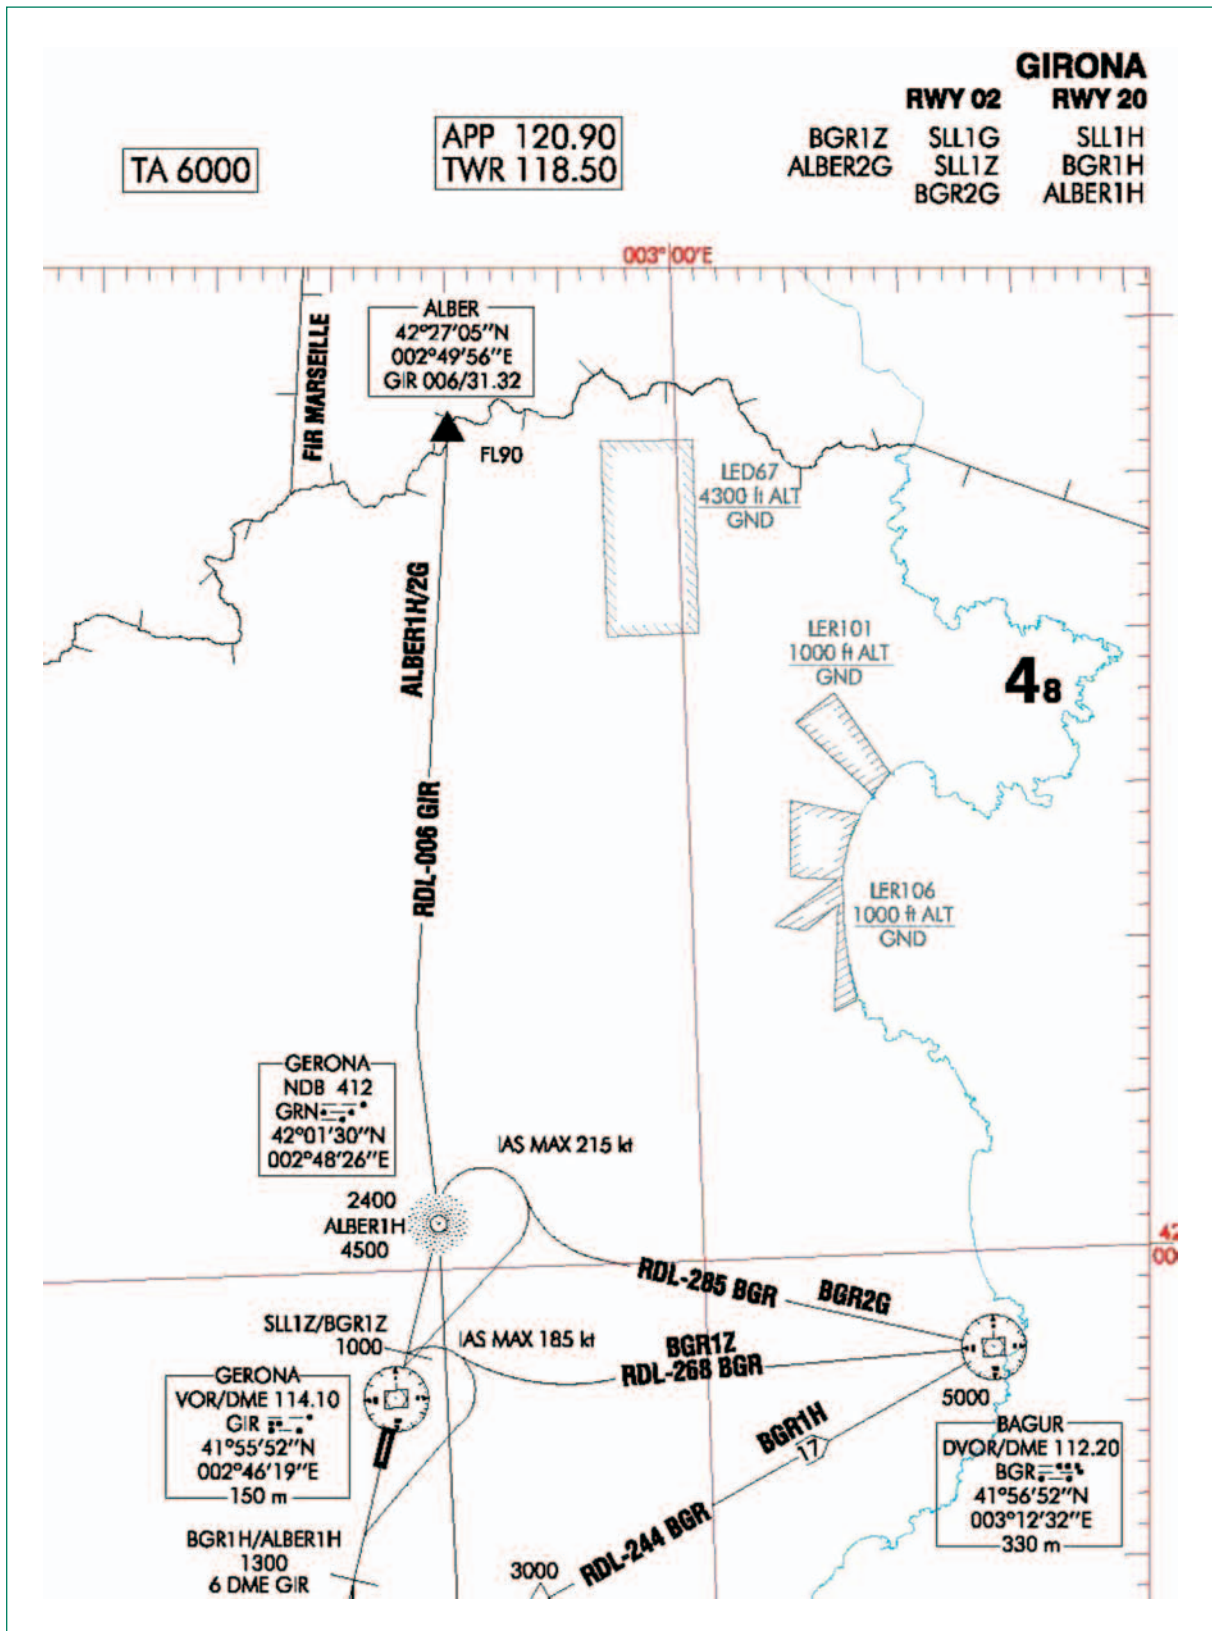
The aircraft was using the SID Bagur 1Z. Other possibility was to use ALBER 2G (see Figure 6) that provided a more direct path to the north. The operator informed that this routing was chosen for weather avoidance. However, the crew probably did not have the information of the weather map (see Figure 4) because that map shows that some clouding was active in the area of the Gulf of Rosas and to the north of BAGUR VOR at 17:20 h (the take off happened at around 17:12 h and the accident at around 17:19 h), although the precipitation level was probably light or moderate at the most. On the contrary, the trajectory of ALBER 2G SID seemed to have less clouds present.

Figure 6. Standard Instrument Departures of Girona Airport
