**COMISIÓN DE
INVESTIGACIÓN
DE ACCIDENTES
E INCIDENTES DE
AVIACIÓN CIVIL**

**Report
A-068/2004**

Impact into the Guadalquivir
River of Agusta Bell AB-412
helicopter, with registration
marks EC-GBE, at San Juan
de Aznalfarache (Seville),
on 14 November 2004

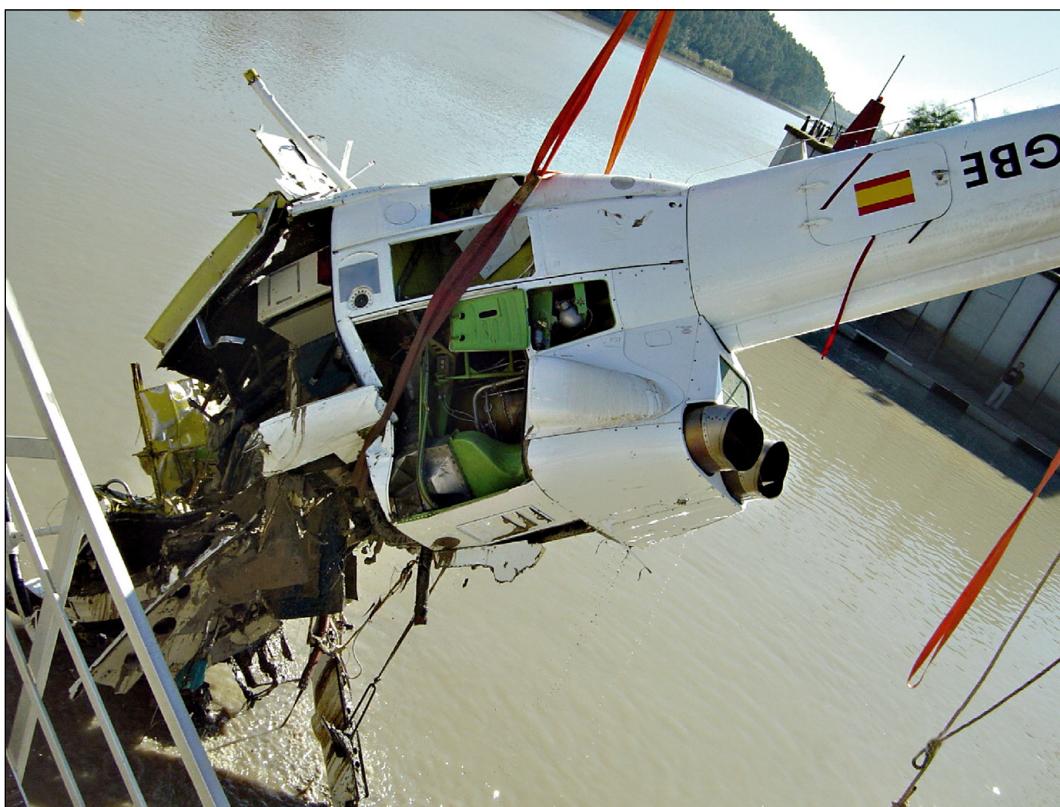
Photo 1

The forward part of the helicopter cabin structure, from the nose to the area of the engine bay, was completely destroyed, resulting in a mass of wreckage (see Photo 1).

The main transmission gearbox, along with the mast and main rotor head, became detached from the helicopter structure and presented multiple breakages and warping.

As a consequence of the direct impact with the water, the helicopter was so heavily damaged that it was essentially destroyed.

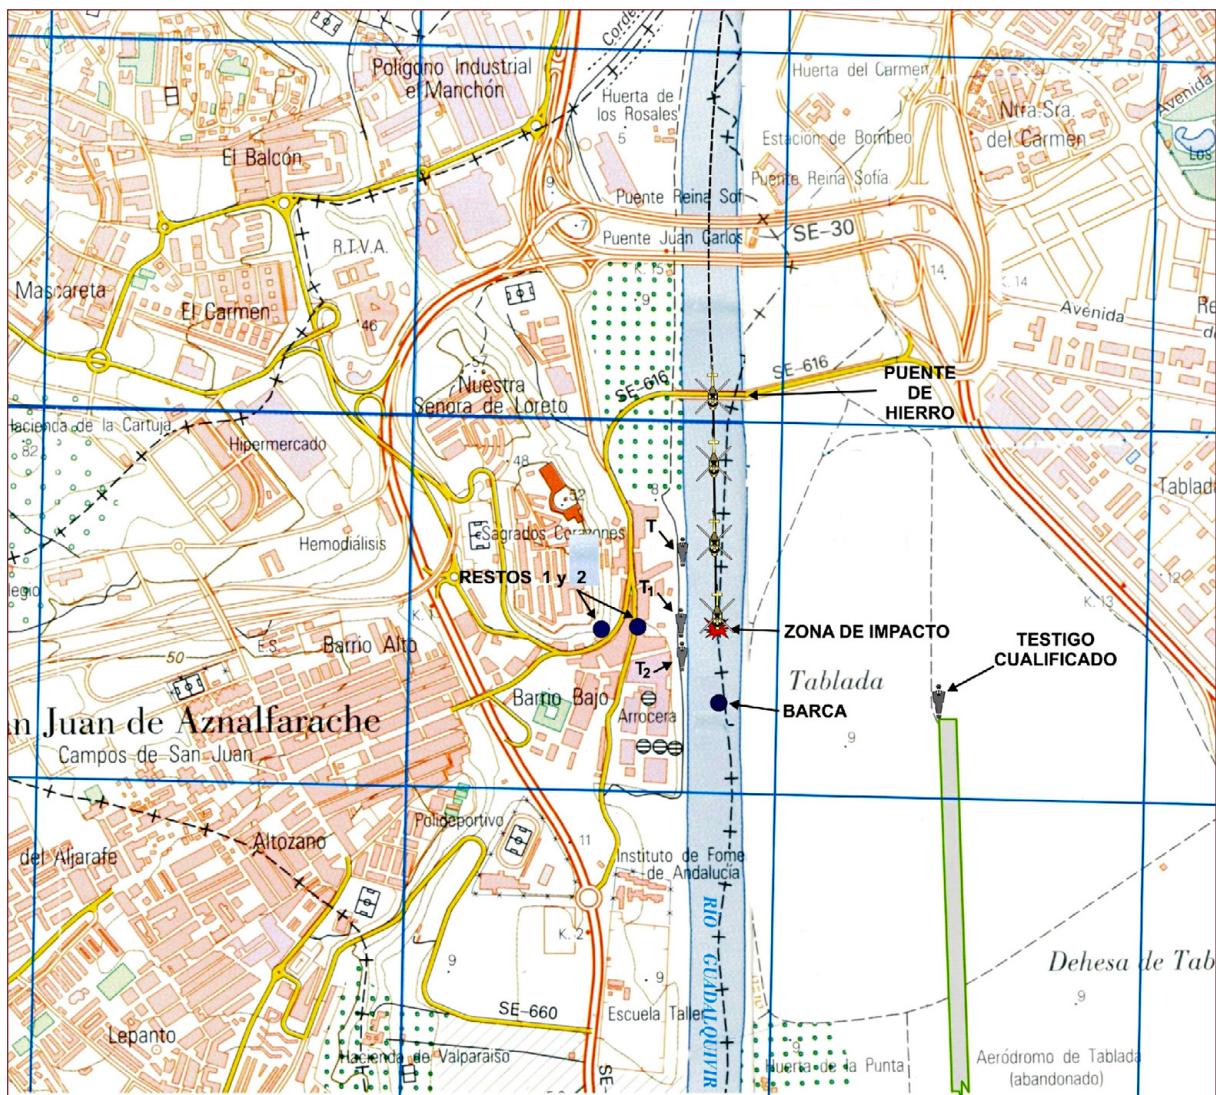
Figura 4. Zona del impacto

The final impact took place within the Guadalquivir River, near its central axis, 600 m downstream from the Puente de Hierro, between the runway at Tablada and San Juan de Aznalfarache.

Two blade tips were found outside the river, both measuring between .60 and .80 m in length, one in the terrace of an apartment building 100 m away from the crash site and the other in the public park around the Monumento de San Juan de Aznalfarache, 300 m away from the crash site. Both points are situated on a line perpendicular to the helicopter's flight path and to the right of the crash site (see Figure 4).

One eyewitness (see Figure 4, indicated as T) located near the right shore of the river, about 15 m upstream from the point of impact, saw the helicopter about 300 m away from his position at an altitude of between 10 and 15 m above the water. He defined its trajectory as constantly heading for the water. At no time before the impact did the sound of the helicopter change. He did not see any paragliders or any other kind of device above the river. As for the impact, he related how the helicopter impacted nose-first. It tipped forward and quickly sank while being dragged downstream by the current until it came to a stop. He saw the people inside begin to emerge a short time later.

Another eyewitness (see Figure 4, indicated as T1) was on the right shore of the river perpendicular to the point of impact. He told how the helicopter was losing altitude at a constant rate. The sound was the traditional one for a helicopter and did not change.

A third eyewitness (see figure 4 indicated as T2) was on the right riverbank some 40 m downstream from the impact point. He said that from the time he saw the helicopter until the impact, some 10 seconds had elapsed. The helicopter was following the center axis of the river, losing altitude. Its trajectory did not change before impact. He also noted no change in the sound of the helicopter. As for the impact, he said the helicopter's skids hit the water first followed immediately by the nose.

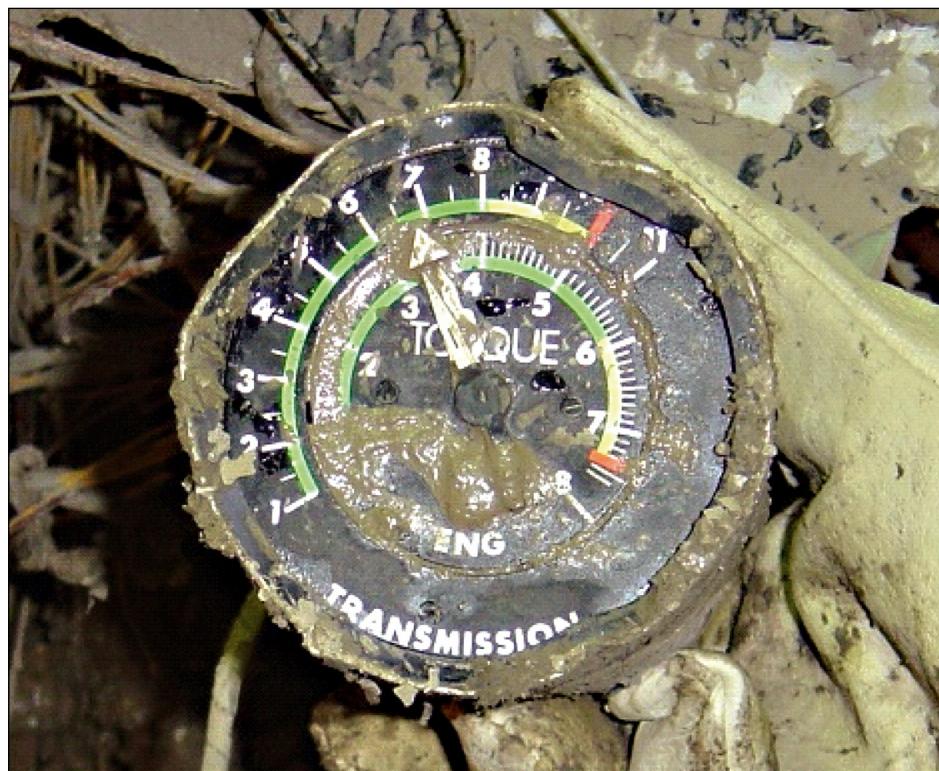
Foto 2. Triple torquímetro

The exclusive use of the cyclic, and therefore the non-use of the collective, would mean that the 68% TQ reading observed on the triple torquemeter should match the TQ values from the previous, level-flight phase and the entire subsequent trajectory until the final impact.

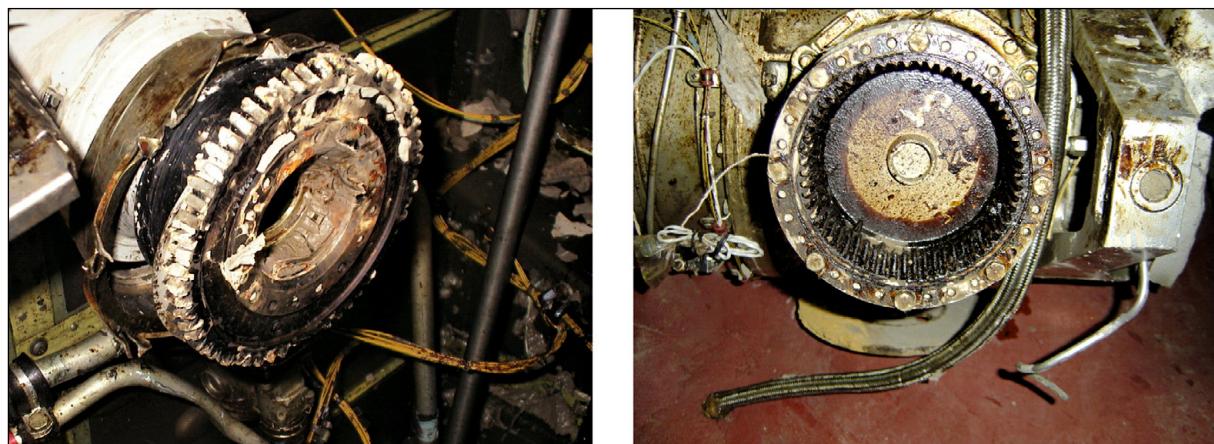
Photo 3. Driveshaft from the engines to the main transmission gearbox

The driveshaft from the engines to the main transmission gearbox broke in two places near the coupling gear. The male coupling on the transmission side had lost several teeth, which were found on the female coupling joined to the main gearbox. There was no evidence that the gear overheated.

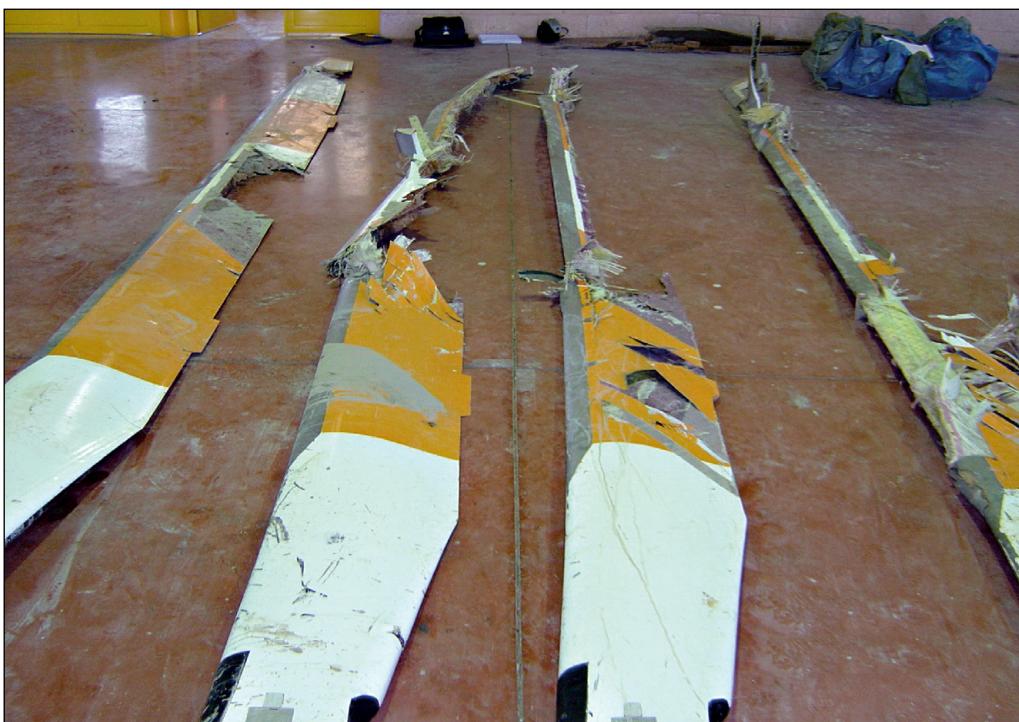
Photo 4. Main rotor blades

The main rotor blades were warped and broken at several points due to torsion loads and drag and reaction forces far in excess of any flight condition.

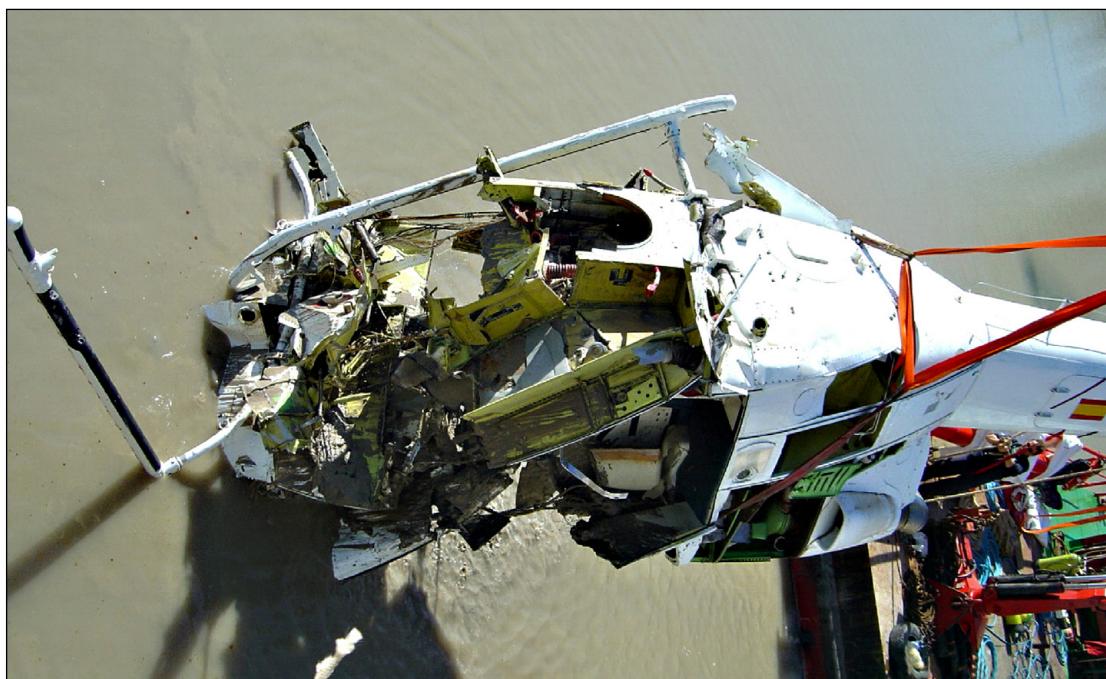
Photo 5. Lower part of the cabin

The forward part of the helicopter was completely destroyed. The passenger and crew compartment was crushed by the impact, the instrument panel was detached and the main spars in the cabin structure were broken (see Photo 5).

An examination of the main structure's wreckage, of the buckling and breakage, and the subsequent reconstruction allowed the investigators to conclude that the cause had been a frontal impact with a high translational velocity and a moderate descent velocity caused by the helicopter's low nose down attitude at the impact.

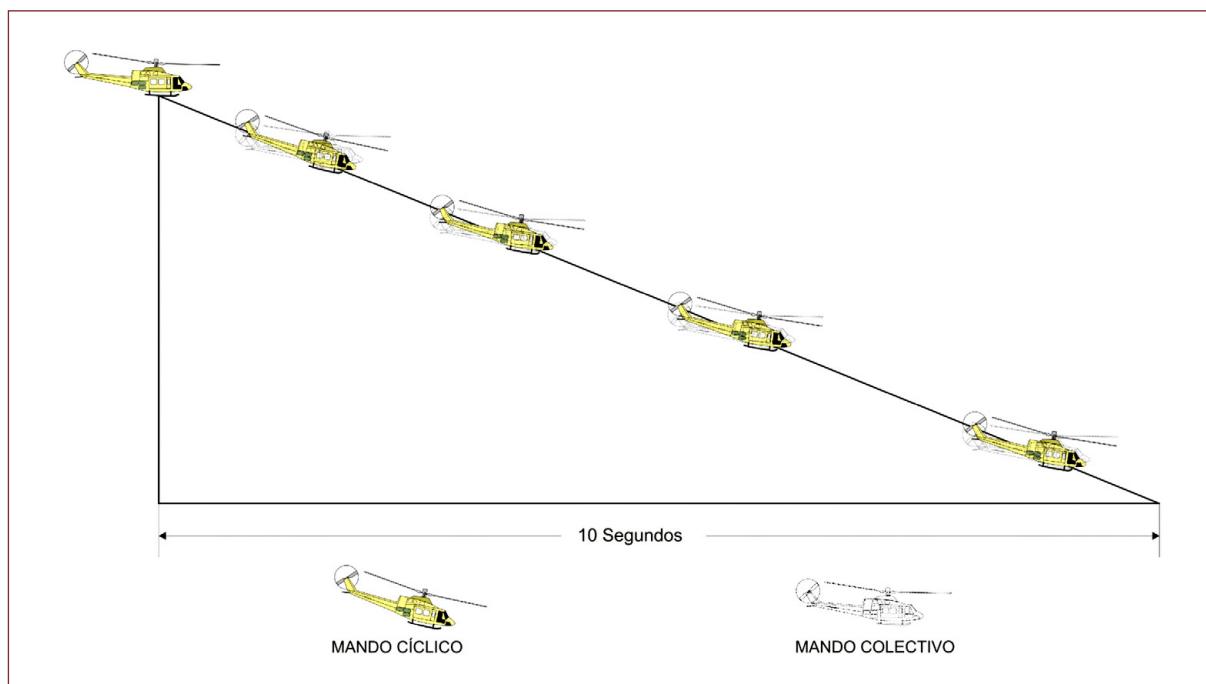
Figura 6. Actitud y trayectoria final del helicóptero

According to the accounts of eyewitnesses on the riverbanks, the helicopter did not change its flight attitude or heading before impact. The skids impacted first, followed quickly by the nose. The helicopter then tipped forward and started to sink. It was dragged forward a few meters by the current.

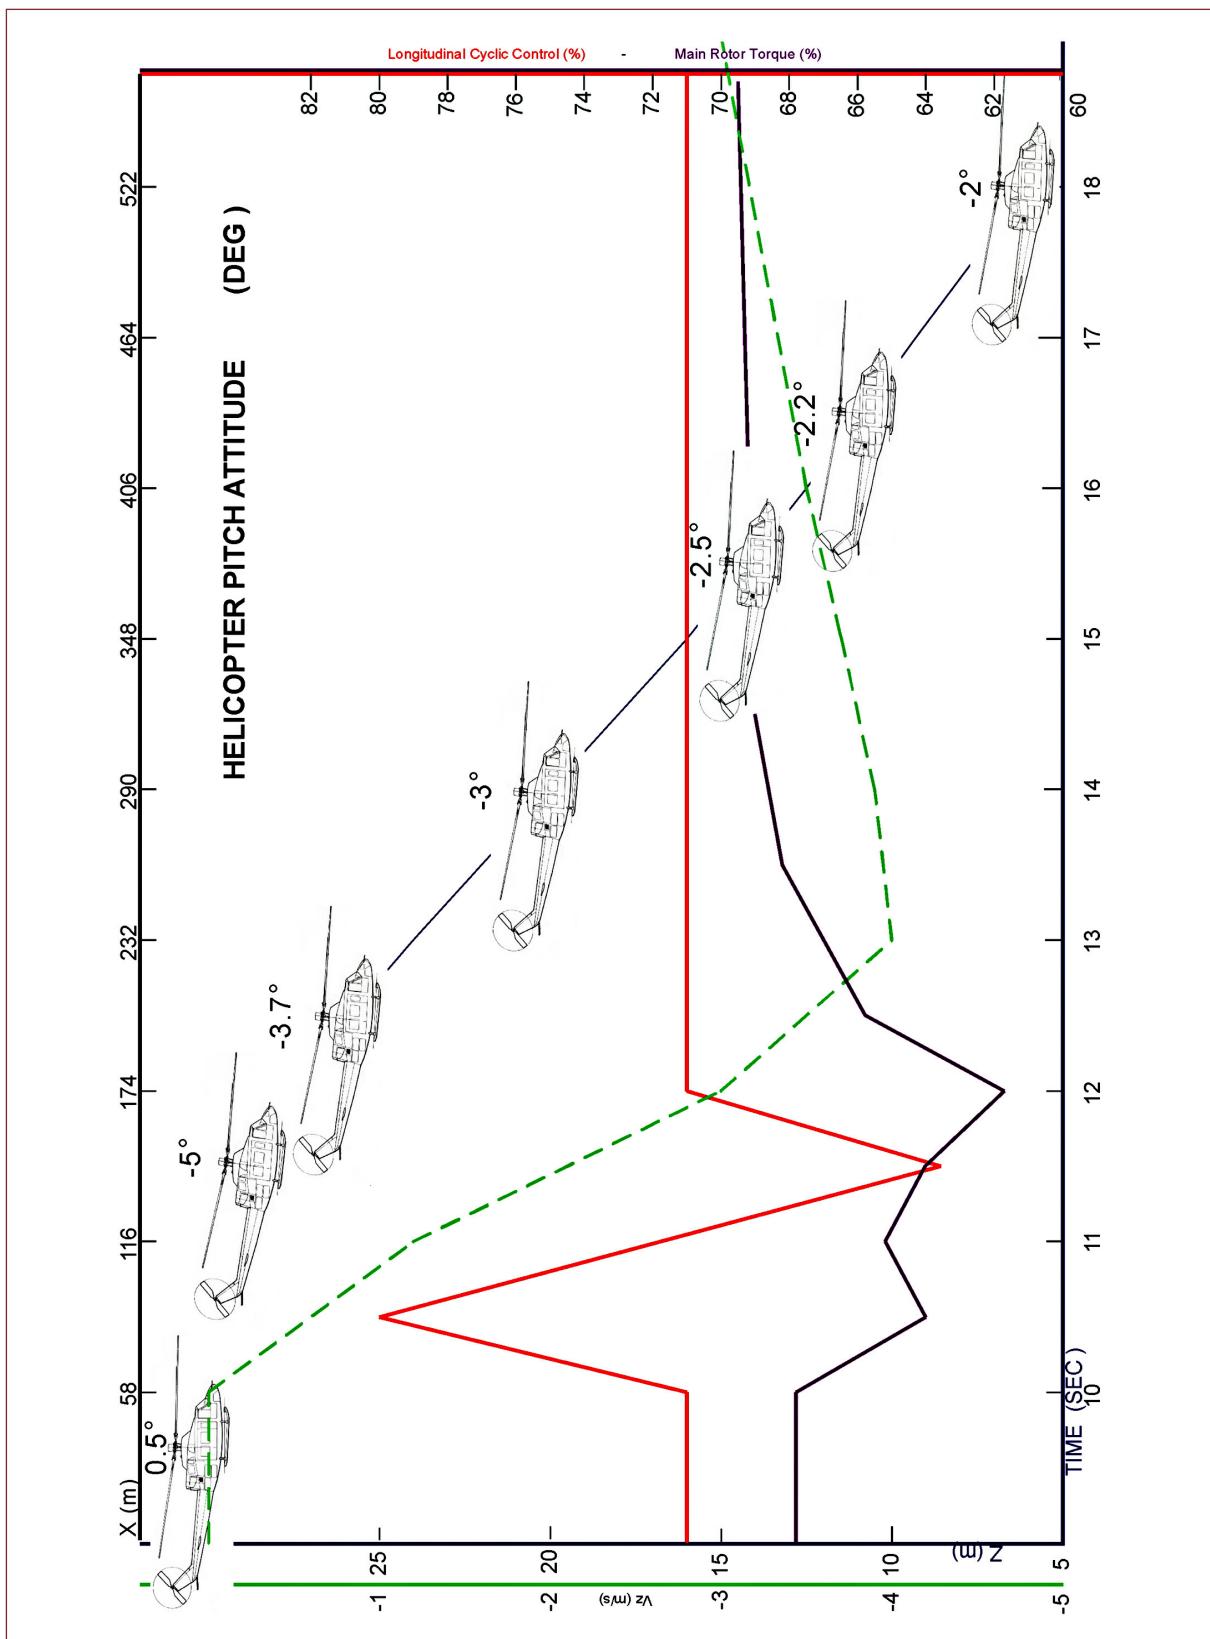
Maneuvers by the helicopter on the final descent until impact

The result concluded that a 9% forward movement of the cyclic control stick and back again in one second, followed in the next second by a 7% movement backward and a return back to its original place could cause the helicopter to descend 100 ft in 10 seconds, in accordance with the profile described (not symmetrical cyclic reversal input).

At the same time it was noticed that starting from level flight, the pitch angle changed to -5° down² in the first two seconds of the descent, followed by a slow recovery to -2° in the subsequent 8 seconds. The descent velocity reached -4 m/s and was reduced to -3 m/s by the time the ground was reached (see Appendix A).

Such a descent over a 10 second time period is consistent —given the weight and environmental conditions present during the flight and according to the manufacturer's simulation— with a 9% forward movement and a 7% aft movement of the cyclic control without any inputs to the collective control or adjustments to engine power. That motion of the cyclic control will induce a negative, or nose down, pitch angle in the helicopter, after which the descent path stabilizes.
