DATA SUMMARY

Date and time	23 January 2005; 13:06 LT
Site	Madrid-Barajas Airport

Registration	TF-ATI
Type and model	BOEING B747-300
Operator	Iberia, L.A.E.

Description

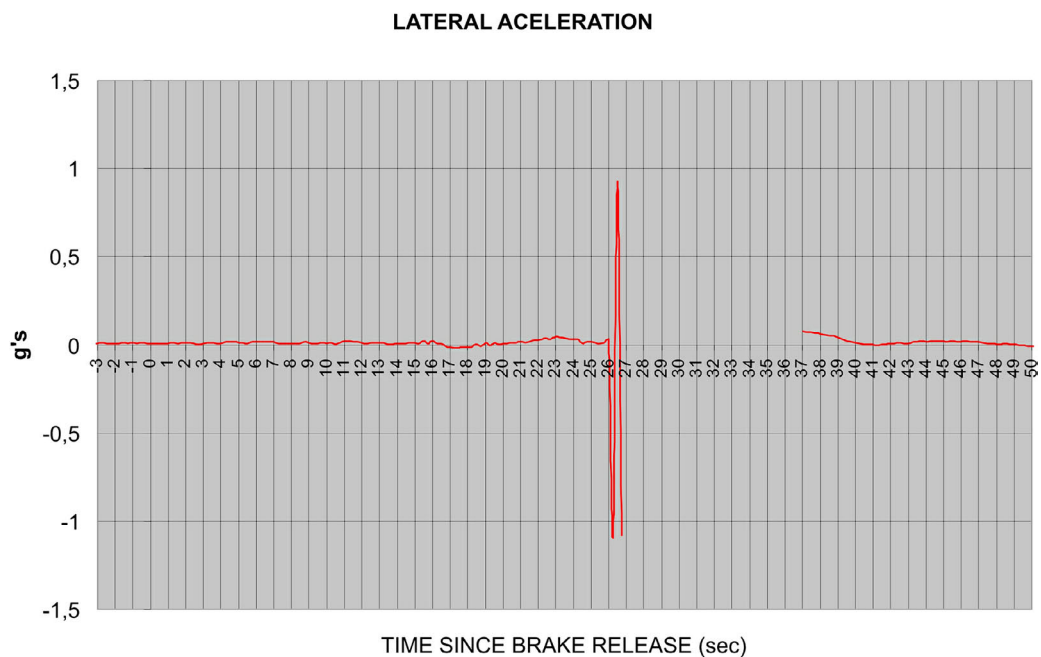
Figure 1. Graph of lateral acceleration

- 13:06:30 The takeoff run is initiated with reduced power, quickly reaching a longitudinal acceleration of 0.23 g.
- 13:06:54 Some 24 seconds later, at an IAS of 98.4 kt, the aircraft reduces takeoff power and starts to brake.
- 13:06:55 The aircraft's speed is still increasing during the following second, reaching a maximum of 98.9 kt IAS; its deceleration reaches 0.27 g and its pitch angle exceeds the -0.9 degrees maintained during the acceleration, to reach an angle of -1.3 degrees.
- 13:06:56 Two seconds later, the speed has reduced considerably to 62 kt (though this reading may be spurious), with the reverse thrust on engines 3 and 4 already engaged. Longitudinal and lateral acceleration readings, which are recorded every quarter of a second, fluctuate between $\pm 1g$ twice in this second.

The data from the recordings of LATG, LATA, LATB and LATC are plotted in one single time sequence on Figure 1.

A check of the recorder's Parameter Data Frame revealed that the amplitude, or range, of the lateral and longitudinal acceleration parameters is limited to $\pm 1g$. Actual absolute values of these parameters experienced by the aircraft in excess of 1 g would not have been recorded.

It should be noted that the lateral acceleration readings while taxiing show values above ± 0.2 g at time marks 12:56:40 and 13:00:00, when the airplane was moving in a straight line on taxiways at speeds, not recorded, below 50 kt.

Later, during the takeoff run, the crew felt a vibration prior to reaching 40 kt. This vibration got stronger and became very violent beyond 80 kt. DFDR data confirm the vibration, with lateral and longitudinal acceleration readings of $\pm 1g$, which are the maximum the accelerometers can record. It is very possible that the actual accelerations were in excess of this magnitude. Just as these parameters were being recorded, and possibly because of their elevated value, the DFDR stopped recording for some 12 seconds, thus precluding the availability of data from the braking conditions experienced during the aborted takeoff.

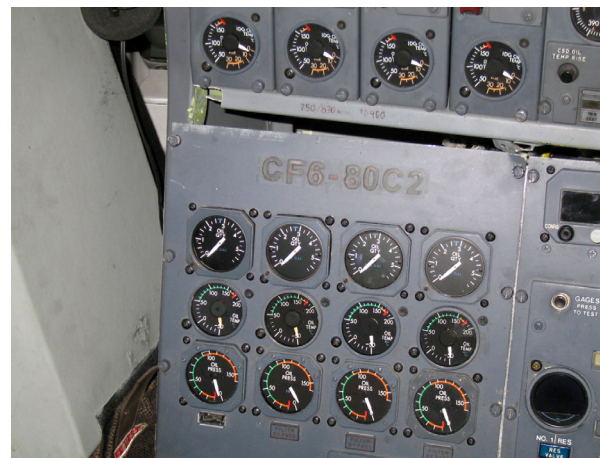
Figure 3. Flight Engineer's panel

The aircraft suffered various forms of damage in the cockpit, with dislodged instrument panels, instruments outside their respective panels or even on the floor, overhead panels and fairings that had fallen, both in the cockpit and in the main cabin. The ceiling support beam between rows 43 and 44 was cracked.

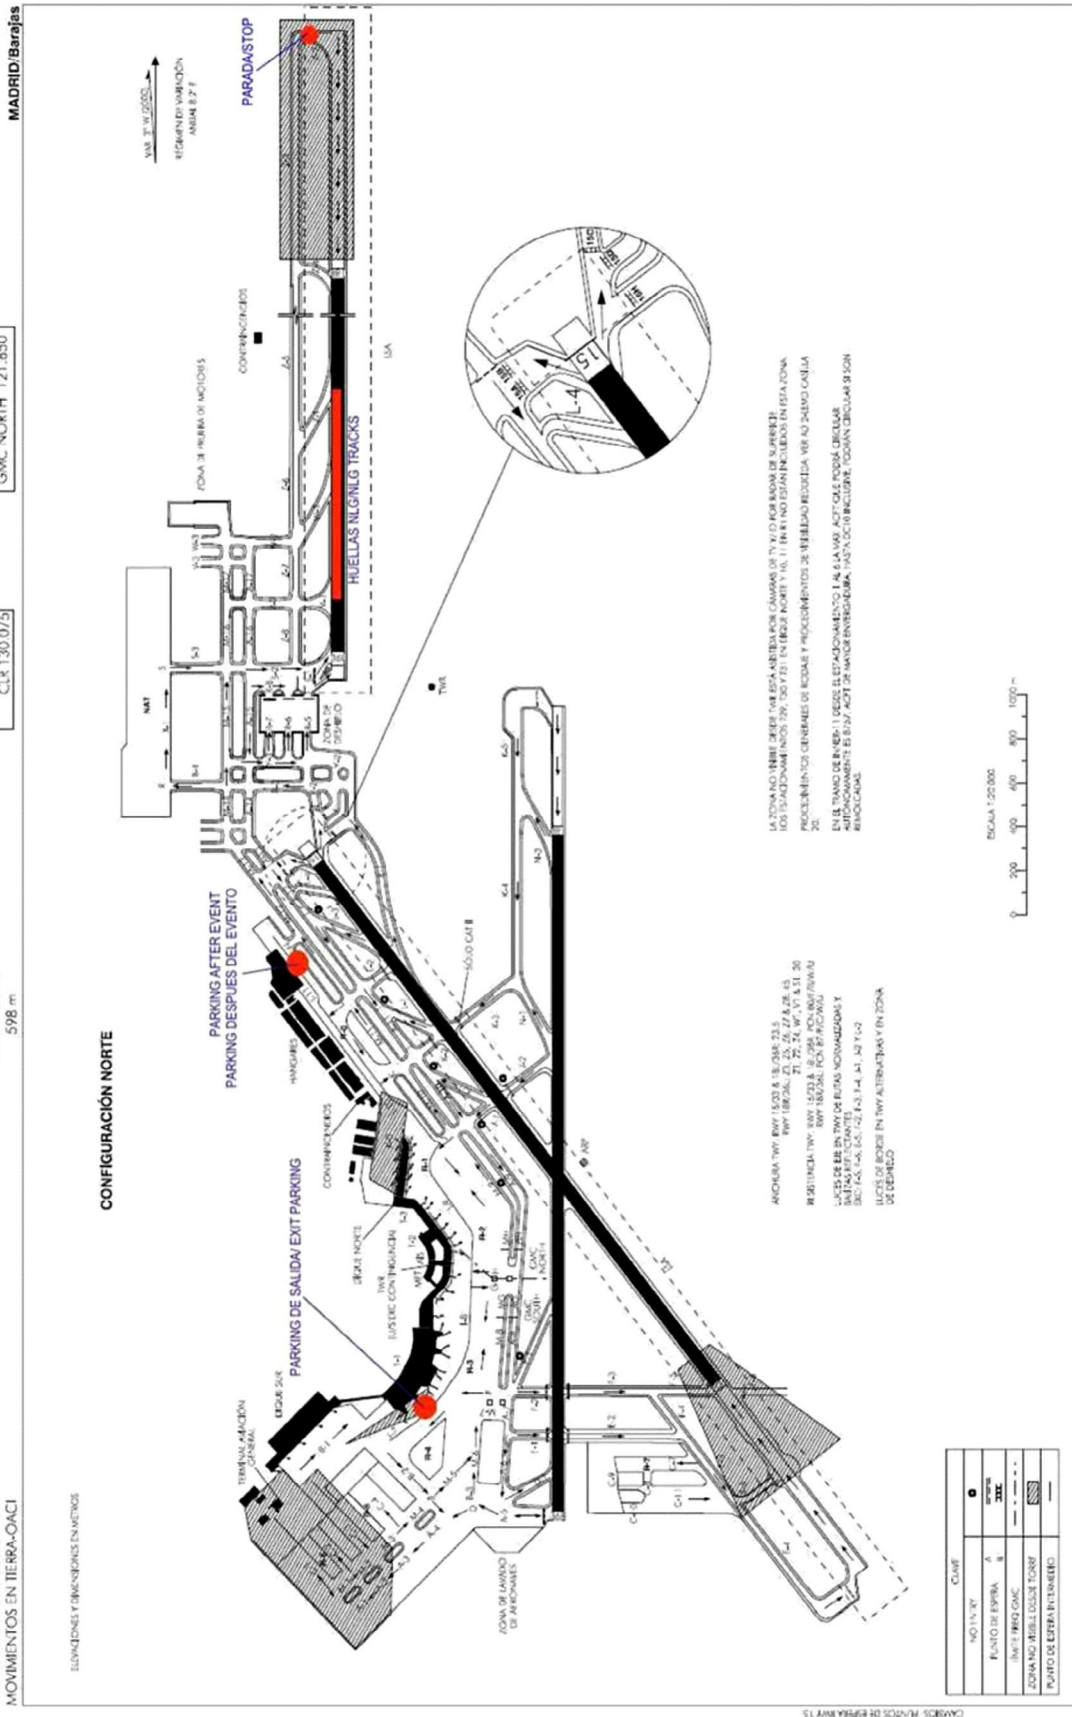
APPENDIX
**Airport map for aircraft
ground movements**

The chart shows the area of the runway between taxiways V-1 and Z-1, where zigzag marks from the nose gear were observed. Also shown are the points on taxiway Z-2 where the aircraft came to a stop and from which it was escorted to the final parking position.

An inspection of runway 36L by airport maintenance services following the incident revealed zigzag lines along the runway axis, apparently caused by the nose gear, from the taxiway V-1 intersection until taxiway Z-1.
