DATA SUMMARY

Registration	EC-HPU
Type and model	BOEING B767-300
Operator	Air Europa

REPORT

1. FACTUAL INFORMATION

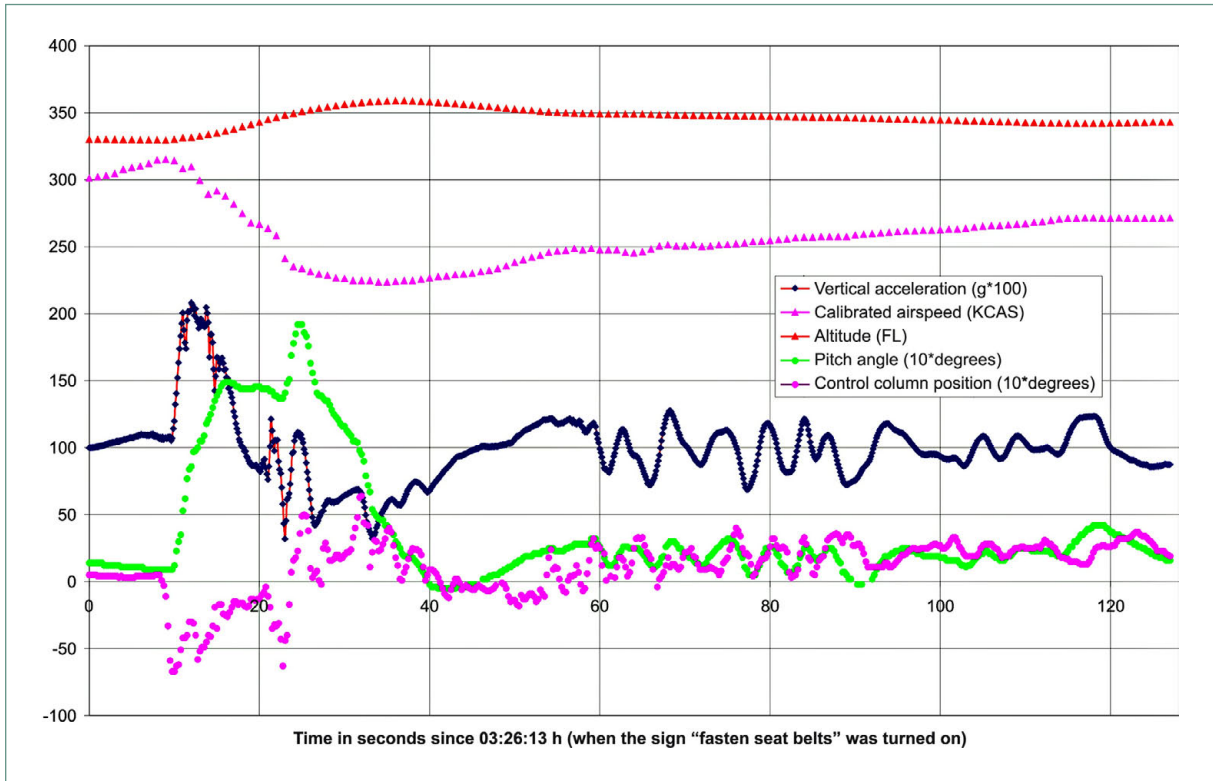
Figure 1.

A sequence of the most relevant events follows (see evolution in Figure 1):

Additionally, the aircraft was probably swept up in a strong updraft which led to the high vertical acceleration. The climb rate increased and the aircraft climbed 2,800 ft in 36 s (4,600 ft/min average). The pitch angle increased and leveled out for a period of time before dropping sharply, which resulted in the minimum vertical acceleration value. A new ascent immediately followed which took the pitch angle to a maximum of 19.2° as a local positive acceleration peak of 1.14 g was reached.

The auto thrust was engaged throughout the event. When the turbulence started, the autopilot moved the controls normally to try to counteract its effects, though it could not prevent the peaks in acceleration and overspeed.

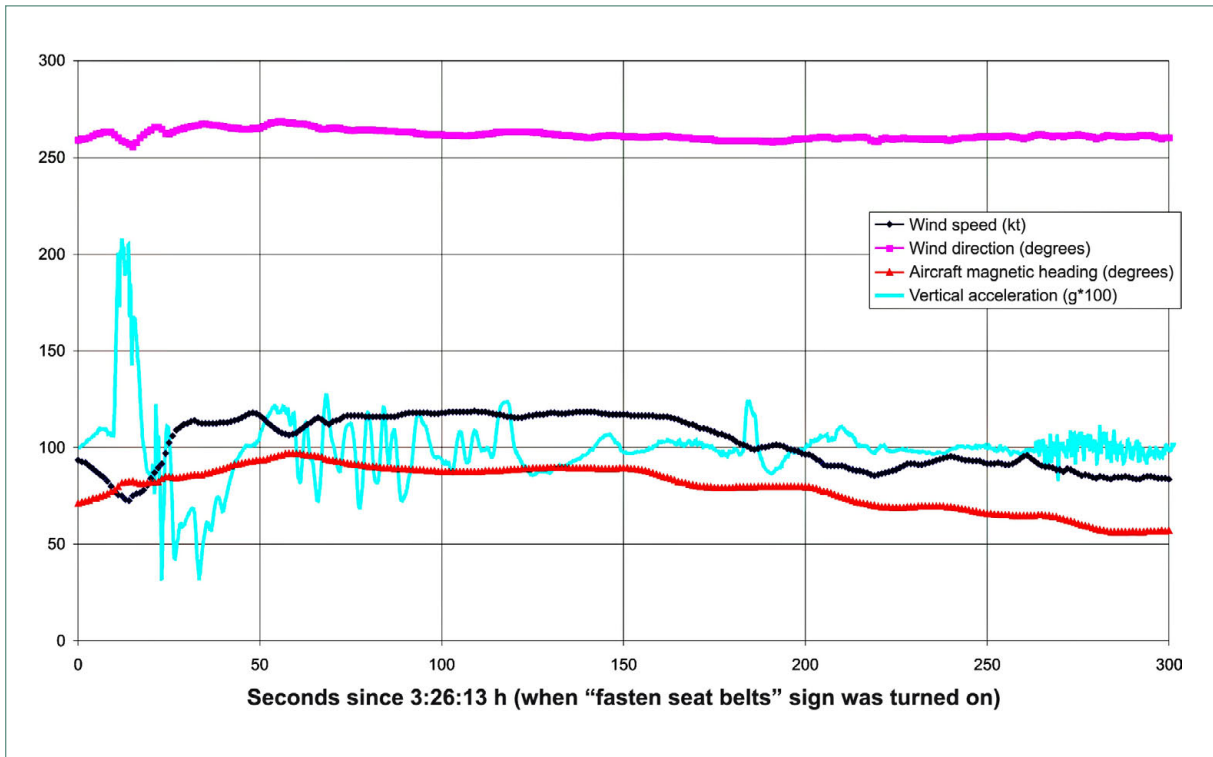
Figure 2.

The ground speed varied between 507 kt at 03:26:46 and 593 kt at 03:28:46. The aircraft experienced a noticeable variation in the tailwind when the turbulence started (see Figure 2).

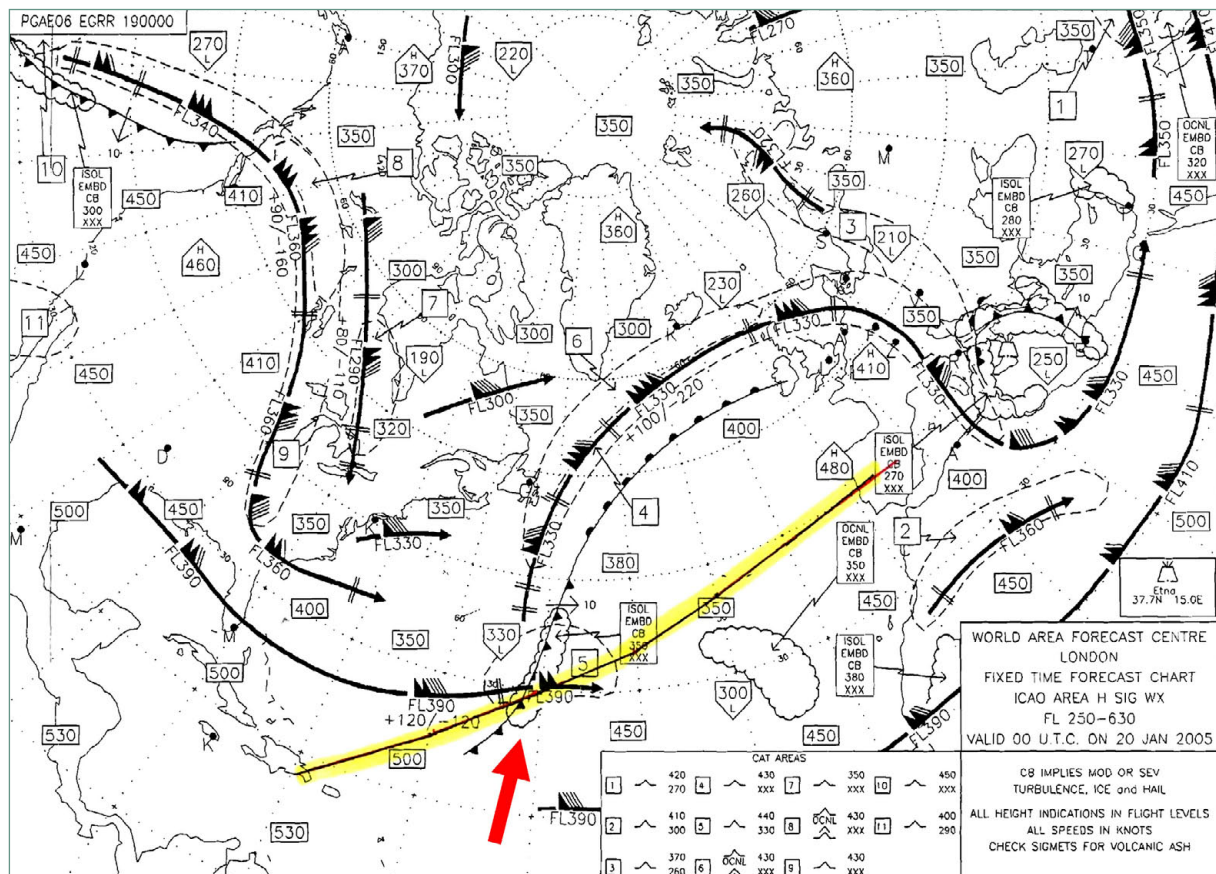
Additionally, clear air turbulence (CAT) was forecast for the area between FL330 and FL440 (see Area 5 in the chart, and altitudes in the box "CAT AREAS", lower part of Figure 3).

Figure 3. Chart from the London WAFC, with the planned aircraft route highlighted in yellow. An arrow points to the approximate area when the accident happened

- Confluence of a jet stream in excess of 100 kt at FL390 with a cold front, which was expected to generate CAT over a rather wide area.

- Embedded and isolated cumulonimbus clouds from below FL250 up to FL350.
- Transition zone from tropical to polar tropopause.
