DATA SUMMARY

Date and time	Monday, February 28, 2005; 06:16 h UTC
Site	Barcelona Airport

Registration	EC-IHD
Type and model	CESSNA 208B Grand Caravan
Operator	Alaire

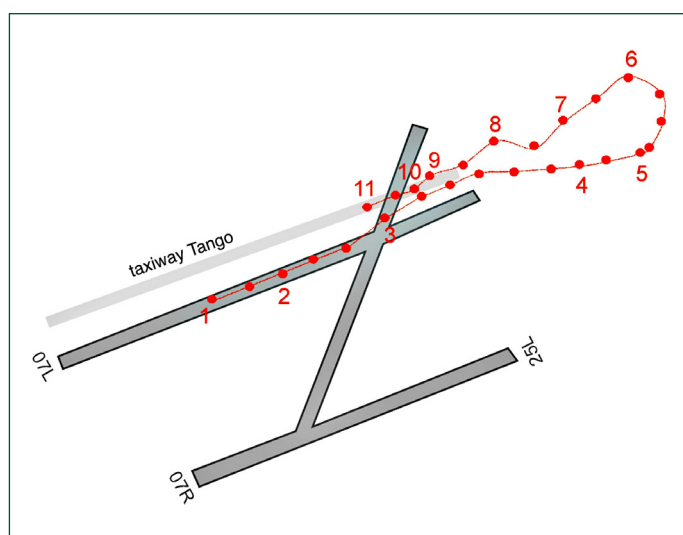
- The maximum height reached by the aircraft was 800 ft (point 5).
- The rate of climb calculated between points 1 and 5 was 564 ft/minute, a value appreciably less than 835 ft/minute which is set by the POH (Pilot’s Operating Handbook) for such flight conditions.
- The aircraft declared an emergency a few seconds before reaching 800 ft (point 5).
- From point 5 (800 ft) the aircraft began to lose height. The point to point calculations show a descent of 1,200 ft/minute until the aircraft descended to an height of 300 ft (point 7), from which point onwards the rate of descent was around 600 ft/minute.

Point	ATC hour	Height (ft)
1	06:13:33	0
2	06:13:43	100
3	06:14:13	400
4	06:14:43	600
5	06:14:58	800
6	06:15:13	500
7	06:15:23	300
8	06:15:33	200
9	06:15:43	100
10	06:15:48	0
11	06:16:08	0

- The next radar echo after initiating the turn is very near to point 5, which indicates a rapid loss of altitude.
- The turn to return to the aerodrome was very steep.
- At around point 8, when the aircraft was at approximately 200 ft, they notified TWR of their intention to land on the taxiway. ATC authorized the landing and informed them of the wind conditions.
