**DATA SUMMARY**

Registration	<b>PH-BWA</b>
Type and model	<b>BEECHCRAFT BONANZA A-36-AT</b>
Operator	<b>KLM Flight Academy</b>

**REPORT**

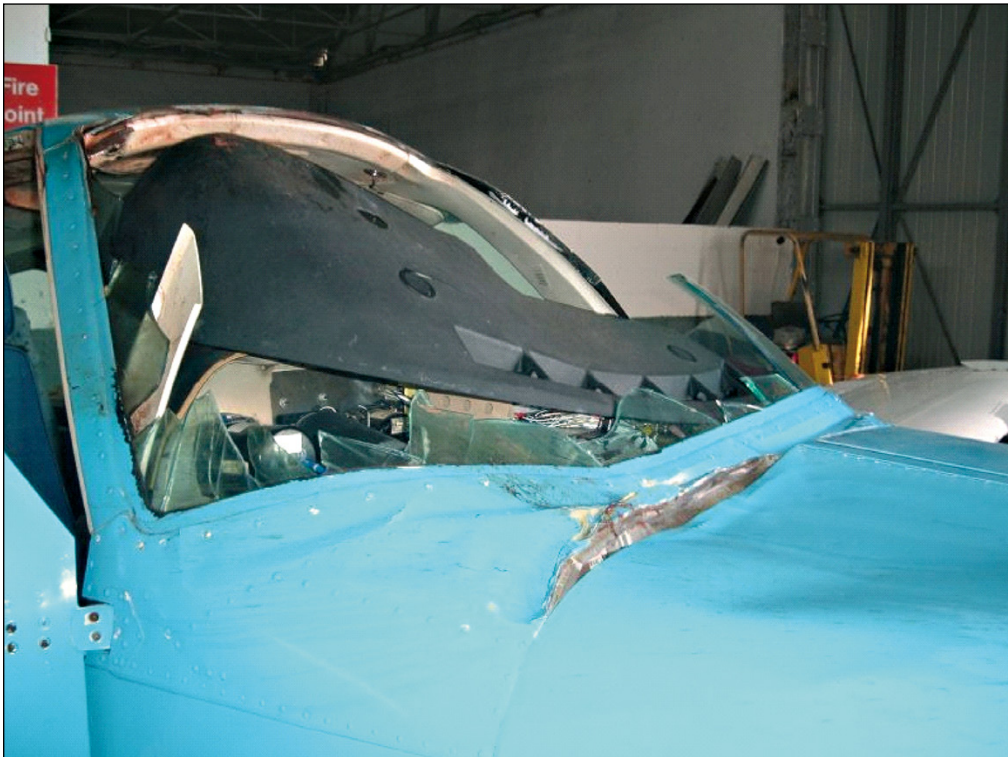
During the accomplishment of this maneuver, a bird struck the front right part of the aircraft. The flight instructor received most of the impact but she managed to recover the controls and returned to Jerez airport, where they landed at 16:05 h local time.

The aircraft had the windscreen broken, damages on the right side of the control panel, to the firewall and to the right door (see Figure 1). Also some minor damages were produced on the right side of the fuselage and to the elevator.

Figure 1. Damages of the bird impact with aircraft

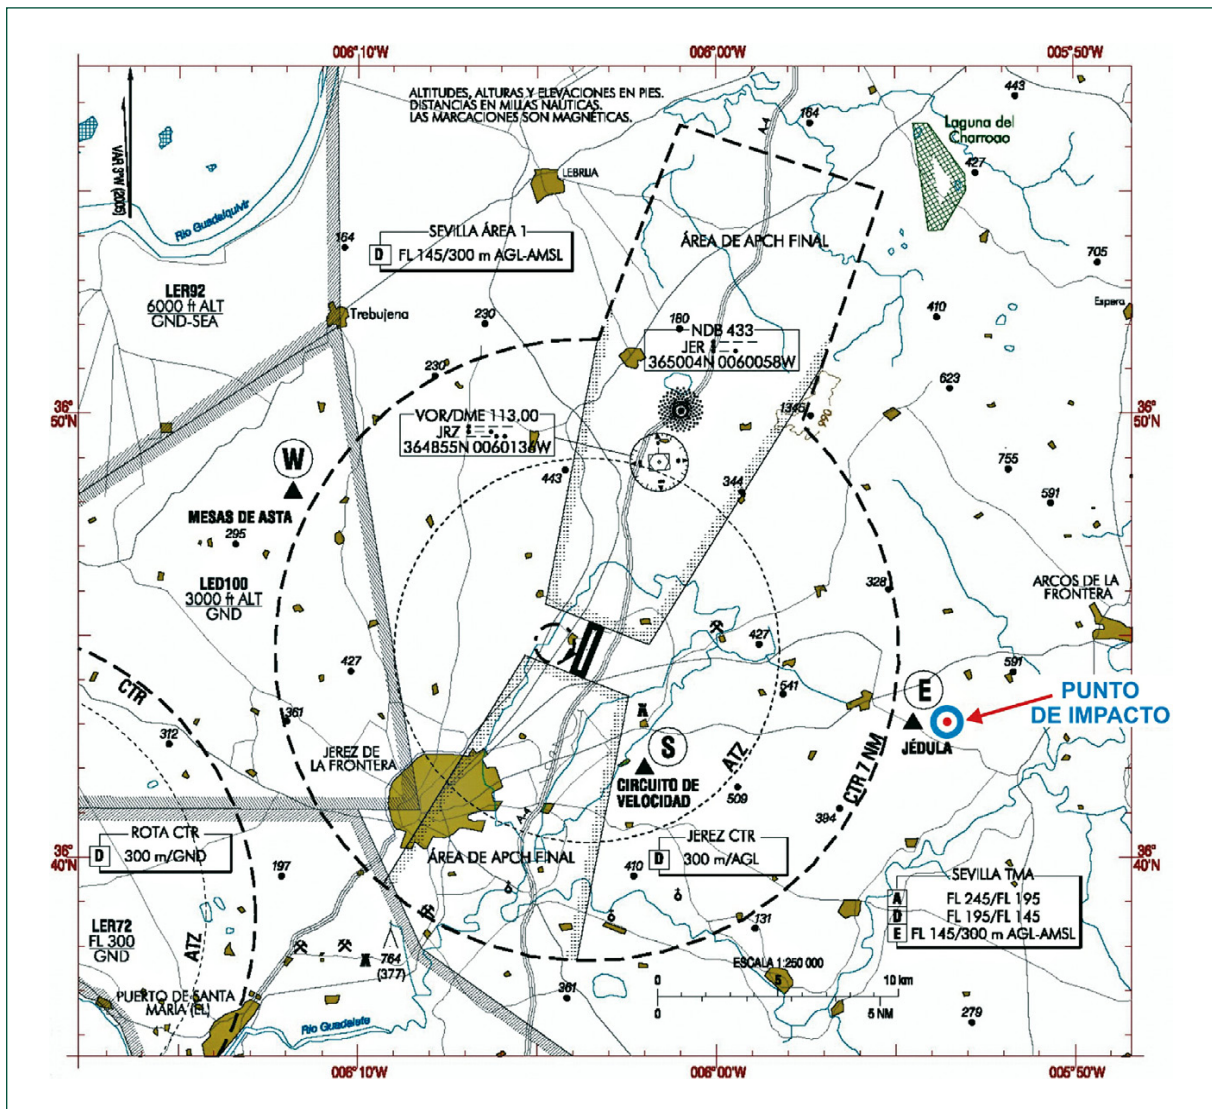
Figure 2. Location of the point of the bird strike

Point ECHO is established as an entering point to the CTR and it is placed to approximately 7.5 NM eastwards from the ARP. The place where the bird struck the aircraft is located beyond that point.
