## Report A-023/2005

Accident involving a PZL  
M18A aircraft, registration  
EC-FDN, operated by Martinez  
Ridao Tratamientos Aereos,  
in Beariz (Ourense),  
on 7 June 2005

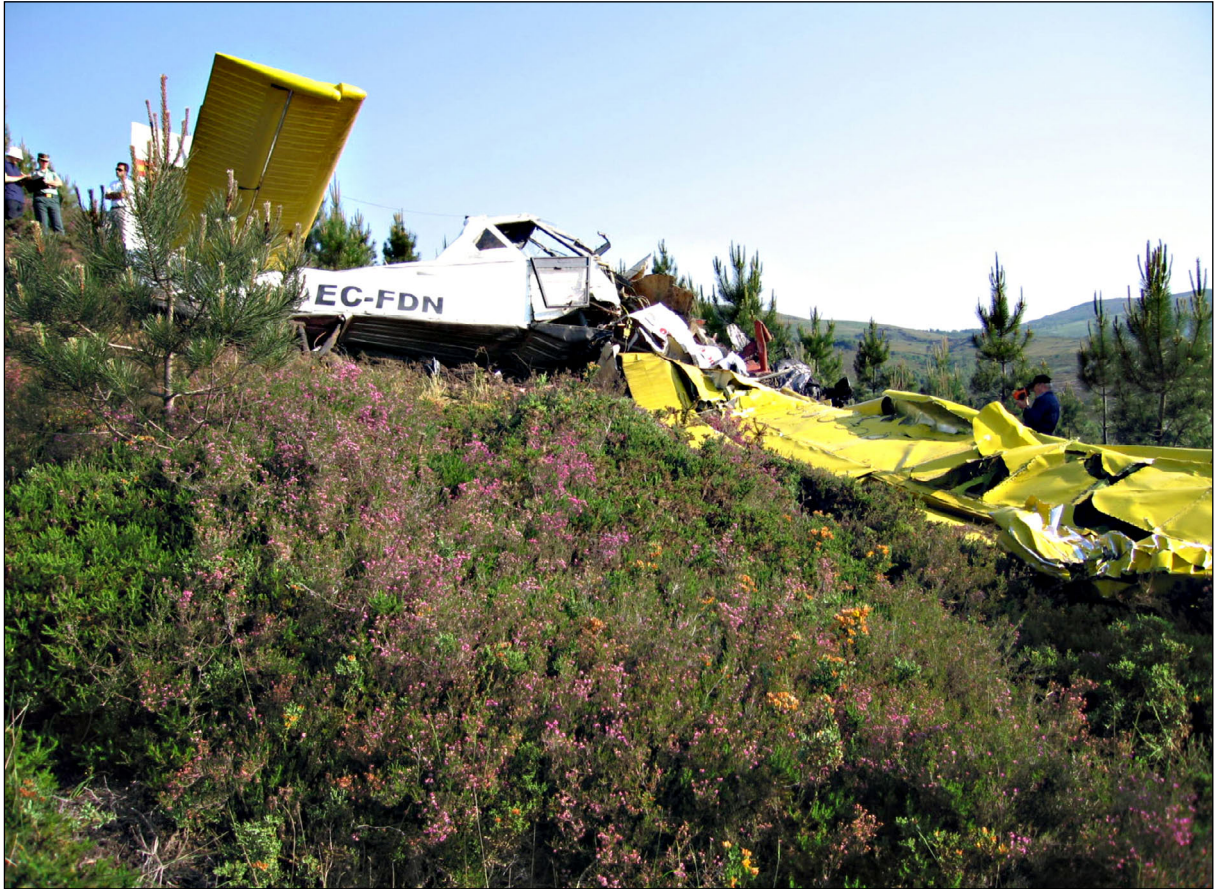
## **Aircraft wreckage**

The aircraft partially maintained its structural integrity and the wreckage was confined to a small area; all of the detached remains were found within 13 m of the main wreckage.

The landing gear had collapsed and the wings were resting on the ground along the entirety of their span, with major damage to the left wing, which was on the uphill side. The right wing was detached from the fuselage.

Two of the four propeller blades were buried beneath the remains of the engine, and the other two blades were slightly damaged, showing signs of buckling toward the rear, evidence of limited rotation at the time of impact.

One engine cylinder had detached axially from the crankcase, symmetrically fracturing its fourteen mounting bolts, and was just a few centimeters away from the engine block, the spark plug cables still intact. The fracture of the fourteen bolts was produced by uniform tensile forces, with noticeable necking of the fractured section.

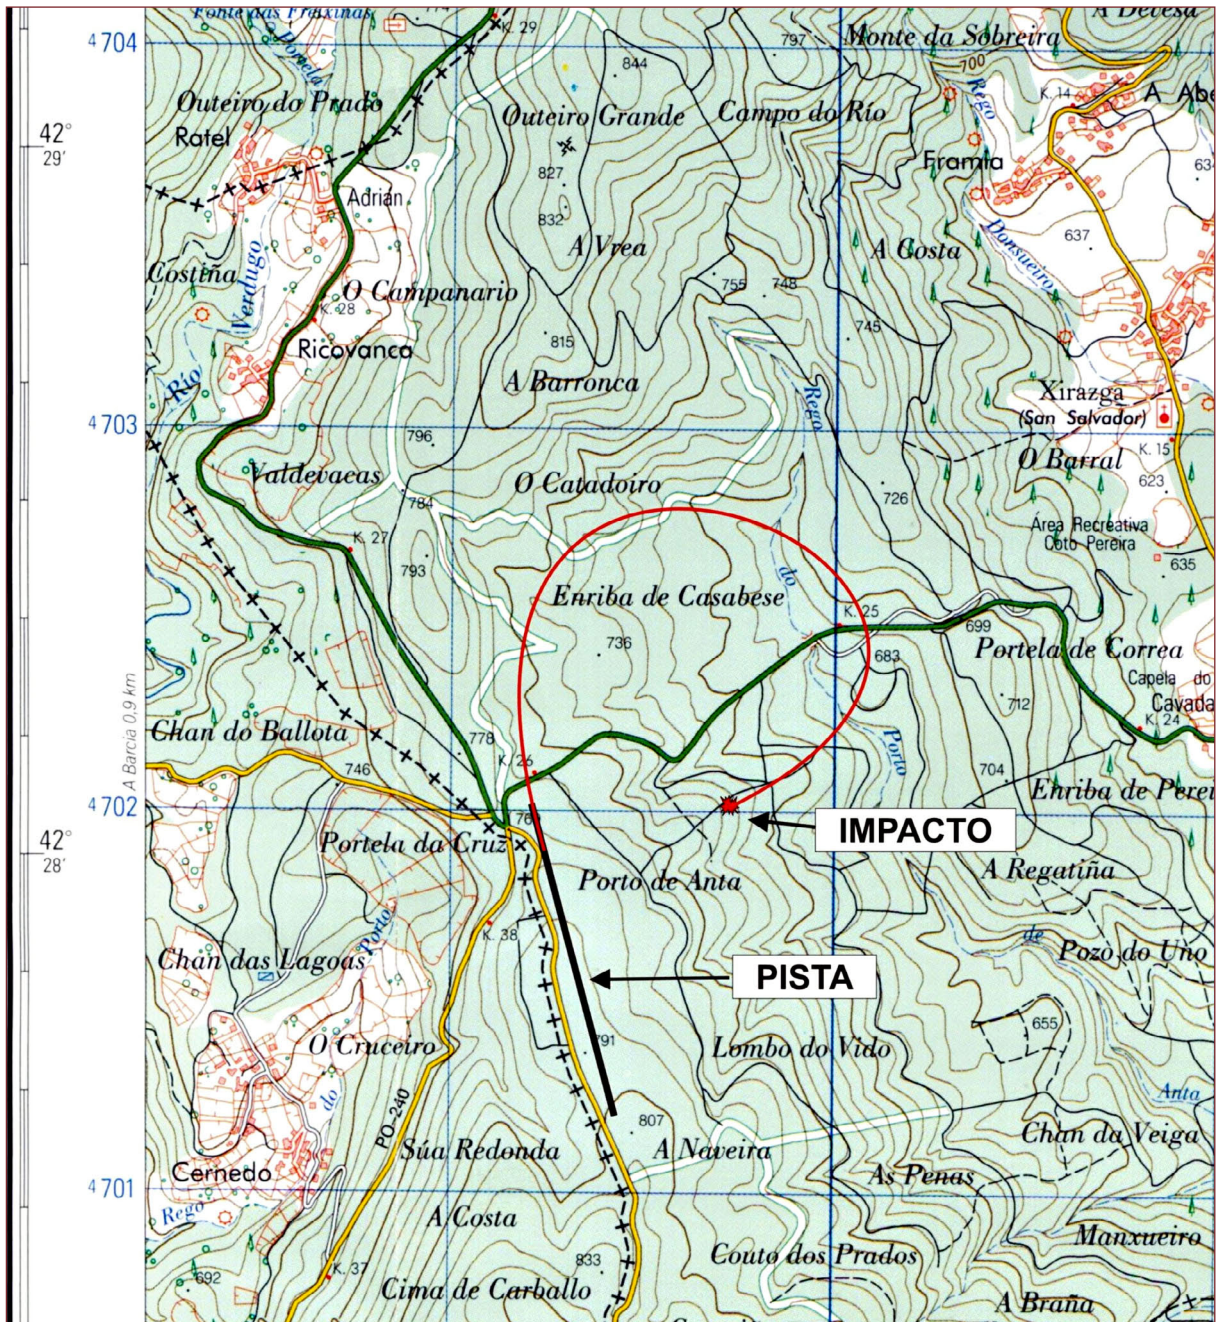
### **Aircraft's flight path**

During the turn, once the aircraft was perpendicular to the runway from which it had taken off, it crashed to the ground on a hill situated on the right side of the runway.

The necessary airspeeds depend on the aircraft's weight, and are also influenced by the flying conditions in the turn. According to the information received and the evidence found, the turn radius may have been approximately 400 m, which yields a bank angle of 30°. In principle, increasing this radius by 150 m would still have allowed the aircraft to clear the obstacles with a lower bank angle, while staying further away from critical turn conditions.

Under these flying conditions, the aircraft suddenly plunged to the ground. The impact marks indicate a nose down attitude and a high speed.
