Report A-035/2005

Accident occurred on 13
July 2005 to aircraft PZL
Swidnik W-3AS Sokol,
registration SP-SUB,
operated by Hispánica
de Aviación in Tineo
(Asturias-Spain)

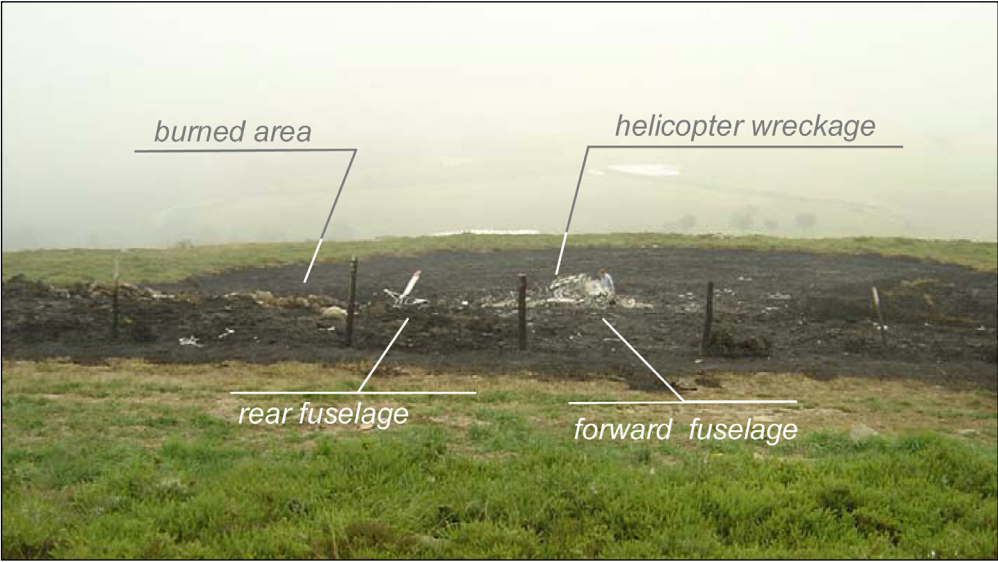
Figure 3. Overall view of the crash site

Following the impact a fire broke out which completely destroyed the main fuselage and most of the tail boom. It was impossible to identify any cabin controls or any hydraulic system components of interest to the investigation. Remains from the main rotor blades were found in the vicinity of the crash site, though the majority of the wreckage was confined to within a 50-m radius of the crash site.

The crash site was 2 km away from the base at Tineo, on sloped terrain with scrubland vegetation. The area around the helicopter caught on fire.

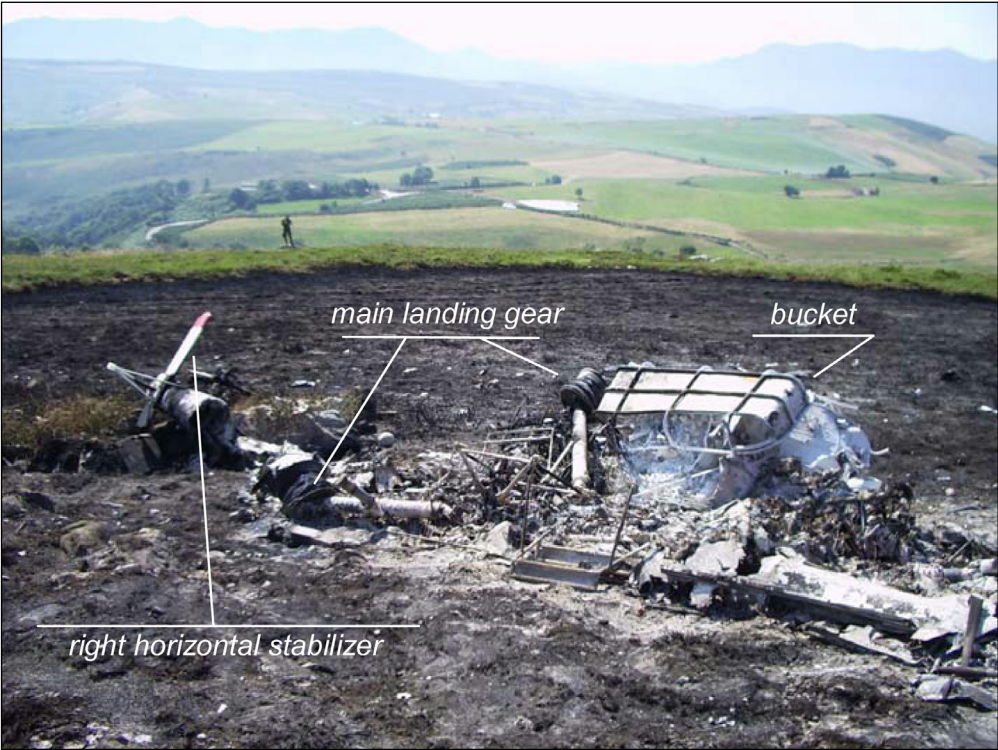
Figure 4. Final position of the aircraft

The pilot and copilot were aboard at the time of the accident. The aircraft overturned and caught on fire after the impact, as a result of which the pilot suffered serious burns and cuts requiring a hospital stay of over 48 hours. The first to exit the aircraft was the copilot, who was seated on the right side and who, once outside, broke the pilot-side window and helped the pilot escape the wreckage, as the helicopter had turned over on the left (pilot) side.

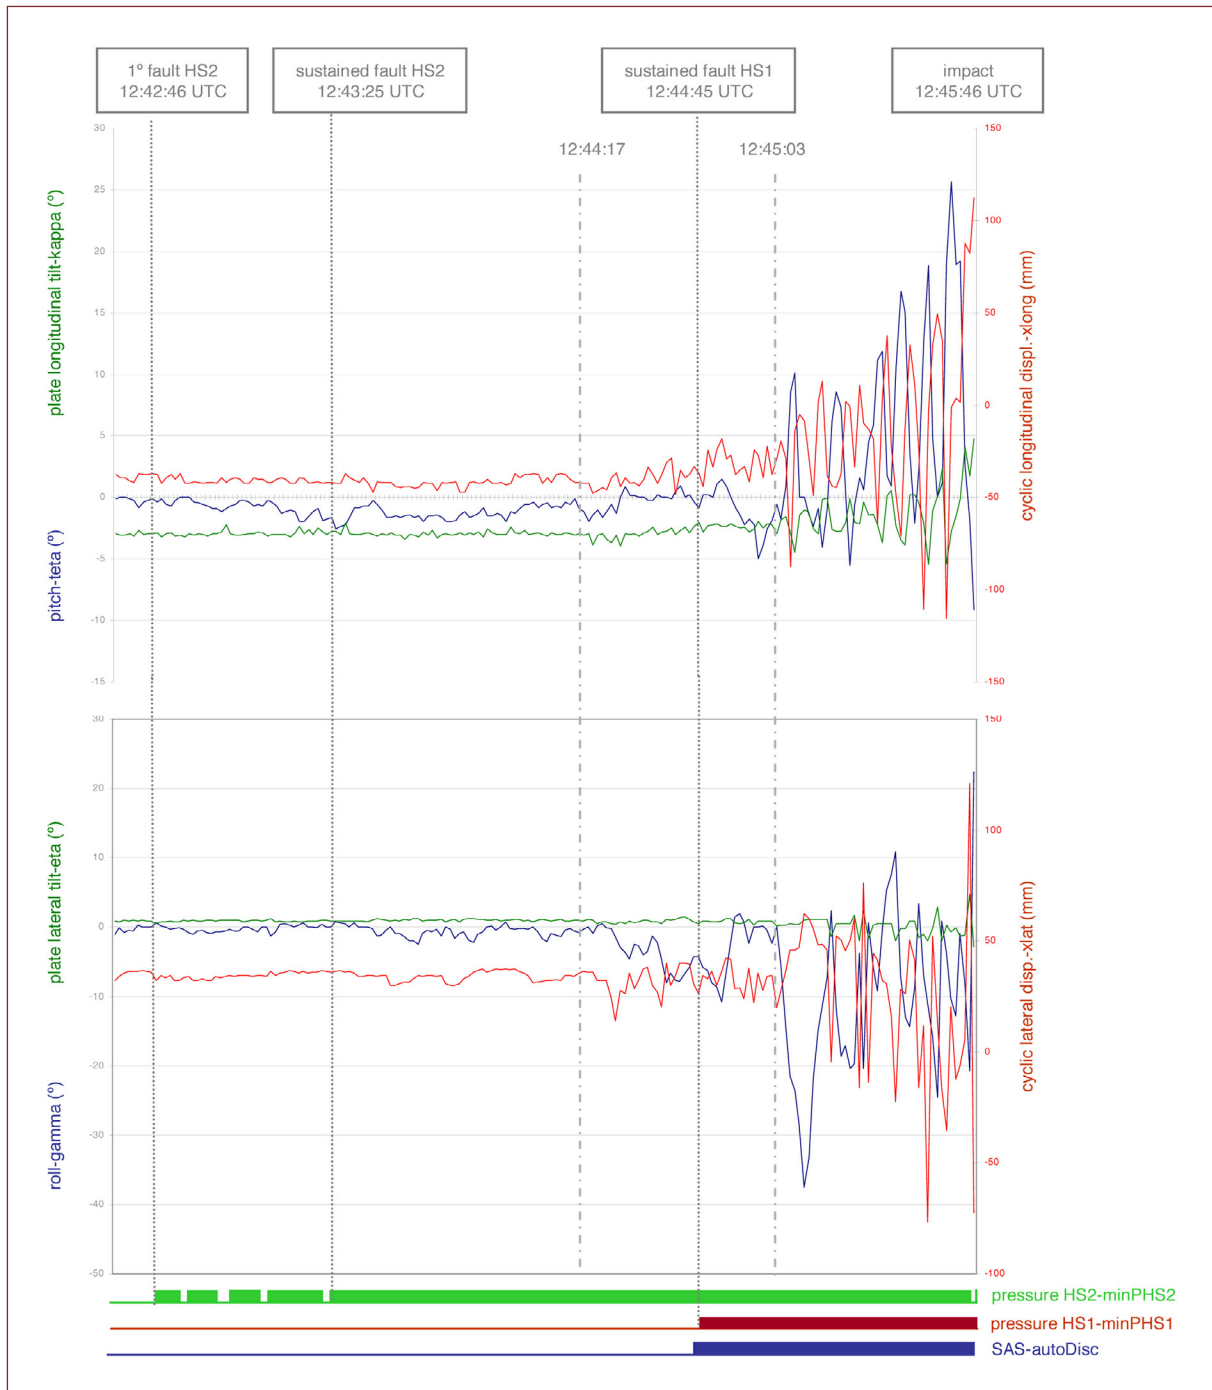
Figure 5. FDR parameters during the final 3 minutes of the flight associated with inputs to the cyclic control

At 12:42:46 the FDR registered a 5-second pressure drop below minimum in HS2. The fault reappeared in increasingly longer intervals (7, 7 and 11 seconds) interrupted by 1, 2 and 1 second-long recovery periods respectively until finally, at 12:43:25, 39 seconds after the initial fault, a sustained loss of pressure occurred in HS2. The aircraft, which was on a heading of 250°, had covered 1.8 km in this time. From the first fault until 52 seconds after the sustained fault (12:44:17 UTC), all flight and flight control parameters remained unchanged with respect to the previous normal flight segment.

At 12:44:17 UTC, 28 seconds before the sustained fault appeared on HS1, the parameters for the cyclic and collective controls showed the first noticeable indications of change, although the yaw control, as well as heading, altitude and airspeed remained essentially unchanged. One second before the loss of pressure in HS1 took place, the SAS went off line.

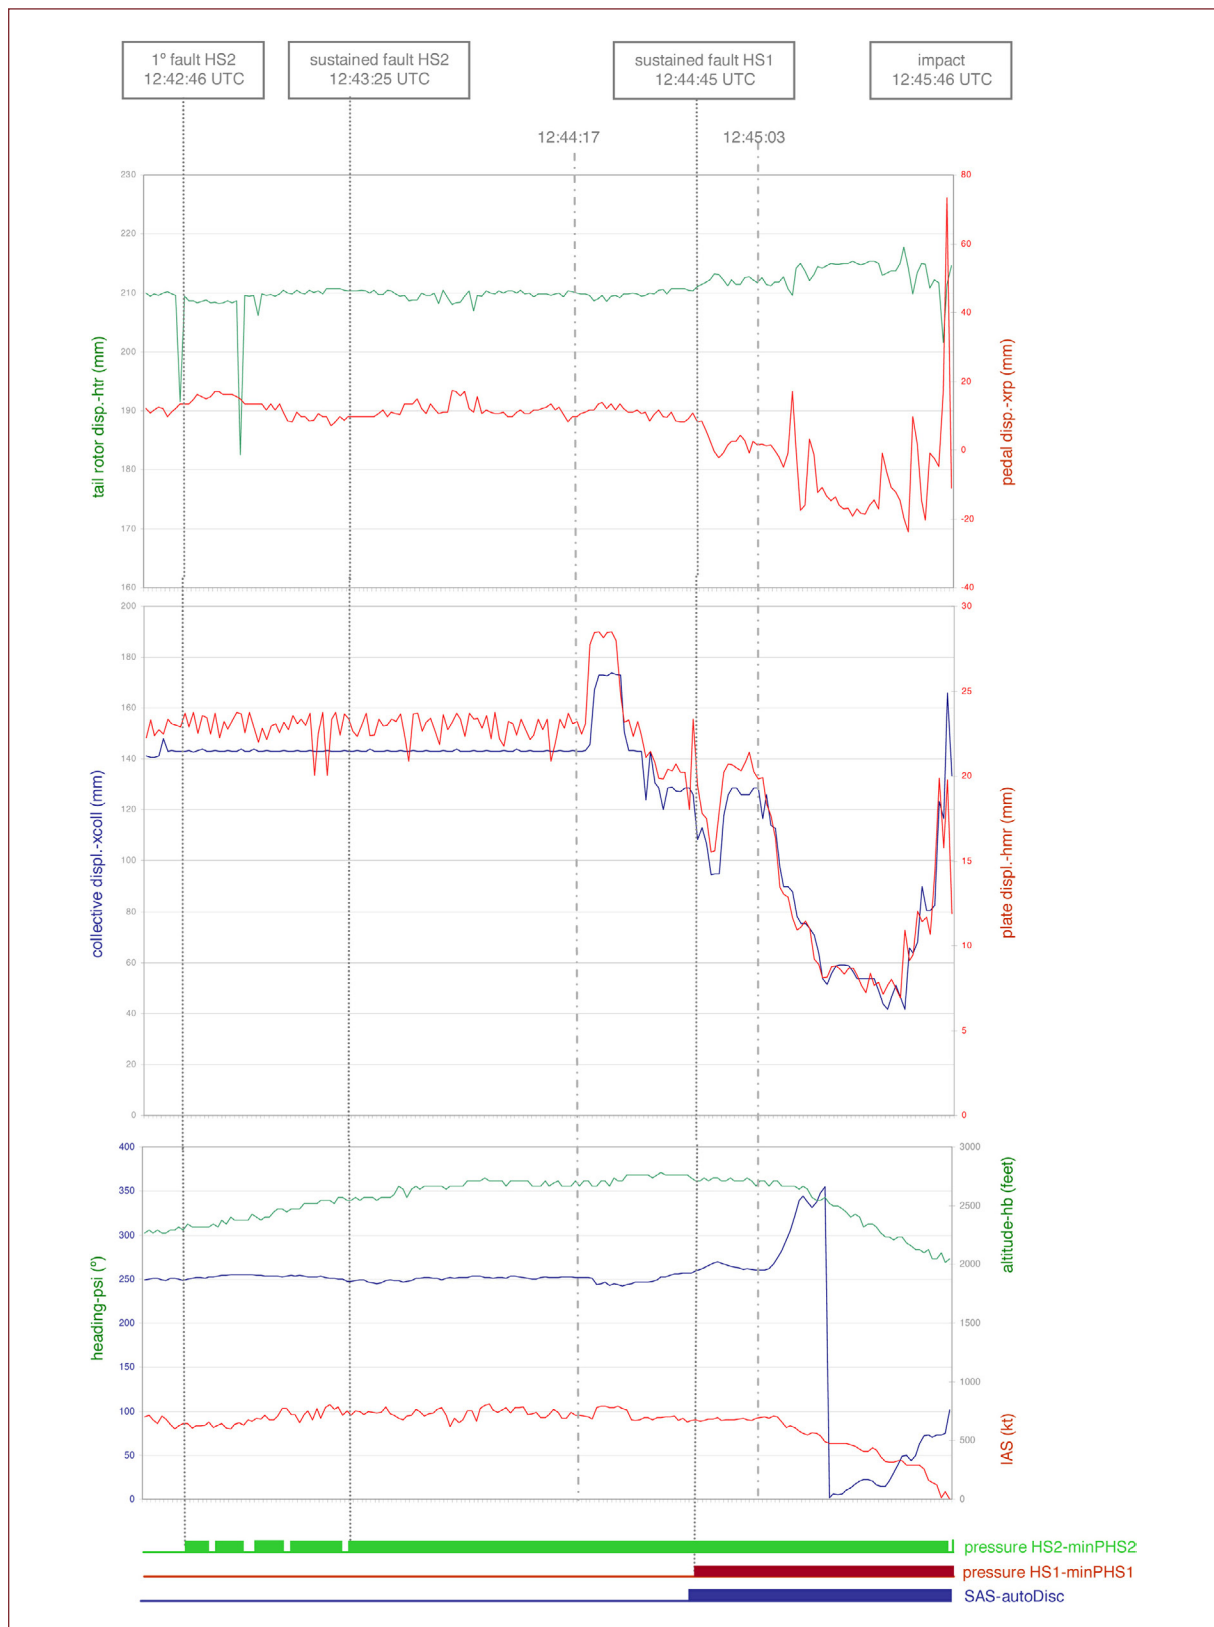
Figure 6. FDR parameters during the last three minutes of flight associated with inputs to the collective control and pedals and the flight profile

Starting with these indications, once the aircraft had changed course to 260° and was flying at an average airspeed above 90 kt, the fault in HS1 occurred at 12:44:45 UTC, leaving the aircraft without hydraulics and 18 seconds later, at 12:45:03 UTC, all parameters indicate the control crisis deteriorated, with the appearance of temporary vertical accelerations, increasing longitudinal oscillations of the fuselage and an increasing yaw,

leading to an uncontrollable flight situation. Concurrent with the instability, there appeared the quick course change to the right and the drop in airspeed, altitude and engine power just before the impact, undoubtedly as part of the preparations for an off-field landing. Vertical accelerations of 1.5 g were registered during the impact. The aircraft covered 7.7 km from the time the first fault on HS2 was recorded until the end of the flight the aircraft.

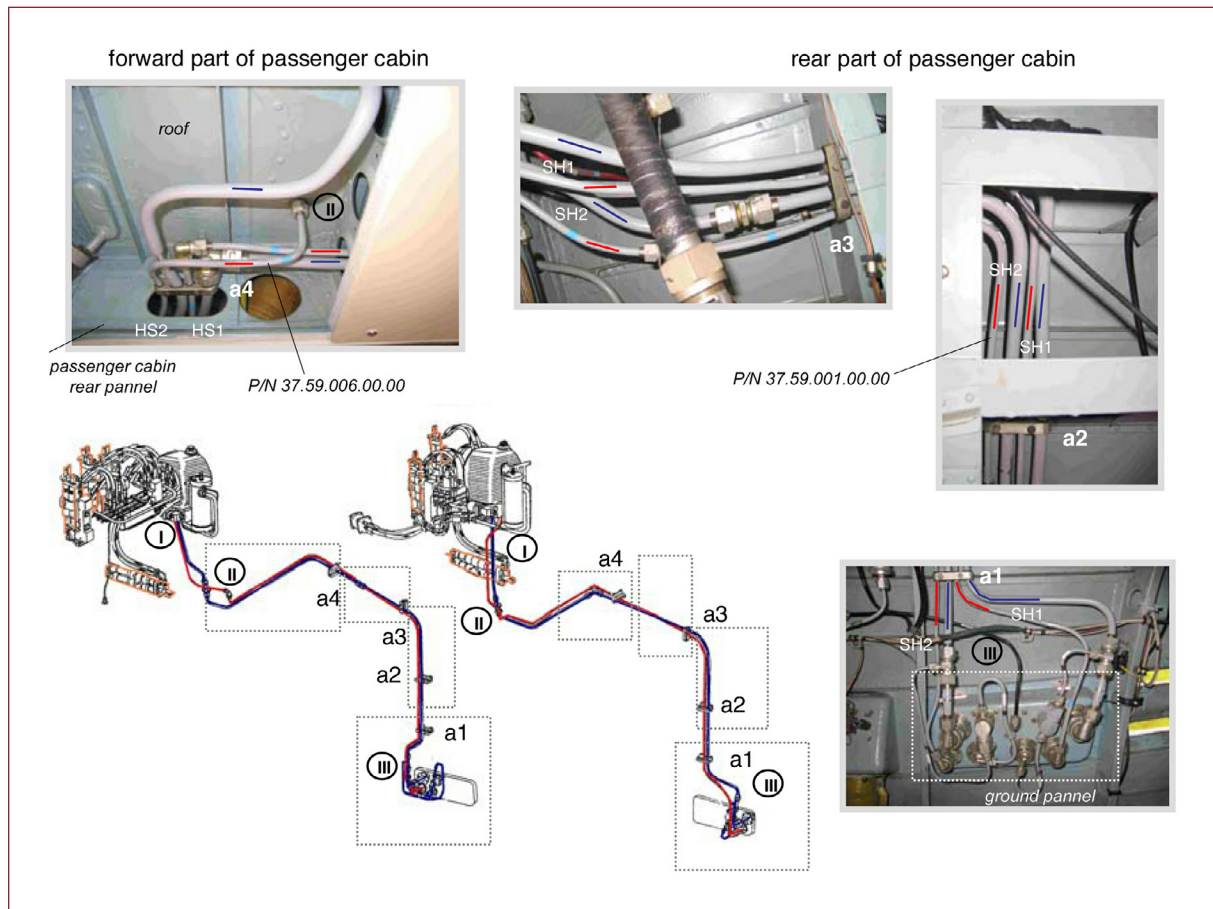
Figure 9. Section II-III of the ground circuit located inside the cabin

In three of the 6 accidents a break occurred in pipe P/N 37.59.006.00.00 in HS2 (see figure 9). This pipe forms part of the ground circuit's pressure piping; specifically, it runs from the overhead to clamp number 4 just in front of the passenger cabin rear panel. The manufacturer determined that the failure was caused by a production defect of the pipes, and therefore new pipes were manufactured and sent to the operator.

In the other two accidents (one of them involving aircraft SP-SUB on the test flight of 04/07/05) there was a break in pipe P/N 37.59.001.00.00 in HS2 (see figure 9). This pipe forms part of the ground circuit's pressure piping and is in the last section just before the ground service panel located behind the passenger cabin between clamps 1 and 3. The manufacturer determined that the cause, in this case, was an improper installation of the pipe. In consequence, the manufacturer initiated the elaboration process of a service bulletin (which was issued after the SP-SUB accident) and the manufacture of the needed components for its implementation. During this process, the SP-SUB accident took place.

It is believed, then, that the faults witnessed and confirmed by the pilot indicative of low pressure in HS2 were likely the result of a loss of fluid due to a rupture in pipe P/N 37.59.006.00.00, which extends from the overhead to the rear of the panel that demarcates the limits of the passenger cabin (figure 9). More data in support of this possibility are the similar problems previously recorded and provided by PZL-Swidnik which indicate that it is in this line in HS2 where all the hydraulic failures ever recorded on the W-3AS have taken place. From among all the faults, breaks in the HS2 ground circuit pressure line account for over 50%. Specifically, there is a history of breaks in the same pipe that is thought to have fractured in the case of SP-SUB.

The pilot's statement, the fault mechanism registered by the FDR and prior history on other W-3AS models indicate that the failure of HS2 (which occurred first) was most likely the result of a rupture in the ground circuit pressure piping located under the passenger cabin overhead, P/N 37.59.006.00.00.

Because of this, and considering the history of faults which have occurred in this pressurized section of the HS2 circuit since the inception of the W-3AS model, it seems appropriate to rethink, on one hand, the real need for a ground circuit that causes so many problems without performing any in-flight functions and, on the other, should the circuit be retained, the pressing need to isolate this part of the system.

- REC 04/07.** Given the history of faults in the ground circuit and this component's use only and exclusively in maintenance tasks, it is recommended that the manufacturer, PZL, study the design of the W-3AS hydraulic system ground circuits to evaluate the possibility of removing them or improving their current design.

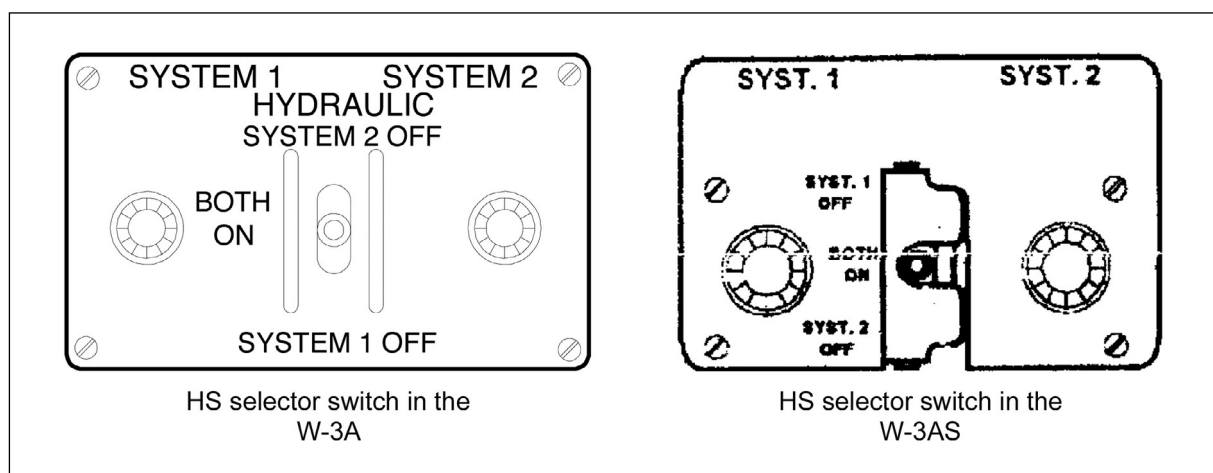
Figure 11. Differences between the cockpit HS selector suites in the W-3A and W-3AS

- W-3A and W-3AS have two independent hydraulic systems identical in every respect except one: the W-3A has two SAS systems, whereas the W-3AS only has one (powered from HS1). The W-3A's cockpit panel is different from that of the W-3AS, which has the warning light, pressure gauge and HS selector switch situated together, whereas in the W-3A the warning light is separate from the selector switch and pressure gauge. Moreover, in the W-3AS the HS selector switch has a guard, not present in the W-3A, which must be lifted to the left to disconnect one of the systems. In the W-3AS, HS1 is disconnected by flipping the switch up while on the W-3A the switch is flipped down. As for the emergency procedures, they are the same for both models and neither mention any required actions for the hydraulic selector switch.

Supposing a deliberate action was taken in the cockpit with the HS selector switch for the purpose of isolating the damaged hydraulic system, as is done during emergencies on the W-3, an added element of confusion is introduced by the fact that the position of the switch which disconnects HS2 on the W-3A, on the W-3AS disconnects HS1. Furthermore, the normal procedures in the W-3AS manual leave open the possibility of disconnecting one system in case of an emergency (without specifying the emergency). Regarding this possibility, it must be pointed out that while this action cannot be carried out that quickly (it involves moving the switch guard and then positioning the switch), it was carried out relatively late (80 seconds after the sustained failure of HS2) and, moreover, given that the aircraft was in the air a further 61 seconds, there was time to correct the action and return the switch to the BOTH position. It must be reiterated that both pilots were emphatic in their statements about not having touched the cockpit HS selector switch at any time.

- Provide operators with adequate training guidelines designed to increase and maintain pilot awareness concerning:
 - The differences between the emergency procedures for a hydraulic failure in the W-3 as opposed to the W-3A and W-3AS models.
