Report A-041/2005

Accident involving
a Canadian SAFARI
helicopter, no registration,
in Cobreces (Cantabria),
on 25 July 2005

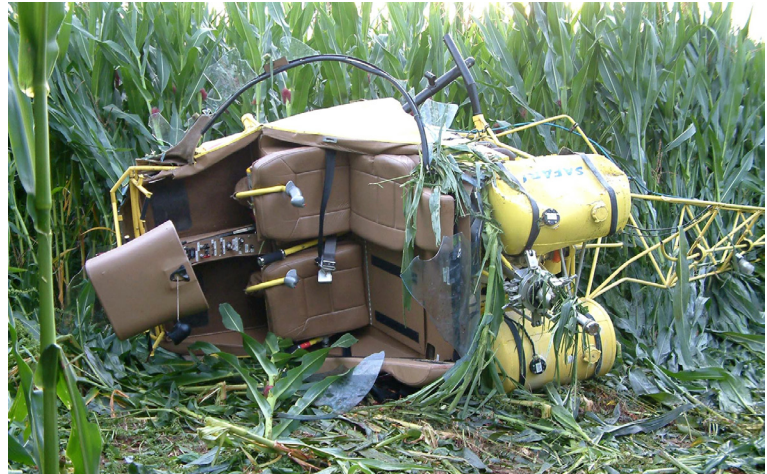
The aircraft came down in a corn field with barely any lateral movement, coming to rest on its left side on the ground.

Figure 1. Final position of the helicopter

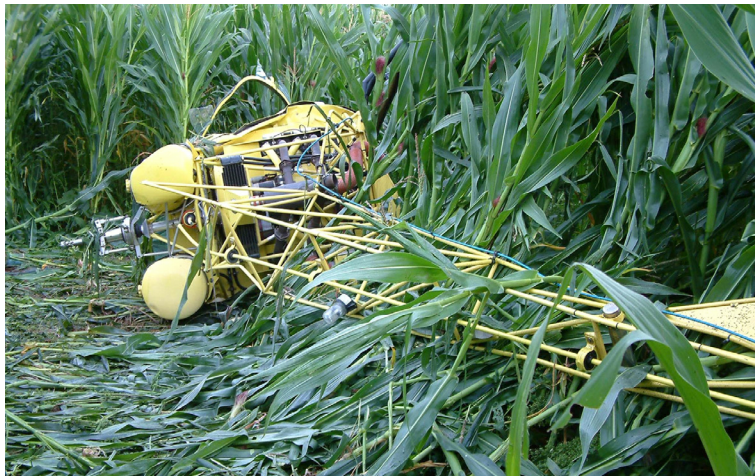
The main rotor was detached from the mast. Its two blades had been bent by the impact. The tail rotor detached in two places, with one blade in one location, and the

Figure 2. Final position of the tail section

assembly consisting of the driveshaft, head and the other blade in another.

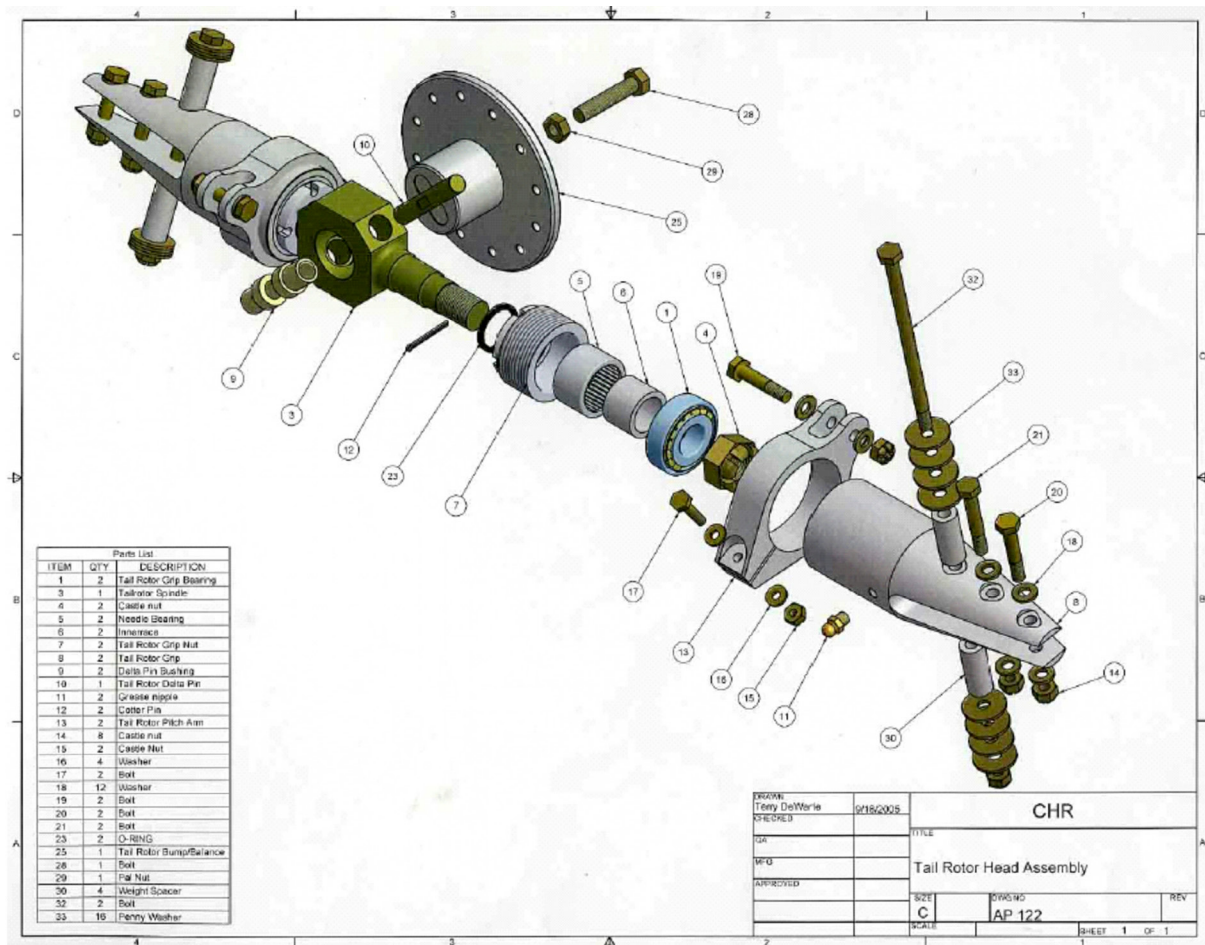
Figure 3. View of the tail rotor

The tail rotor delta pin (10) is housed inside the spindle (3) and is held in place by the bolt (28). The spindle, in turn, is connected to the driveshaft by the delta pin.

The diagram in Figure 3 does not specify accurately how to assemble the spindle. The design of the component is such that if given half a turn about its longitudinal axis, it can be mounted in two different orientations, with the delta pin varying its position relative to the rest of the tail rotor head and blade assembly.

On the other side, and in order to avoid future mistakes in the tail rotor spindle assembly, the manufacturer will proceed to engrave this piece, indicating which side is situated in the outside area.

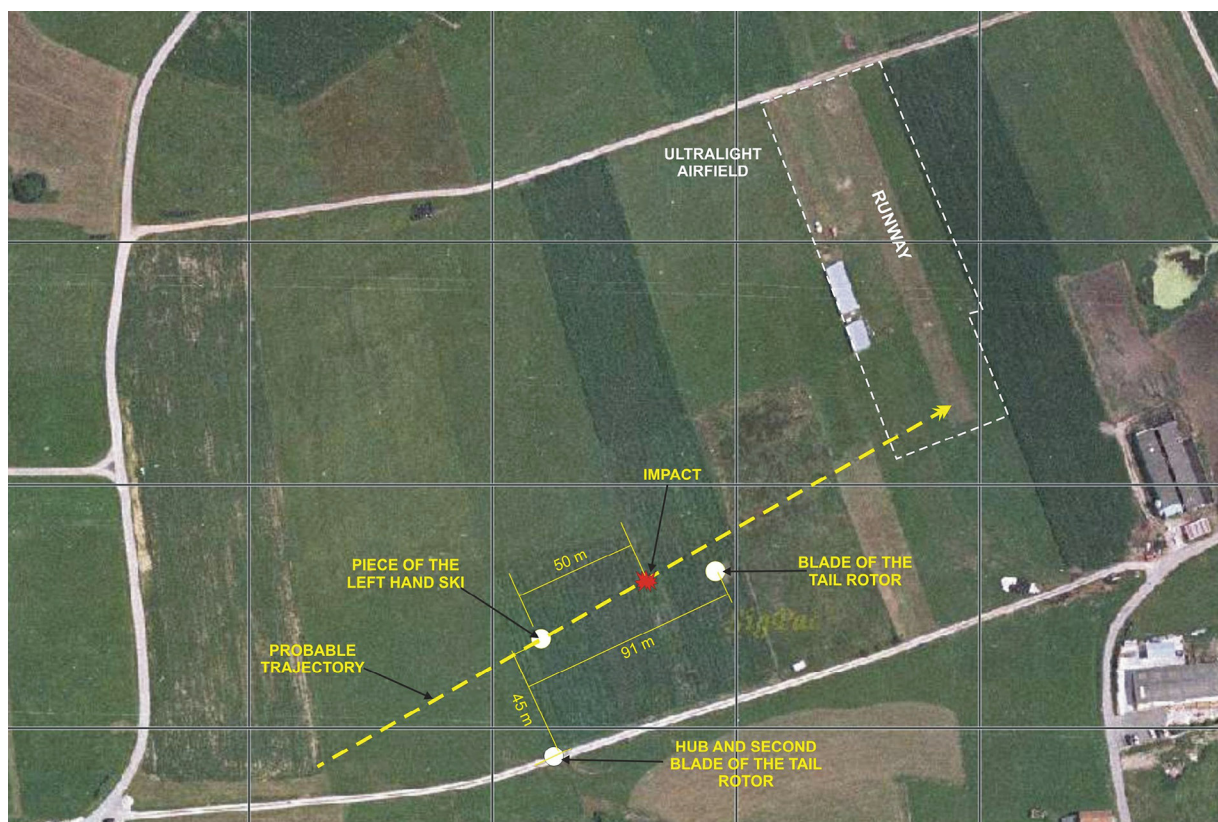
The front third of the helicopter's left skid was separate from the main wreckage but along the same likely path taken by the helicopter in the final moments of flight (see Figure 4).

Figure 4. Overhead view showing the trajectory and wreckage distribution

The tail rotor remains were in two groups, separate from the helicopter:

1. The group comprising the rotor head, the right angle drive and one of the blades was found next to the skid fragment mentioned above. The last third of the tail rotor blade had received a severe impact.
2. The second tail rotor blade was found ahead of the main impact site.

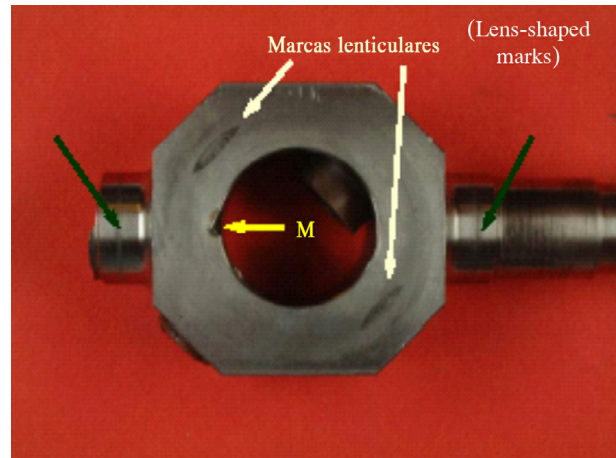
Figure 5. Spindle as seen from the driveshaft side at the time of the event

The tests revealed that the spindle was mounted in a different position from that specified in the manufacturer's assembly instructions (see Section 1.18.1). This resulted in a delta pin that was 90° out of alignment.

The fracture of the spindle arm resulted from fatigue and developed at a point situated on the tail rotor's rotational plane, on the leading edge side. No cracks were found on the corresponding section of the other spindle arm.

There were lens-shaped marks on both sides of the spindle, situated symmetrically about and perpendicular to the delta pin, apparently due to contact with the edges of the tail rotor bump/balance and resulting from excessive clearance in the assembly.

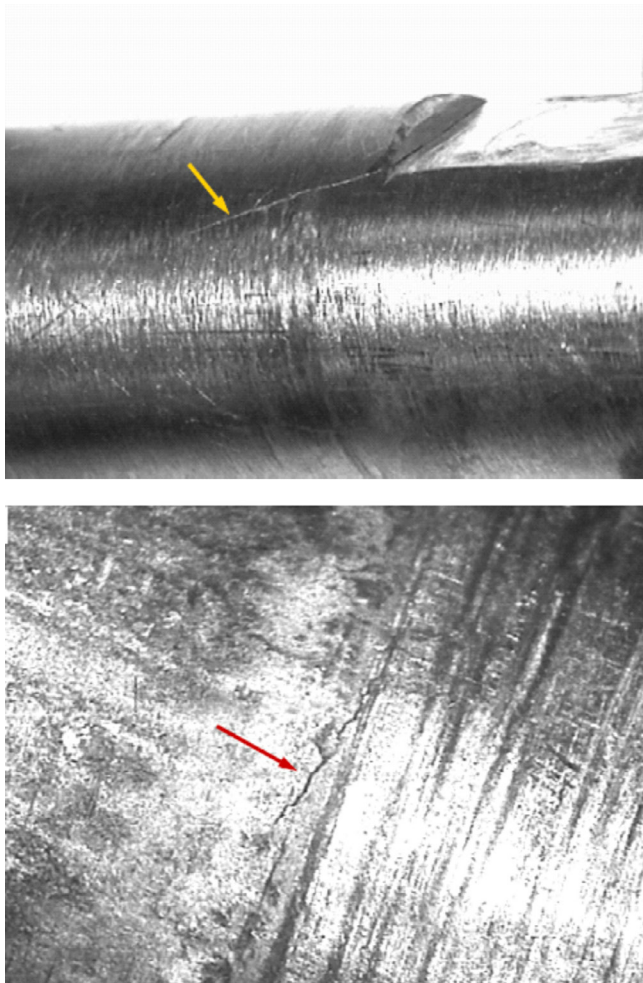
The delta pin also fractured as the result of fatigue originating on the external surface opposite an existing notch. The fracture surface did not exhibit any obvious signs of static failure, leading to the conclusion that the crack propagation mechanism was fatigue-induced.

On the opposite side, in a position corresponding to that of the crack propagation point, there was another crack, indicative of a second fatigue process analogous to that which caused the failure of the component.

A third crack was found propagating lengthwise along the surface at the base of the notch, apparently resulting from a slight bending moment experienced by the delta pin

Figure 6. Delta pin showing the crack and a third crack (top picture); and the crack symmetrical to that of the failure (bottom)

and therefore associated with a different loading mechanism from that which affected the other two.

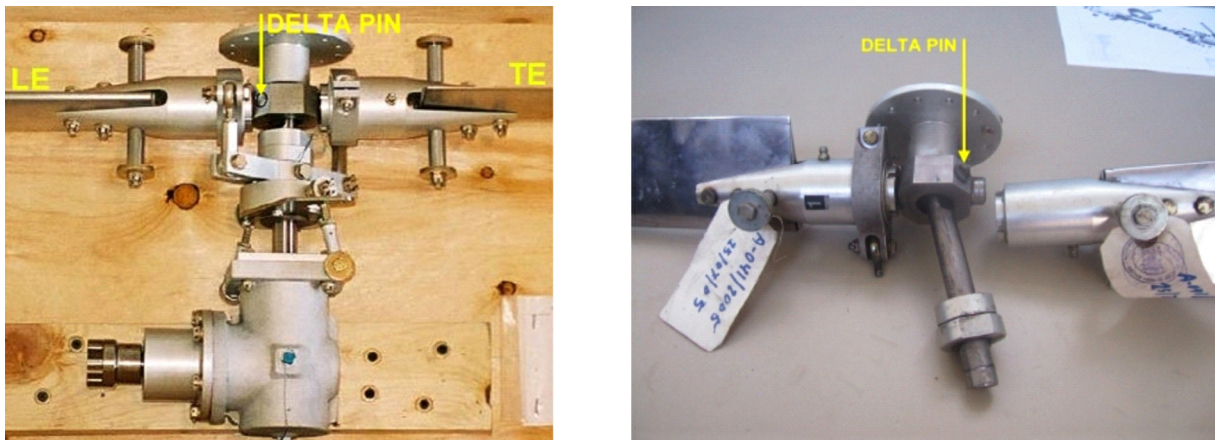
The spindle was installed on the helicopter such that the drill hole housing the delta pin was not facing the leading edge of the blades (see Figure 7), but faced the trailing edge instead, that is, it was 90° out of alignment with respect to the manufacturer's instructions as appear for the customers in the internet site.

Figure 7. Spindle assembly according to CHR's Compliance Procedure (left); asfound assemble of the tail rotor (right)

It is CHR's considered opinion that a faulty installation of the spindle will result in increased gyroscopic forces on the component when wide pedal movements are applied or when wind gusts impinge on the tail rotor.

The likelihood of improper assembly should be avoidable, and on that purpose the manufacturer has communicated their intention of engraving such spindle by indicating which side has to be placed in the outside area. Therefore it is considered that these measures adopted by the manufacturer are sufficient enough in order to avoid future wrong assemblies.
