DATA SUMMARY

| Registration | LV-ALN |
| Type and model | EUROCOPTER AS 350 B3 "Ecureuil" |
| Operator | Helicopters A.R., S. A. |

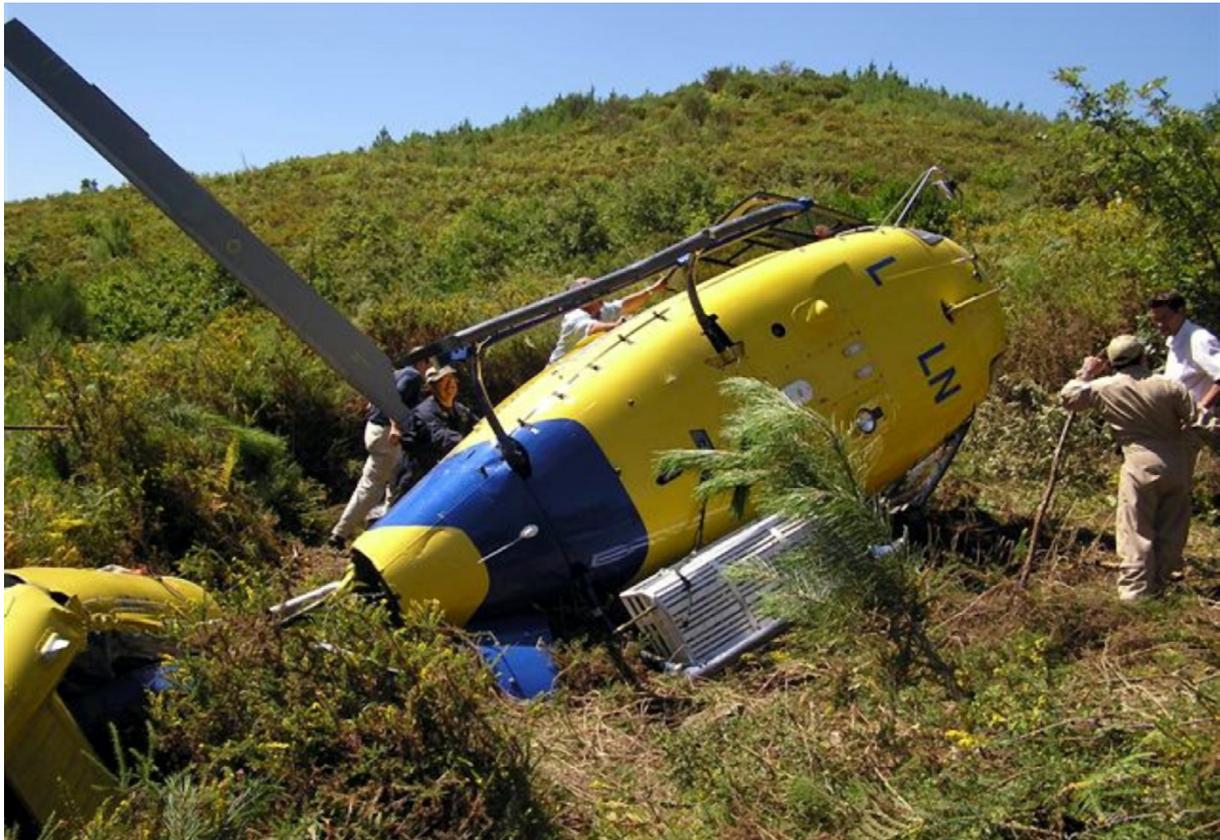
Photograph 1. Condition of the helicopter after the event

The tail and right skids contacted the ground first. One of the main rotor blades sheared off part of the tail cone and the helicopter turned over on its left side. There was no fire following the impact.

The aircraft suffered significant damage to its fuselage, landing gear and dynamic components, namely the main and tail rotors and transmissions.

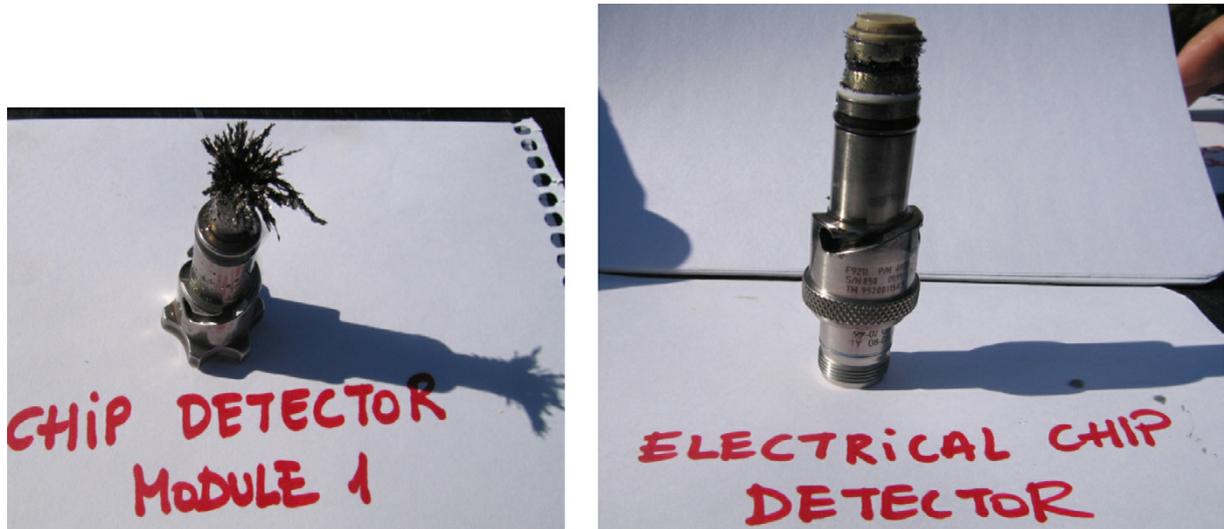
Photograph 2. Particles in the chip detectors

The inspection revealed a large quantity of particles obstructing the magnetic plug in Module 01 and only a few particles in the electrical magnetic plug.

The shaft of the compressor-gas turbine assembly was noted to rotate freely, but without transmitting the motion to the accessory box, thus indicative of a connection or continuity problem between the engine shaft and the accessory box.

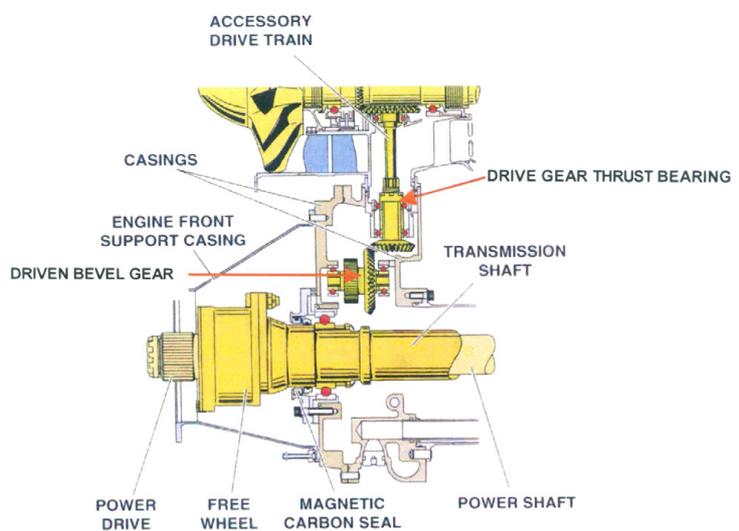
Upon opening the engine, it was discovered that the driven bevel gear in Module M01 (see Figure 3), which transmits power from the gas generator to the accessory box, was broken and that its counterpart, the 23-tooth accessory drive bevel gear thrust, was damaged. In addition, the drive gear upper thrust bearing was heavily damaged (see Figure 3). Material was flaking off the shaft, which exhibited excessive

Figure 3. Detail of module 01

axial clearance, much greater than expected. The decoupling between the gas generator and the accessory box interrupted the operation of the fuel pump, and thus to the in-flight stoppage of the engine.

The breakage of the ring gear on the 41-tooth driven bevel gear resulted from the fatigue that started and propagated radially from the edge and base of the gear, on the side with the smaller diameter. The main cause of this fracture was rooted in the degradation of the drive gear upper thrust bearing, which allowed for a gradual increase in axial motion, producing a shift of the contact area between the teeth of the gears which resulted in a secondary bending moment between them. This cyclic overload in the gears' contact area initiated cracks in the base of the teeth. The cracks propagated toward the edges until the gear failed completely.

It is recommended to the engine manufacturer, Turbomeca, to review the need to modify the design, manufacture or assembly instructions of the drive gear thrust bearing assembly to the accessory box of the Arriel 2B engine.

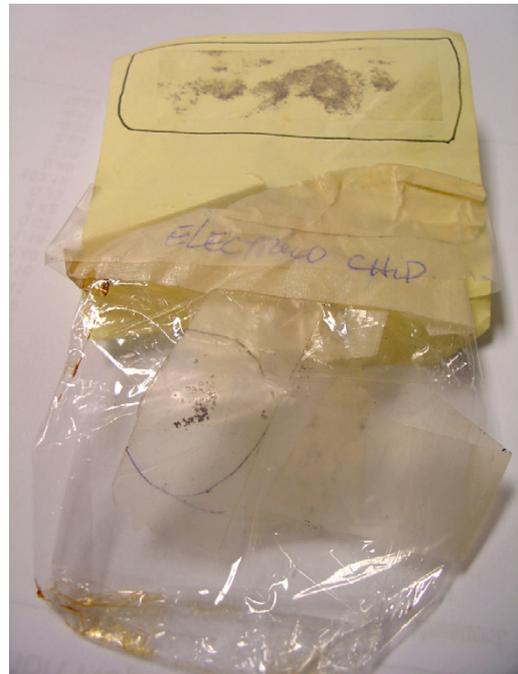
As stated in Section 1.4.2, subsequent to the accident, the manufacturer's laboratory analyzed and identified the particles collected from the magnetic plug of Module M01 at the 741.9, 753.5 and 759.5 flight hours. All the particles were metallic, magnetic and shiny and matched the material used to manufacture the bearings. No metallic particles from the gears were found. This indicates that all the particles found in the oil in the days leading up to the accident were generated by the degradation of the aforementioned bearing, there being no signs of wear or damage to any gear.

The condition of the particles collected by the magnetic plug of Module 01 following the in-flight warnings appeared before the accident on 7 and 15 August would have required the interruption of helicopter operations in accordance with the requirements of the Flight and Maintenance Manuals. The bright magnetic metallic particles could have been identified without the need for a detailed laboratory analysis.

Photograph 3. Metallic chips collected the 07-08-2005
