Date and time	Thursday, 6 October 2005; 13:30 local time
Site	Collado La Segueta-Rioseta in Canfranc (Huesca)

Registration	EC-ILD
Type and model	EUROCOPTER AS 350 B2
Operator	Heliswiss Ibérica, S. A.

REPORT

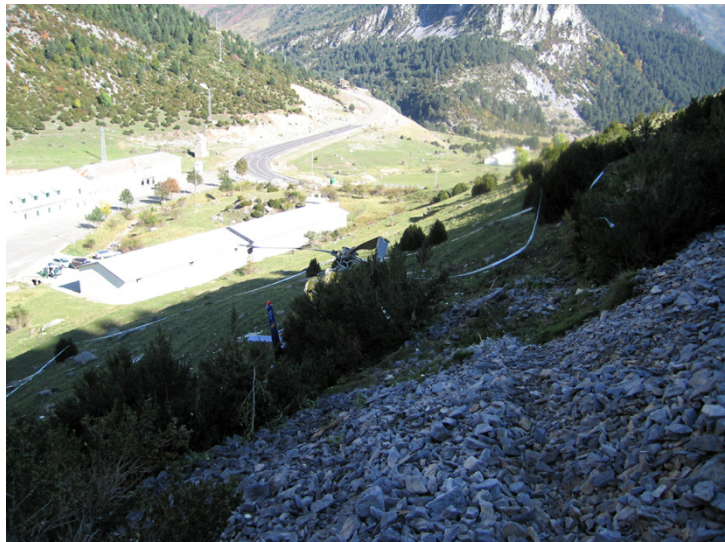
Photograph 1. Area where the aircraft impacted

The helicopter had impacted on its right side against the slope of the Barranco del Rio Seta, which faces Northward and features a gradient of approximately 45°. The aircraft's longitudinal axis came to rest oriented towards the Northeast.

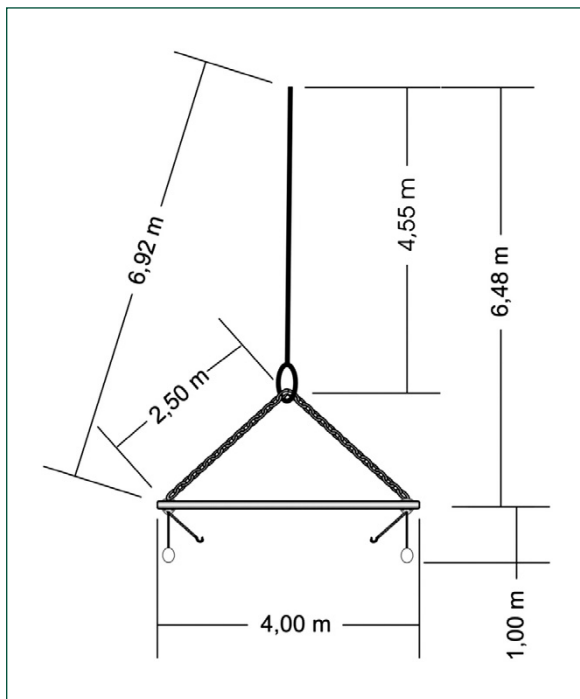
Figure 1. Diagram of the External Cargo Transport Device

The device used to transport the cargo featured the design indicated in figure 1. A 4,55 m sling was attached to the barycentric hook. On the other end of this sling were attached two 2,5 m chains, which in turn held a 4 m metal bar. From both ends of this bar hung two other chains measuring approximately 1 m, to which the cargo was attached.

The entire apparatus measured about 7 m in length.

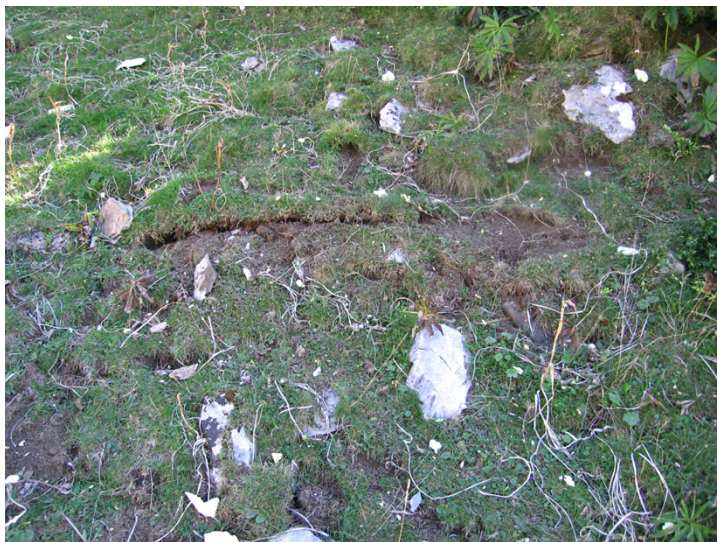
The blades of the main rotor had broken from the impact against the slope, with the marks resulting from the contact clearly visible.

Photograph 2. Mark made by a main rotor blade in the ground

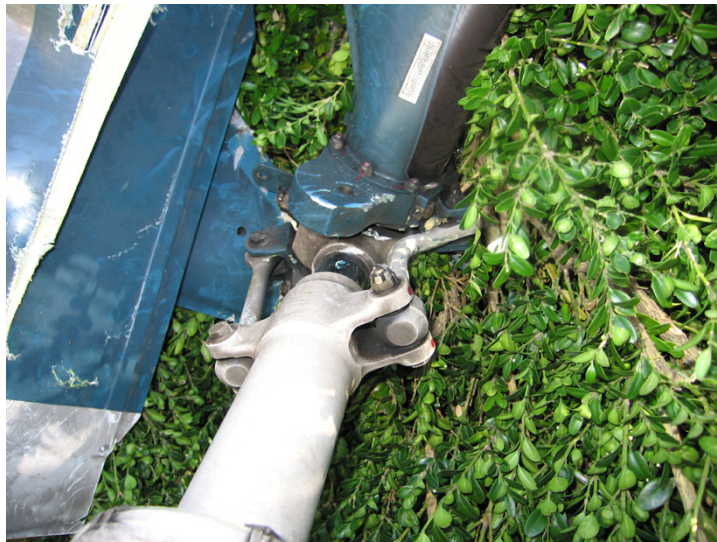
The aircraft's tail had fallen upon a bush. Both tail rotor blades were broken, although one of them was damaged much more severely than the other. Thus, while one revealed damage only to its outer part, the other was totally destroyed from the blade root. A detached piece from this blade was found, fragmented in two, between the branches of a bush located two meters behind the rear of the aircraft. A mark

The rest of the anti-torque rotor remained in place and it was verified that it spun as normal. The pitch change links were deformed and showed clear evidence of having been hit by a metal object. Nevertheless, despite this damage, the pitch change links were found to function; when the corresponding command bar was activated, the pitch change did respond properly.

Photograph 3. Tail rotor

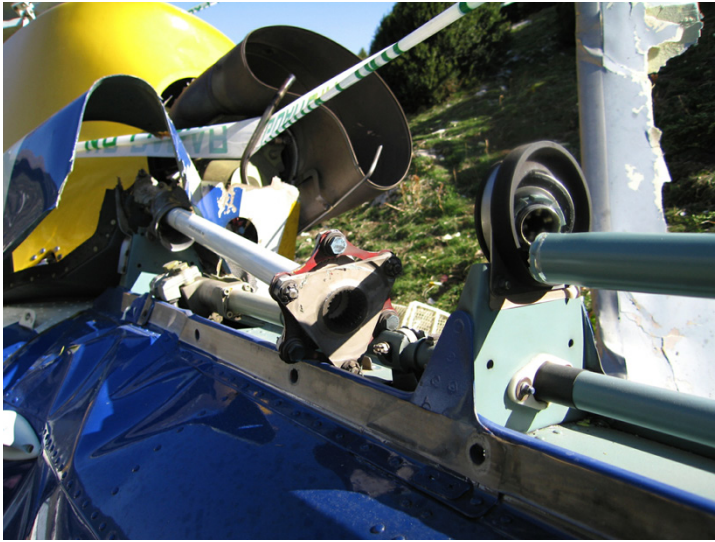
The tail rotor transmission fairing was dismantled and it was observed that the power axis had broken at one point very close to the joint with the short shaft.

During the inspection of the aircraft wreckage it was noted that the anti-torque rotor assembly (power transmission, control and rotor) revealed two different and localized areas of damage: one on the power transmission shaft and the other on the blades, which broke into several fragments, which were found very close to the aircraft's tail at the impact site.

Photograph 4. Area where the rear anti-torque power transmission shaft was broken

In light of the aforesaid, it is possible to conclude that the damage to the tail rotor's power transmission shaft must have taken place in the instant when the trapeze holding the external cargo struck the anti-torque rotor. For that reason, the pilot would not receive any response when he worked the pedals given that, though the pitch change was produced, its aerodynamic effect would be nullified given that at the time the rotor was not spinning.

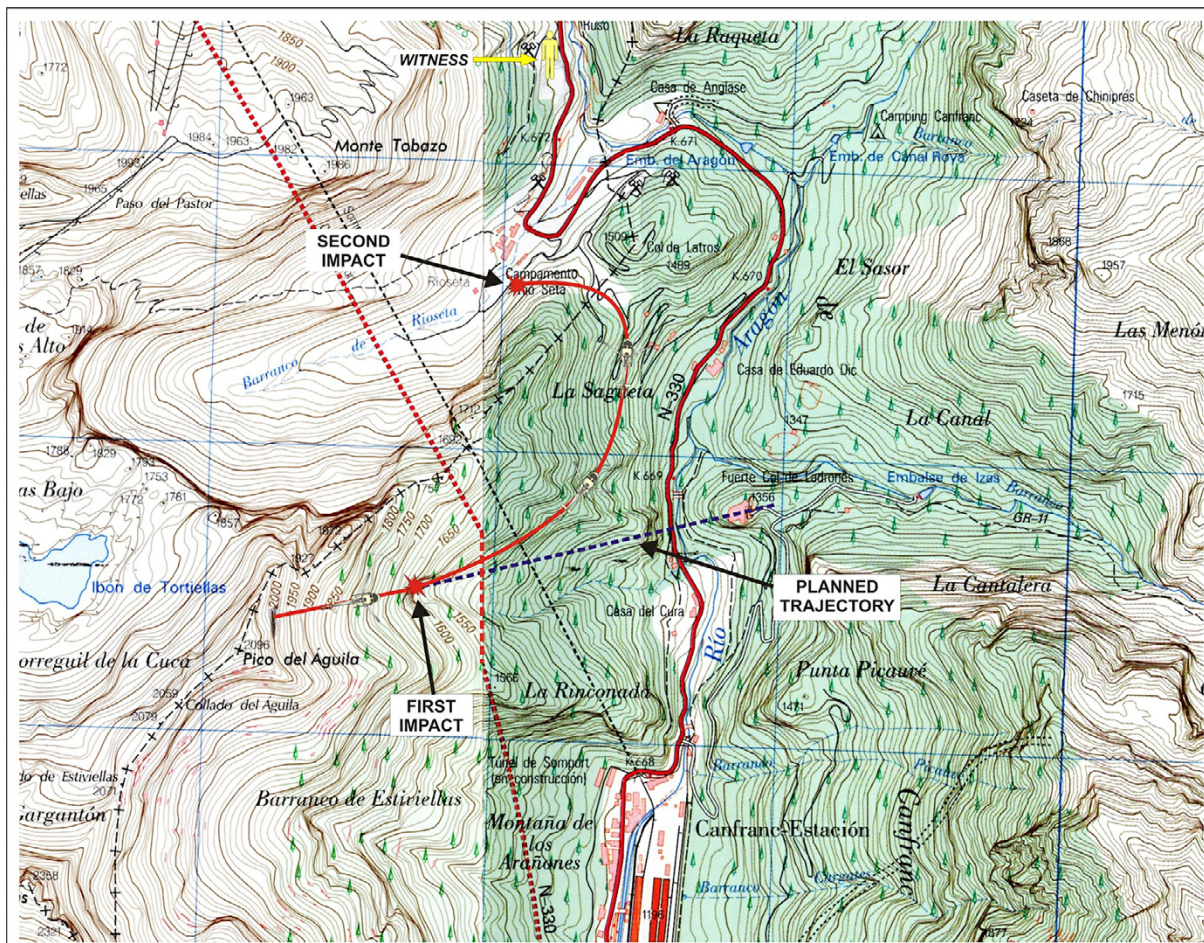
Figure 2. Actual and Planned Trajectories of the Aircraft
