**DATA SUMMARY**

Date and time	<b>Sunday, 16 October 2005; 13:15 h UTC<sup>1</sup></b>
Site	<b>Flight level 280 approximately 40 NM away from VOR Zaragoza</b>

Registration	<b>HA-LOM</b>	<b>EC-HAF</b>
Type and model	<b>BOEING 737-800</b>	<b>AIRBUS 320-214</b>
Operator	<b>Malév Hungarian Airlines</b>	<b>Iberia</b>

**REPORT**

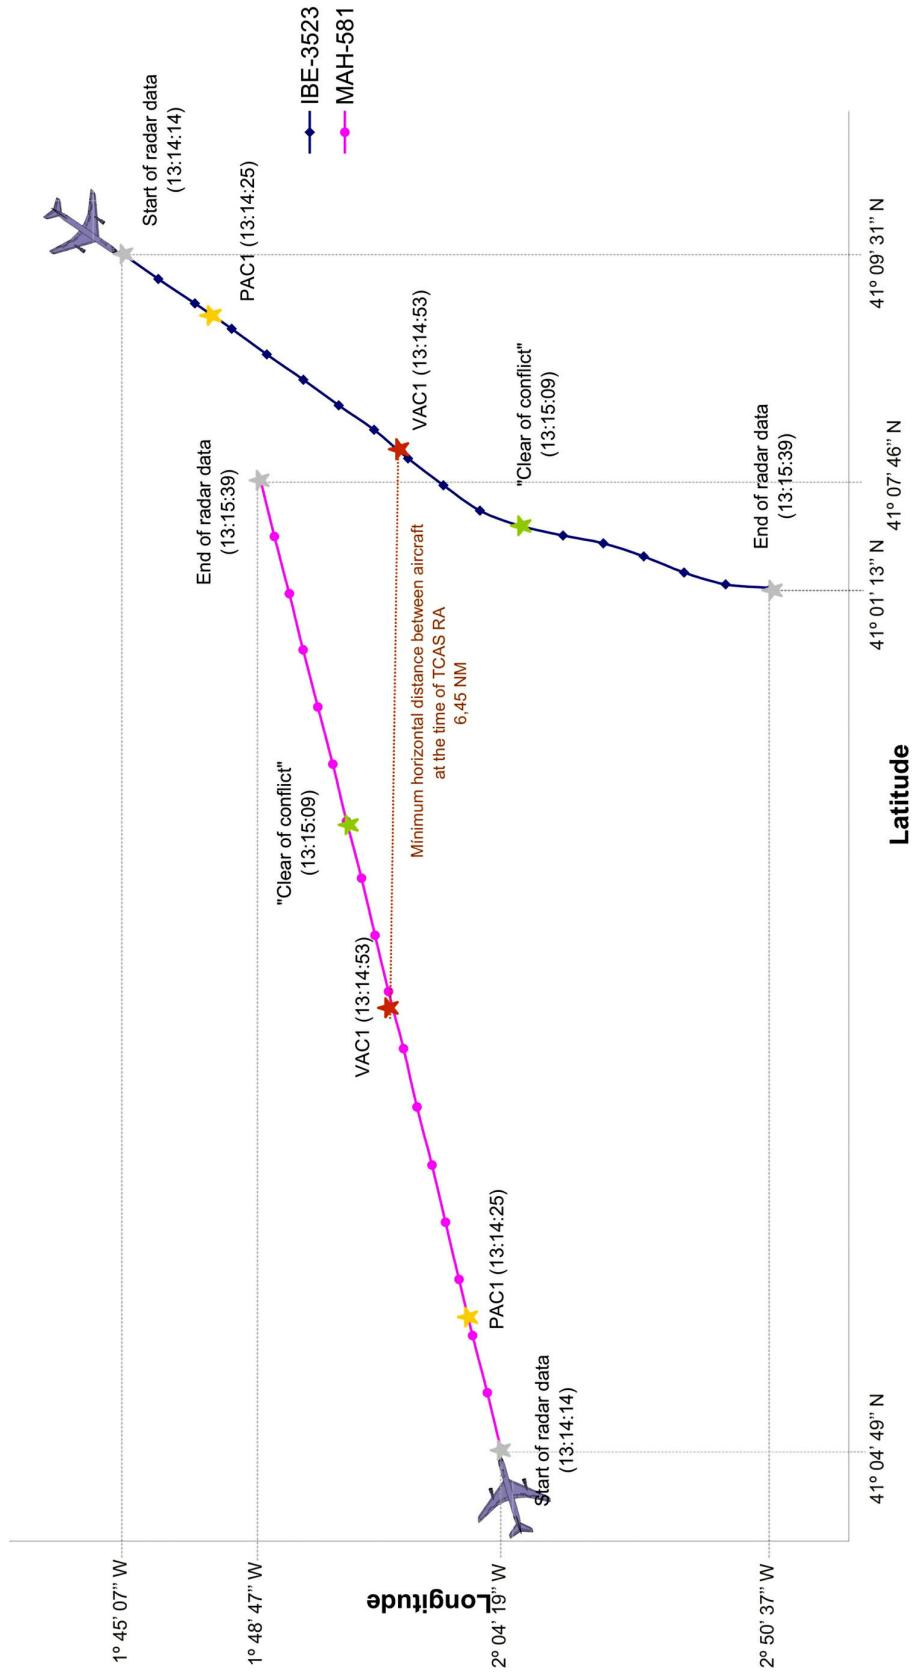
Figure 2. Flight path of the two aircraft

According to radar information, the first conflict prediction alert (CPA) appeared on the radar screen at 13:14:25. This information is consistent with the time at which the controller started giving instructions to achieve separation between both aircraft. According to this information on the conflict alerts, the first conflict violation alert (CVA) was received at 13:14:53 as the separation between the aircraft reached a minimum: 400 ft vertically and 6 NM horizontally (see Figures 2 and 3). MAH 581 had relayed the receipt of a TCAS RA a few seconds earlier.
