Report A-063/2005

Accident involving
a Cessna 172N,
registration EC-EME,
on October 24, 2005,
in San Quirze del Vallés
(Barcelona)

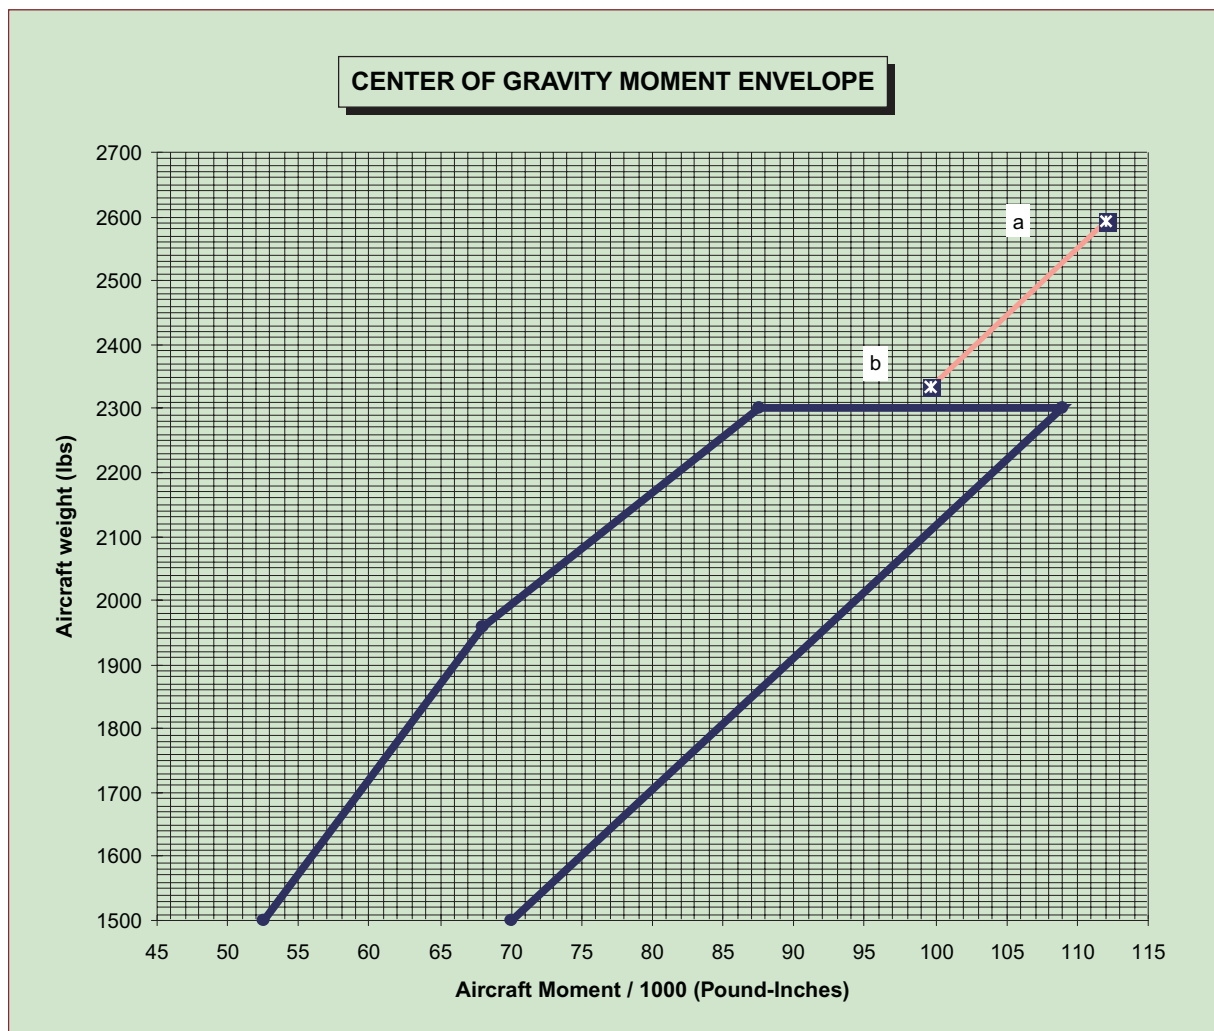
Figure 1.1. Center of gravity parameters

According to the above information, the aircraft’s total weight at the time of the accident was 2,592 lb, which would have put it 339 lb over the limit. These data are only approximate, however, and the takeoff weight cannot be known with certainty.

Had the aircraft’s excess weight been as estimated, its moment would have been outside established limits. Figure 1.1 shows the location of the aircraft’s center of gravity without fuel (Point b) and with fuel (Point a).

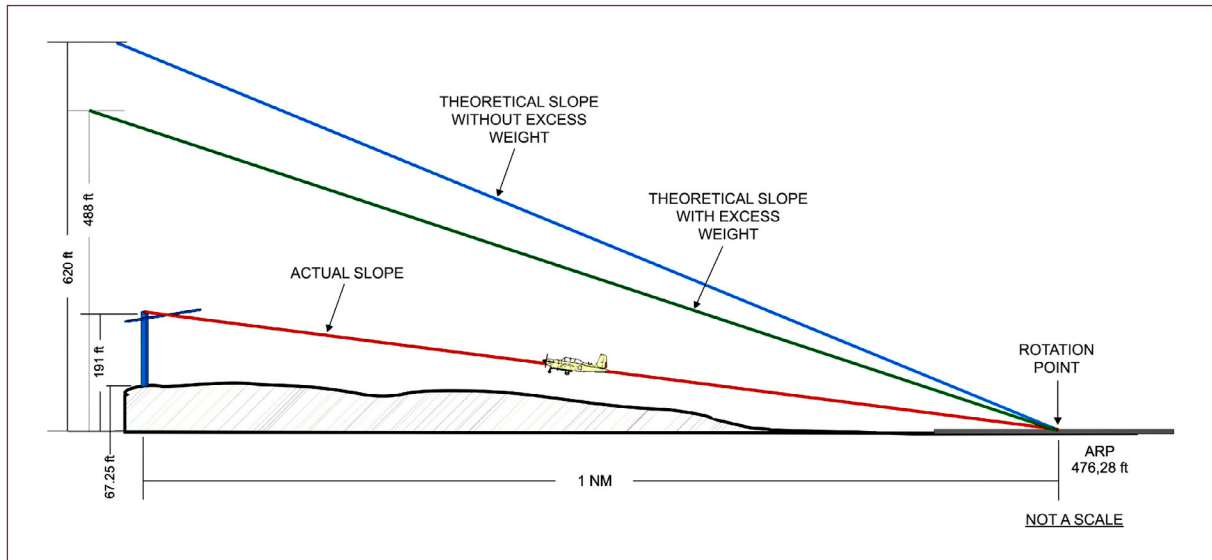
Figure 1.2. Theoretical and actual aircraft slopes

According to design specifications, for a takeoff weight of 2,253 lb (its maximum take-off weight) and a temperature of 21 °C, the aircraft should have climbed 620 ft in one mile at a speed of 73 kt.

For an excess weight condition like the one estimated for the aircraft, the ascent path would have been reduced by 160 ft per minute, according to data provided by the manufacturer. Thus, the aircraft should have climbed to 488 ft above ground.

The crane arm against which the aircraft collided was at an elevation of 667 ft and the point where the aircraft made its rotation was at an elevation of 476 ft. The aircraft therefore climbed 191 ft.

Figure 1.2 shows the theoretical slope without excess weight, the theoretical slope with excess weight and the slope actually taken by the aircraft.

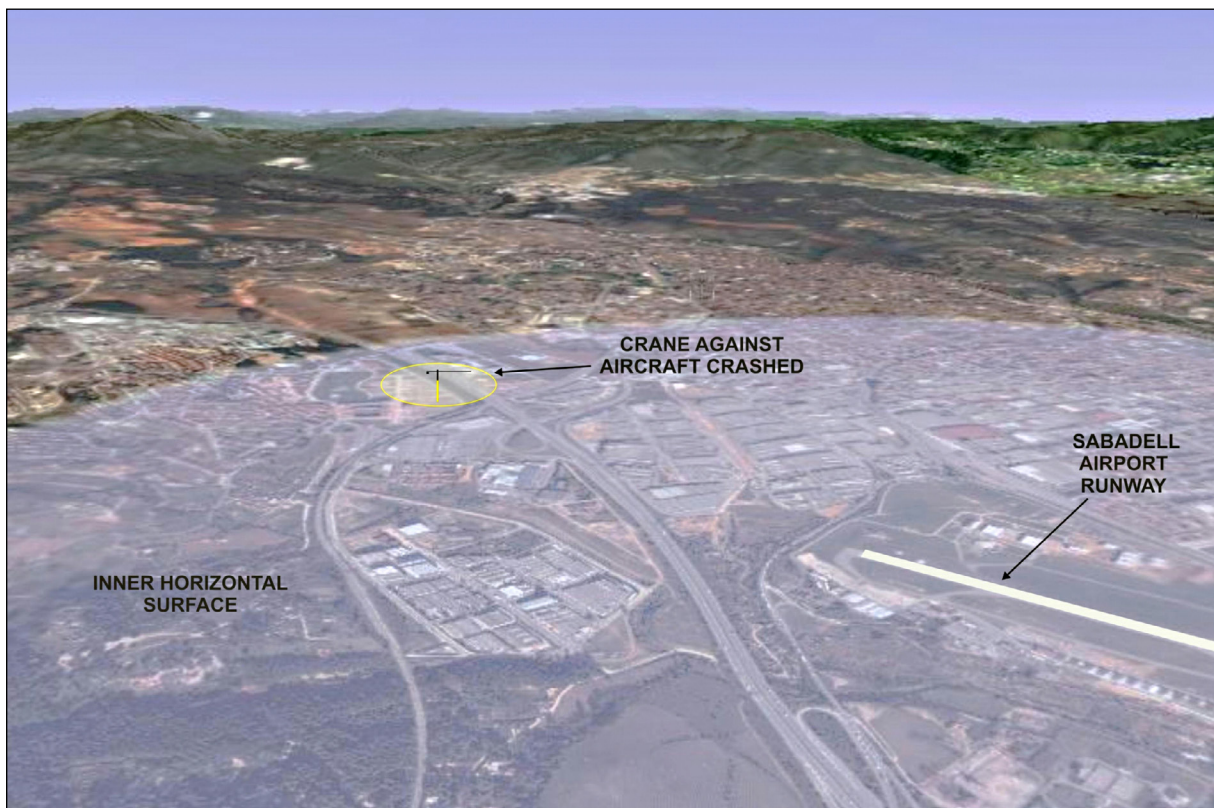
Figure 1.3. Inner horizontal surface

One of these areas defined as an aerial right-of-way is the airport's inner horizontal surface area. It consists of a circle that, in the case of Sabadell Airport, has its center at a height of 45 m (147.6 ft) above the airport's reference point and a radius of 2,500 m (1.35 NM).

The part of the crane the aircraft crashed against, the lever arm, encroached on the inner horizontal surface area by 17.4 m (57 ft).

Place measures in effect so as to guarantee the safety of operations by eliminating, reducing or informing users of the risks found as a result of the evaluation of areas affected by airport rights-of-way.

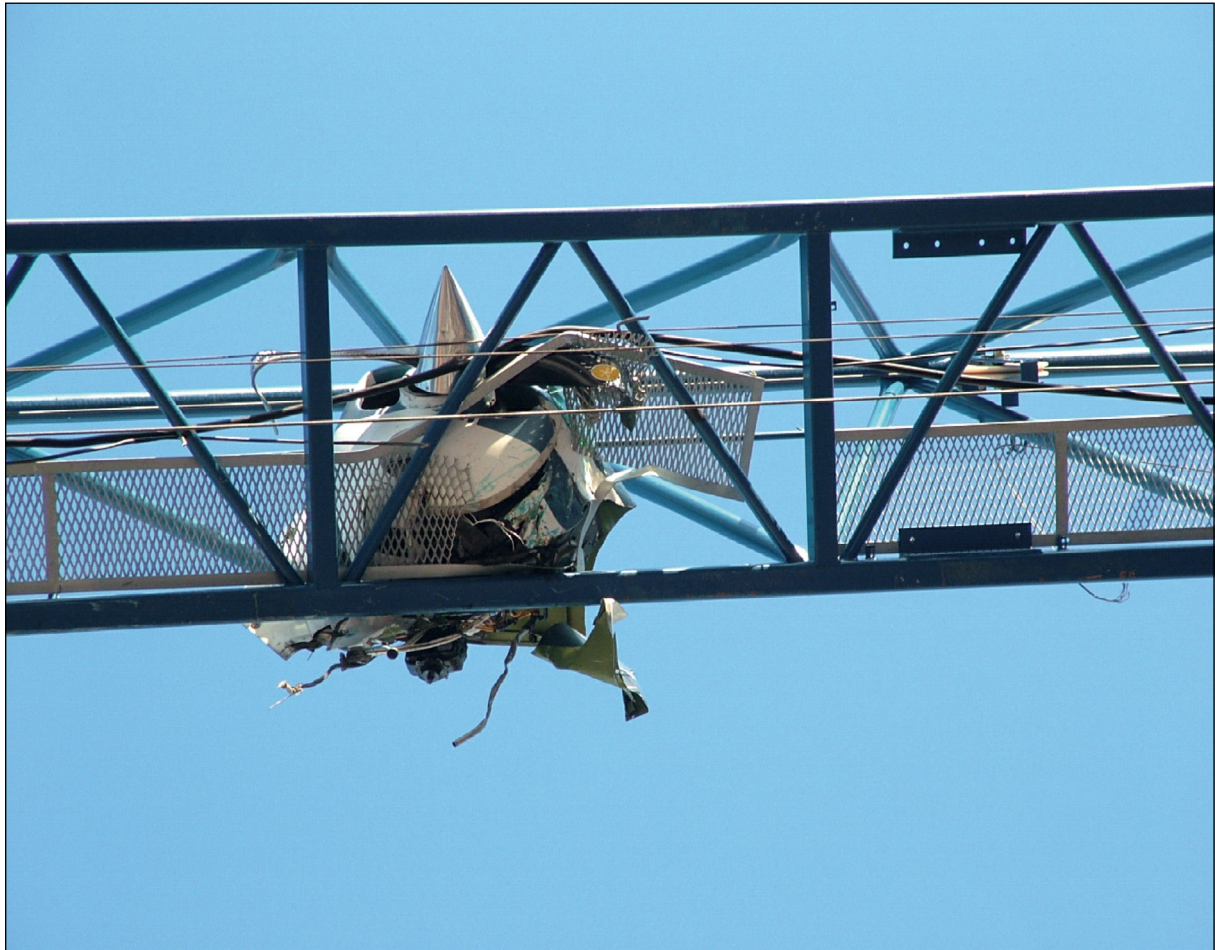
The impact stopped the aircraft completely. When the propeller blades struck the crane it brought the engine to an abrupt halt, causing it to wrap itself around the crane, in particular around the steel grating platform. This resulted in the aircraft detaching from the powerplant with a counter-clockwise motion.

Figure 1.4. Photo of the powerplant stuck in the crane structure

The engine damages matched those found on the crane where it had lodged itself, the most noticeable being those on the underside, where the exhaust is located. One of the two propeller blades was twisted around the metallic mesh that was used as a walkway atop the crane arm.
