DATA SUMMARY

Registration	EC-HCT
Type and model	BELL 206 L4T
Operator	Helisureste, S. A.

1. FACTUAL INFORMATION

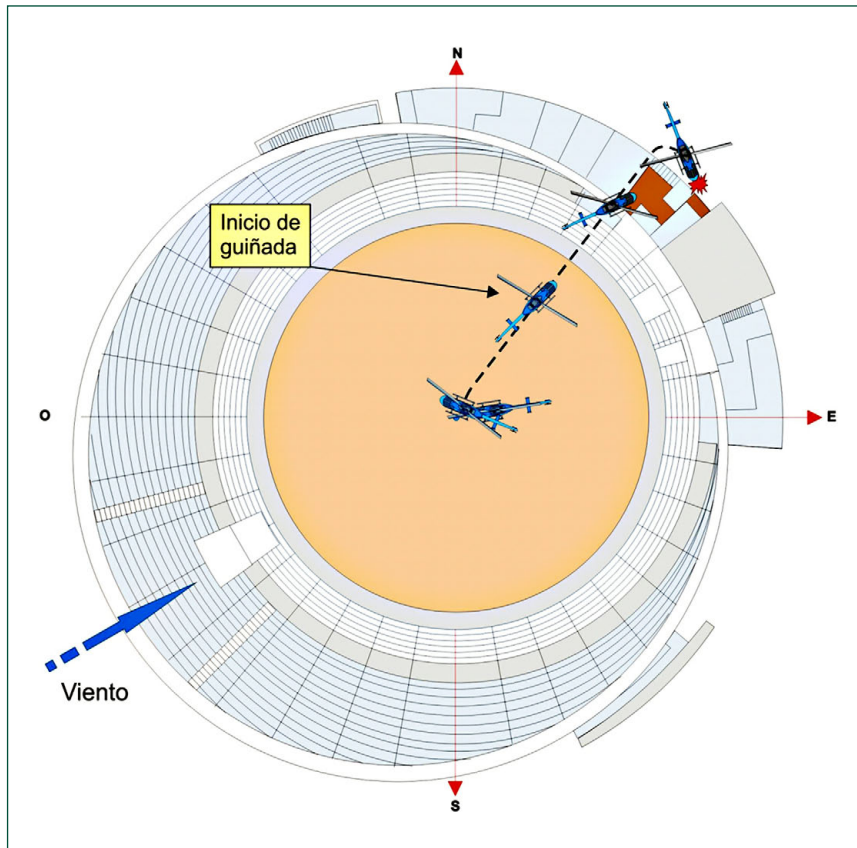
Figure 2. Trajectory of the second take-off (inicio de guiñada = initiation of yaw)

At the start of the helicopter's forward movement, and when it was still located above the earth area inside the ring, it began a slight leftward tail yaw (with the nose moving rightward), then increasing its turn rate while moving forward a few meters, and during its drop.

Outside the ring, the helicopter came to rest turned over on its left side. The engines continued to function until they were shut down at least 25 seconds after the crash.

These conditions which the helicopter faced during this phase of the flight and the subsequent increase it suffered in rightward turn speed coincide with the factors that can produce a loss of tail rotor effectiveness. As a result, it is believed that the aircraft was affected by this phenomenon.

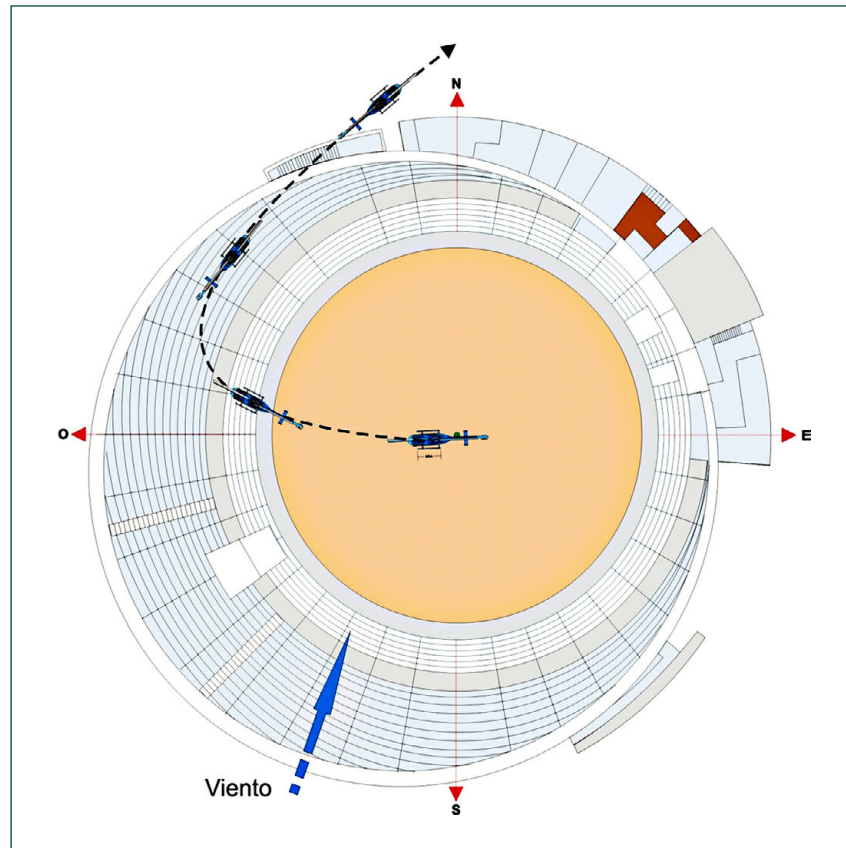
Figure 3. Trajectory of the first take-off (for the practice flight)

In order to review the flight itinerary and conduct a practice run, he landed at the bullring on a westerly heading and three persons were embarked. Thus, a total of five persons were then on board. He carried out a power test and took off towards the west. When the helicopter was located above the stands, it turned towards the right and departed the ring, passing over a lower area of the facility.

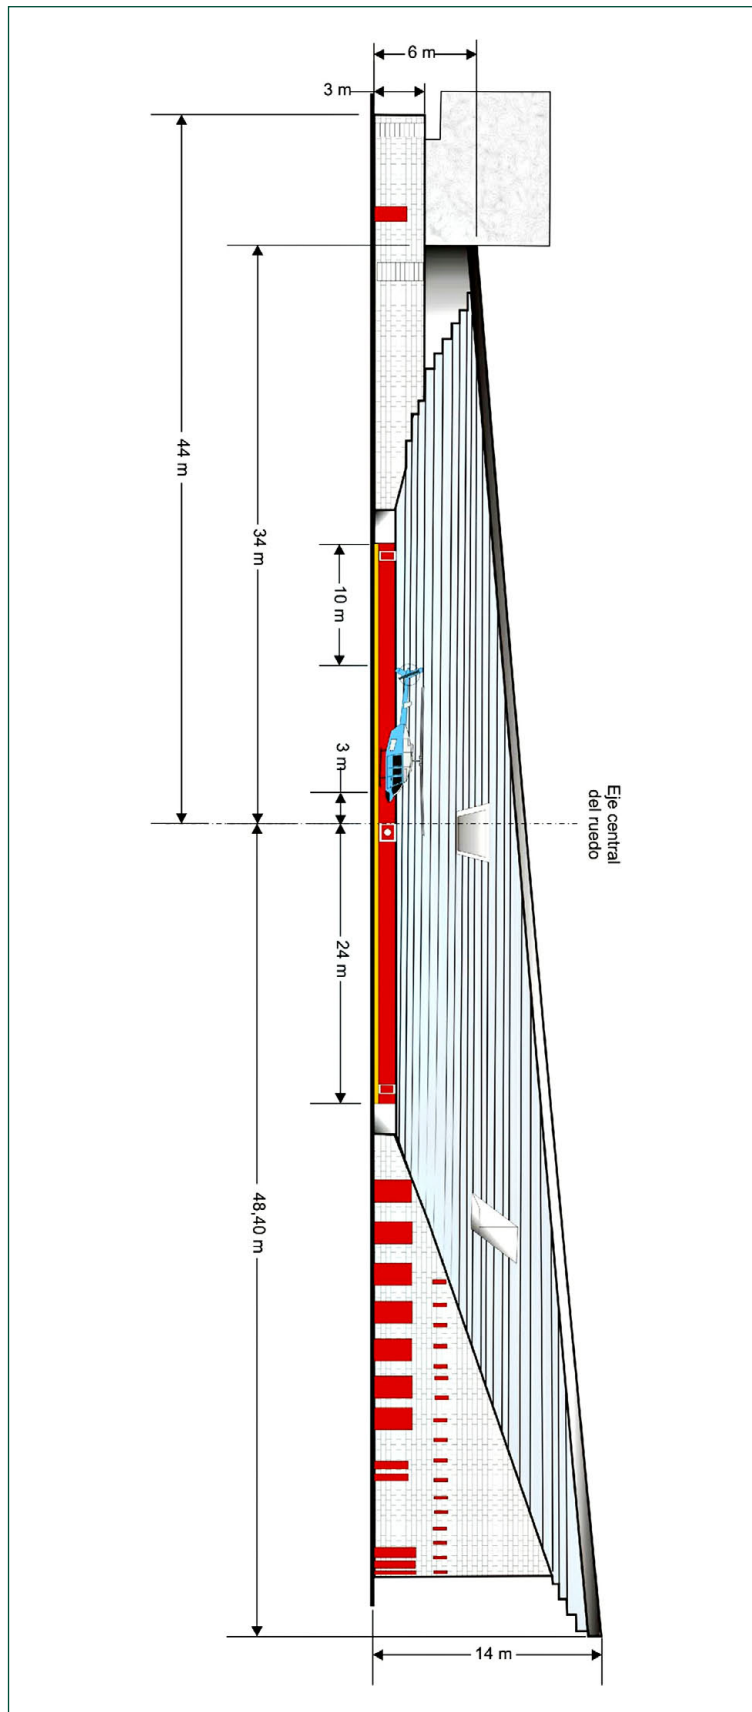
APPENDIX 1
Side view of the Móstoles
bull ring

The interior, ground level area of the ring consists of a compact earth surface in a circular shape with a radius of 24m, enclosed by a wooden barrier measuring 1.6 meters high (see Appendix 1).

Around said barrier and at a radial distance of 1.6m are the stands, which reach their highest point on the western side, there measuring 14m high and standing 48 m from the center of the ring. The lowest part of the stands is located on the eastern side, where they reach a maximum height of 6m and stand 34 m from the center.
