DATA SUMMARY

Date and time	Monday, 9 January 2006; 09:00 h UTC
Site	Barcelona-El Prat Airport

Registration	EC-GAT
Type and model	MD-83
Operator	Spanair

Operation	Commercial air transport – Scheduled – Domestic – Passenger
Phase of flight	Landing

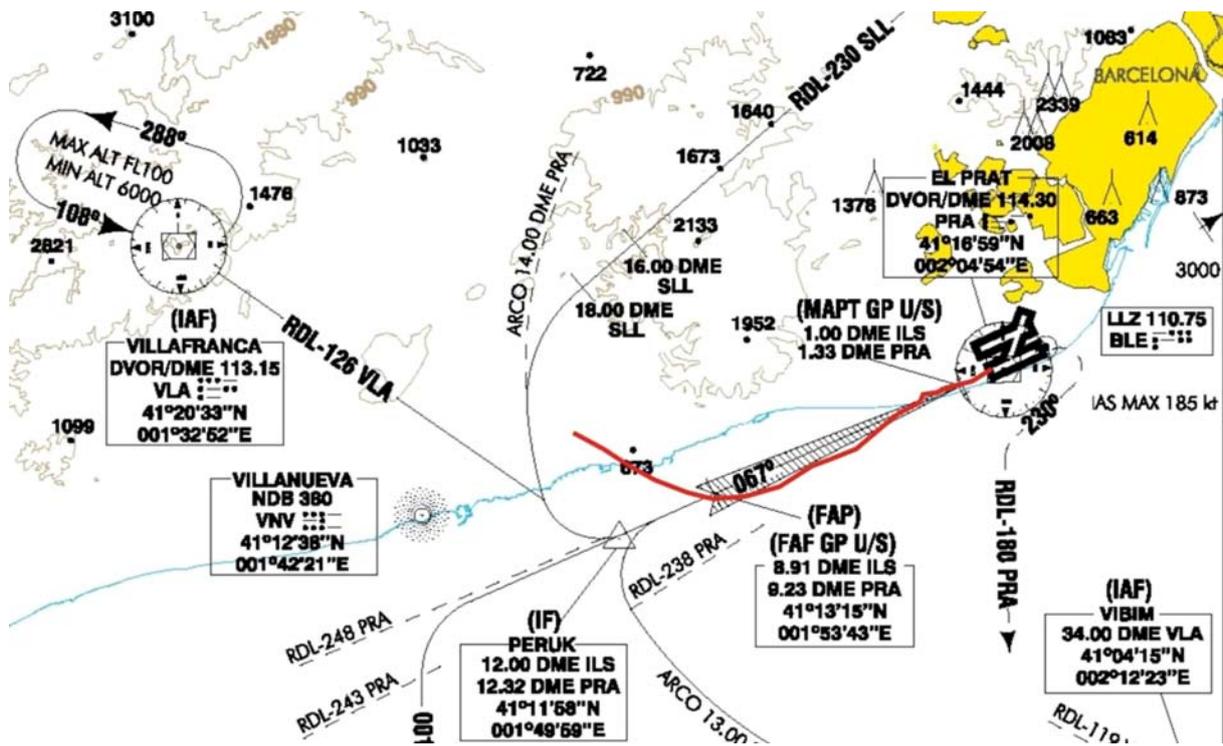
Figure 1. Radar track followed by the aircraft

The flight had been uneventful until shortly before the start of the initial approach on a heading of 150° with the airplane at a relatively high altitude. ATC reminded the crew of the restriction not to descend below 5,000 ft before crossing the coastline. This restriction, imposed due to environmental concerns, had gone into effect a few months earlier.

The aircraft was cutting short the turn to intercept the ILS localizer at the final approach fix (FAF), located at a distance of 8.91 NM. It was flying at an altitude of 3,700 ft and an indicated airspeed of 260 kt.

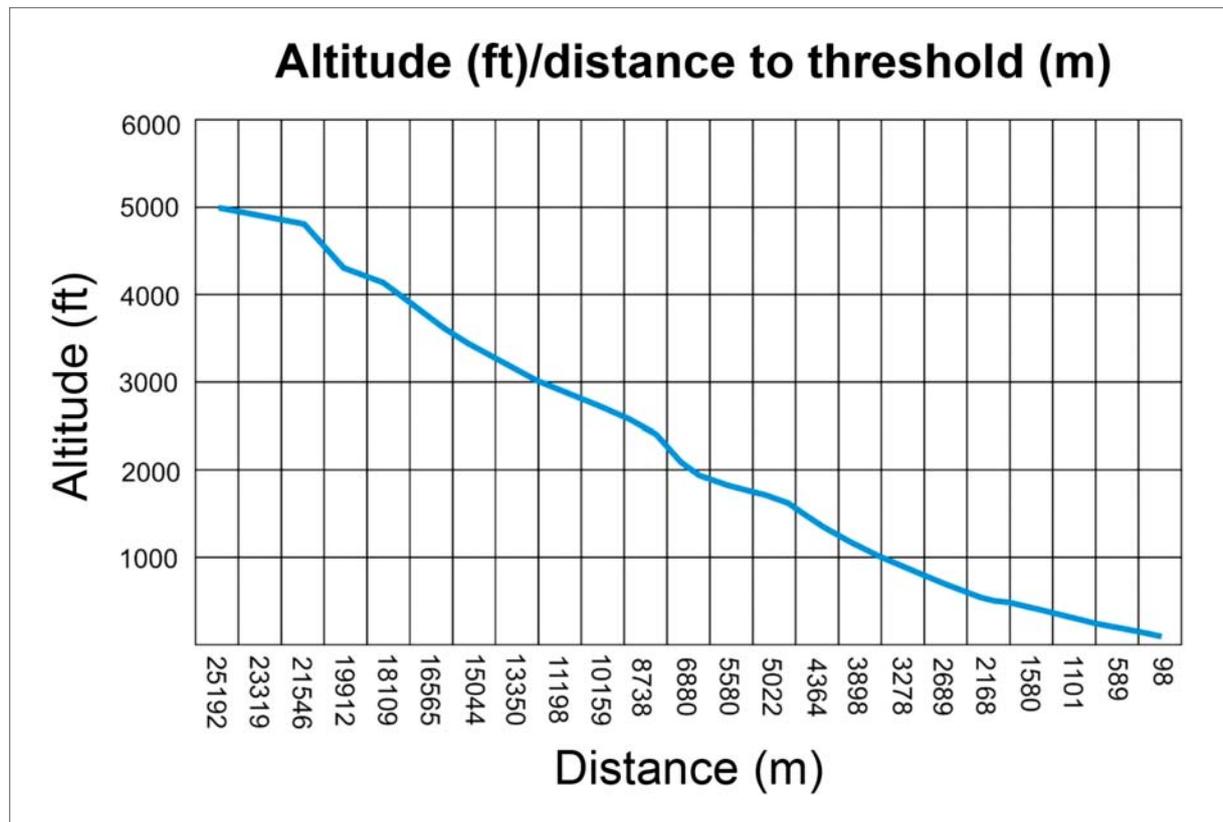
Figure 2. Graph of altitude-distance to threshold on approach

Since the aircraft was above the glideslope, the final descent was very steep, on the order of 2,500 ft/min. On short final, the aircraft established on the ILS glideslope (GS) but at a high airspeed and while changing to a flaps 40° landing configuration, meaning the approach was not stabilized.

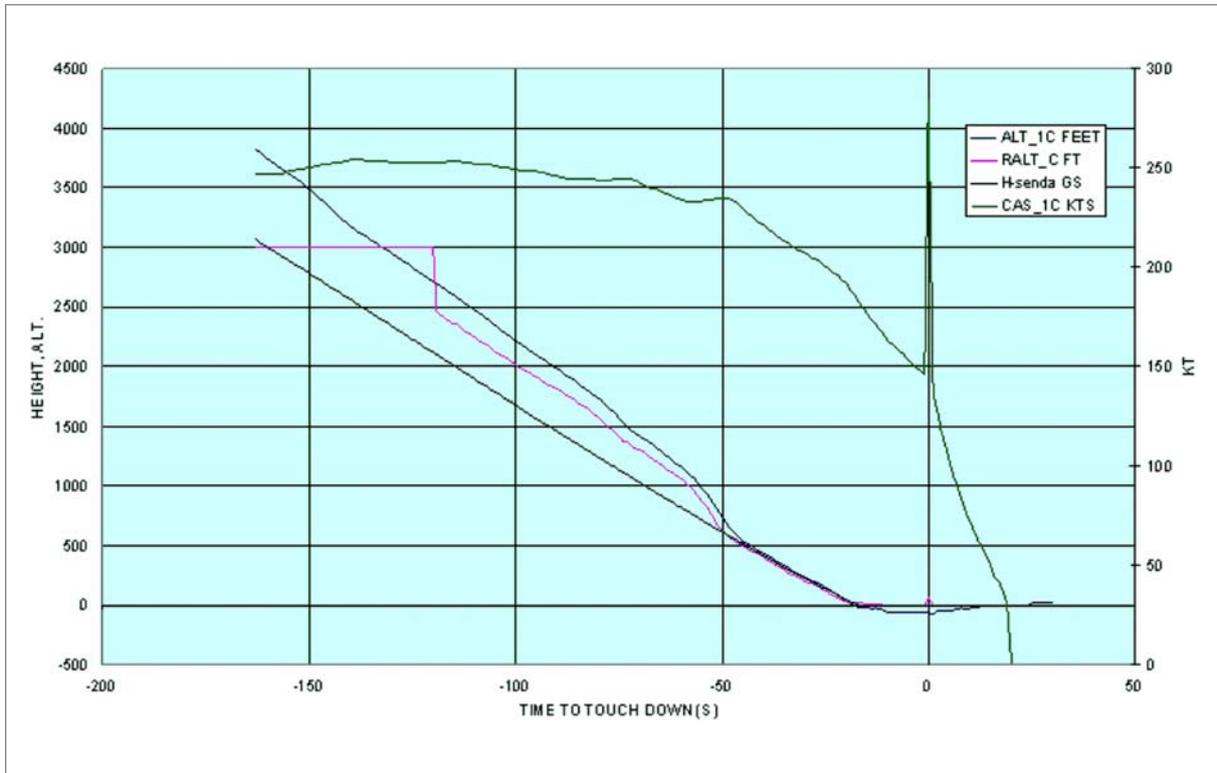
Figure 3. Speed and altitude during approach

The engine thrust was set to idle during the entire approach. There was no thrust demanded until the braking maneuver on the landing run, during which the reversers were deployed. The deviation of up to three dots with respect to the glideslope indicates that the airplane was flying well above the slope.

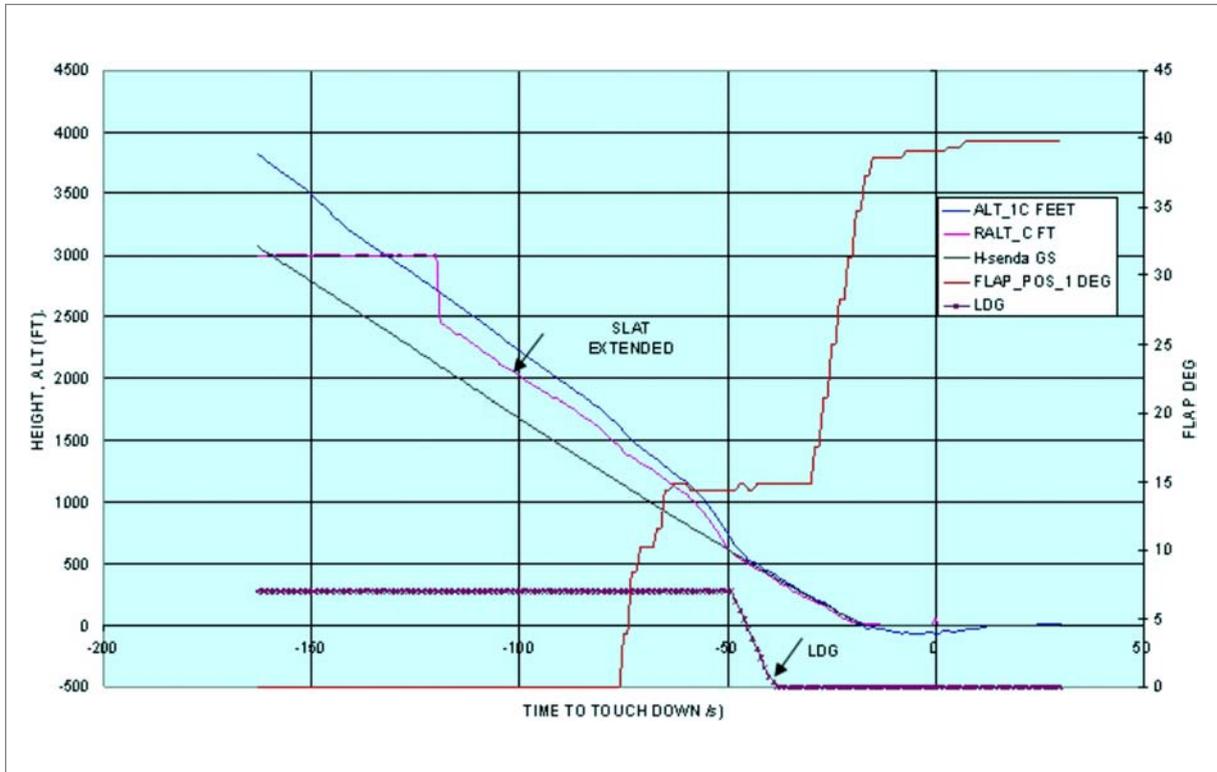
Figure 4. Configuration during landing

The aircraft adopted a landing configuration a few seconds before touchdown and while flying over the runway.

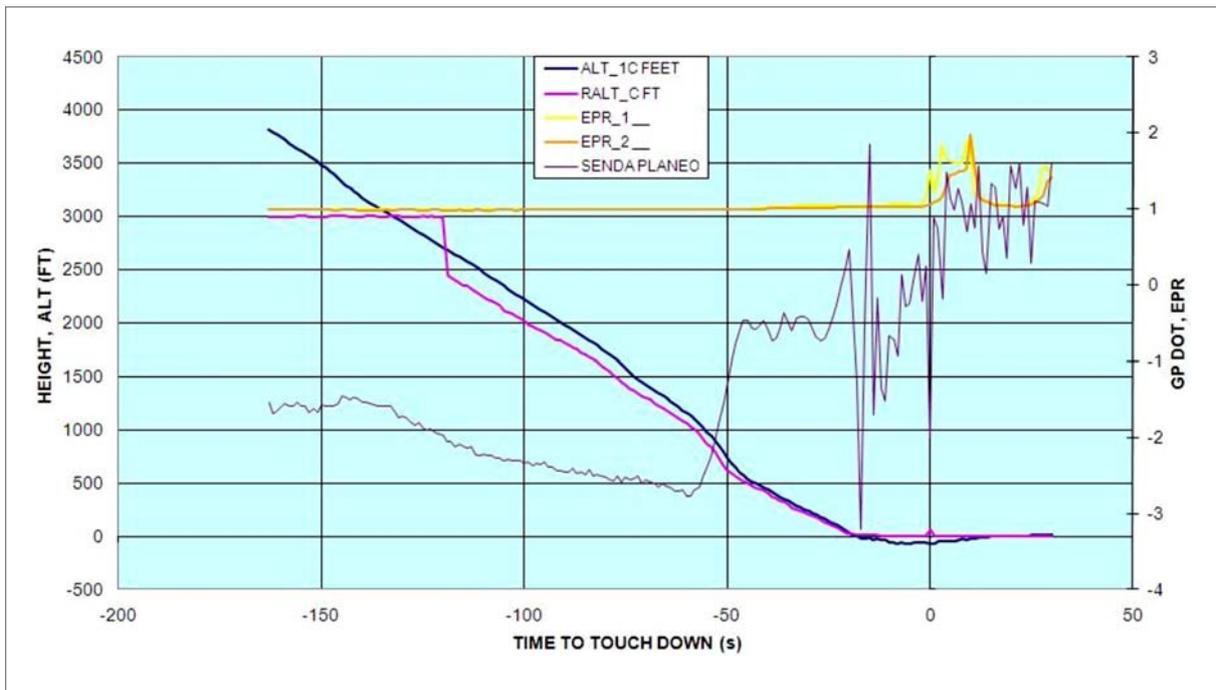
Figure 5. Deviations from glideslope and EPR

The aircraft's descent rate for the segment between the FAF and its reaching 500 ft AGL was high, with an average of 1,648 ft/min, a minimum value of 1,345 ft/min and a maximum of 2,900 ft/min. The final part of the approach saw the descent rate drop to an average of 385 ft/min, with a minimum of 11 ft/min and a maximum of 2,396 ft/min.

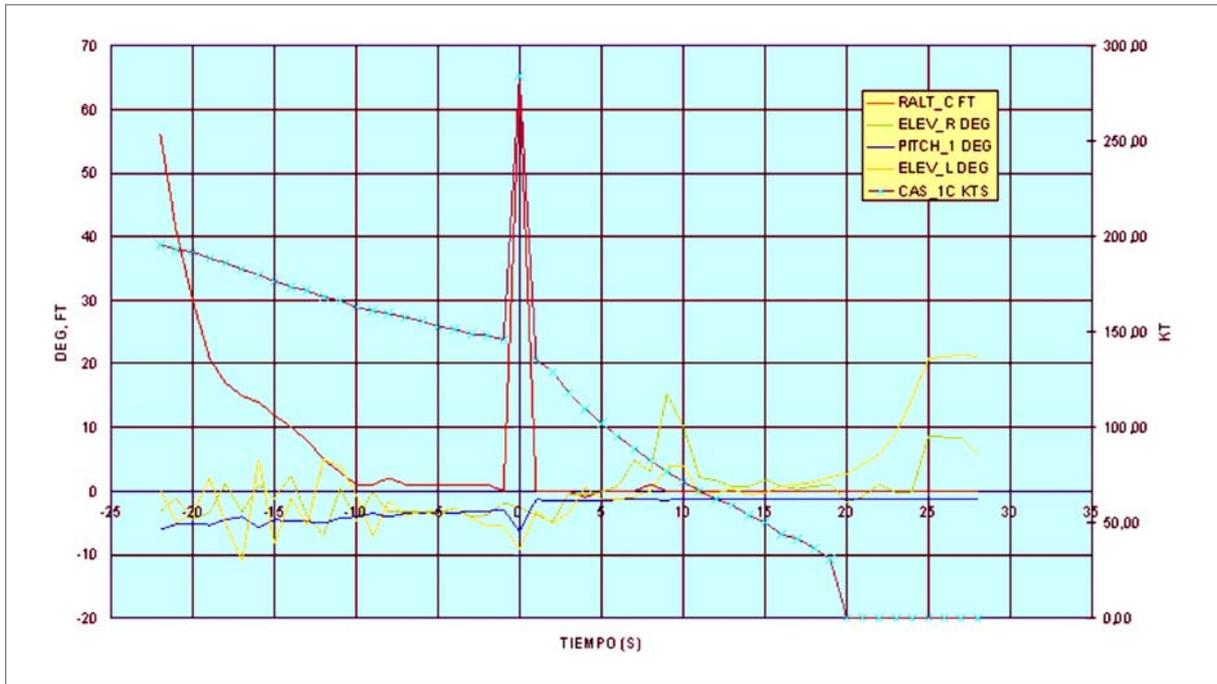
Figure 6. Trend for various parameters during touchdown

Said altitude was practically zero during the 10 seconds prior to the contact made by the main gear at $t = 0$ s. This implies that the nose wheel contacted the runway some 790 m before the main gear legs did.

The recording of the discrete datapoint for the compression of the nose wheel shows a value corresponding to an AIR position throughout the recording until the end of the landing run. This was due to a problem that affected this parameter's recording only, but not the parameter itself.

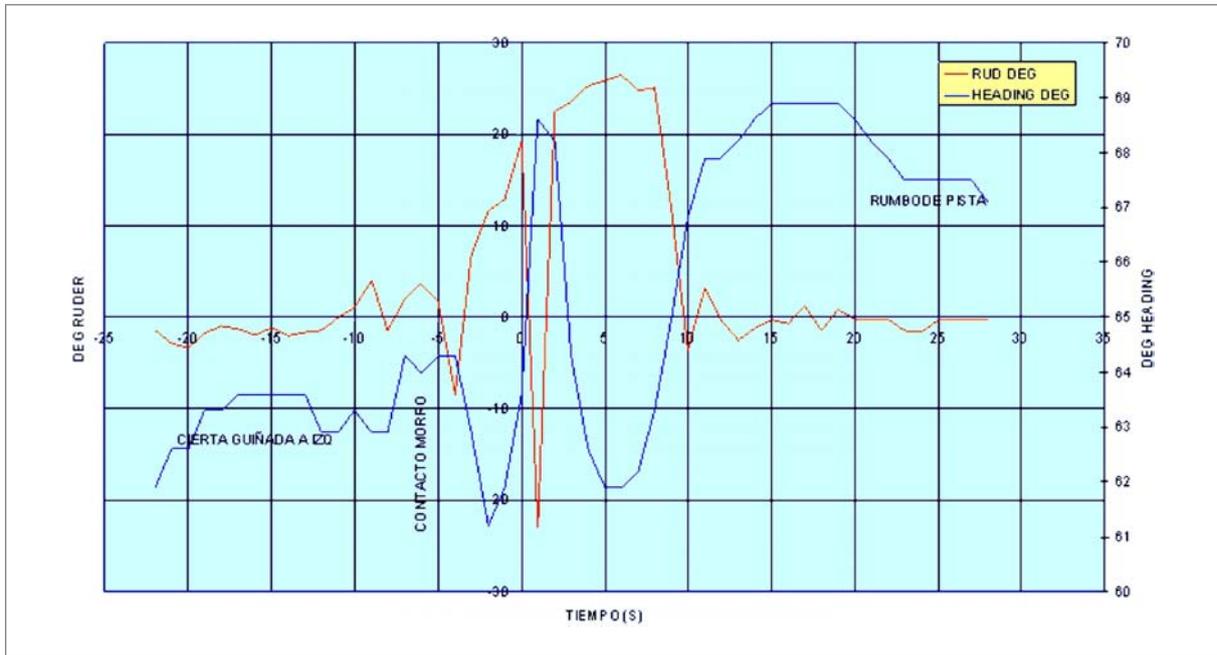
Figure 8. Trend of rudder and course parameters

The DFDR recording shows that the airplane was flying on short final with a slight left yaw. Four or five seconds prior to touchdown, the left yaw increased sharply, which the pilot corrected with hard right pedal. He then corrected the airplane's tendency to continue yawing left by applying right rudder.

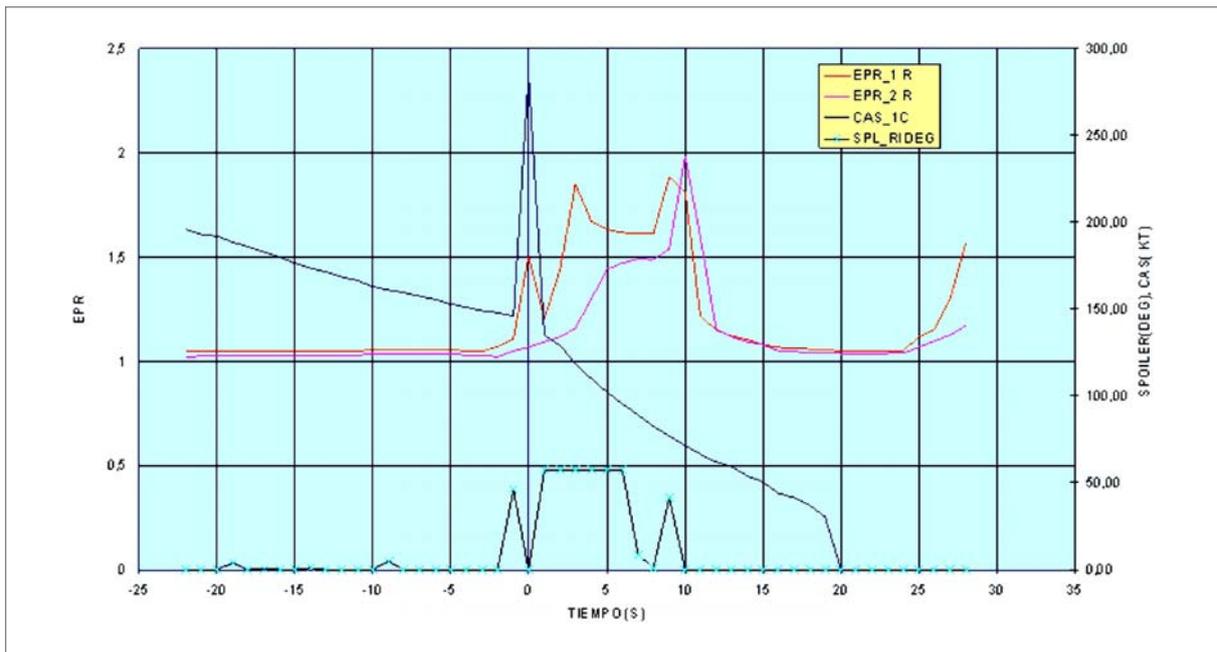
Figure 9. CAS, reverse thrust and spoilers

Even if the main wheels had not spun up, since the nose wheel was already in contact with the ground, the safeguard that prevents the spoilers from being deployed in flight was already defeated. It can also be confirmed that the ground spoilers were not armed, as recommended for a power-off landing, since in that case they would have deployed automatically when the nose wheel touched down, generating a "ground" signal.

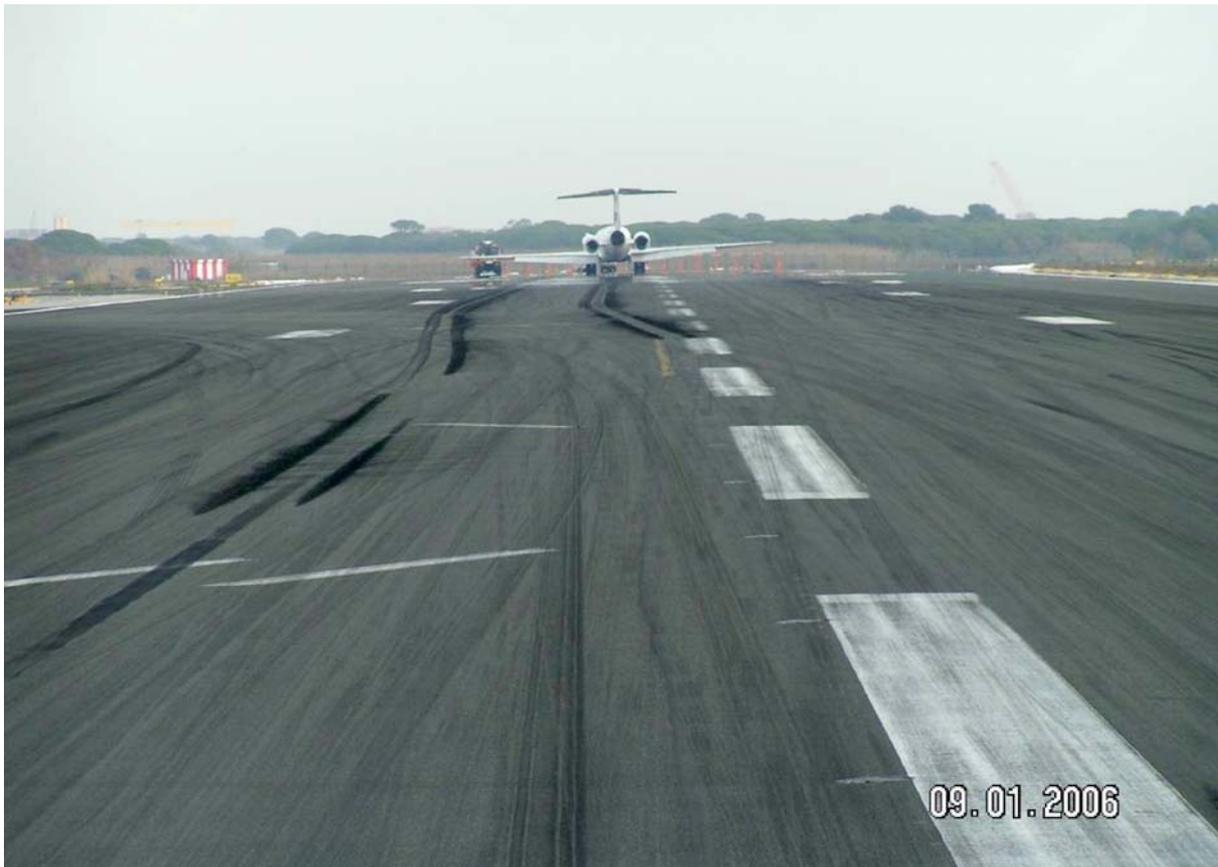
Figure 13. Photographs of tracks on the runway

The distance from the first track until the end of the landing run was 930 m.

From the airplane's final position until the end of the runway there were about 140 m.

The tracks left by the tires were mostly made by rubber. The rim on the number 1 wheel made contact and left metallic marks shortly after the second appearance of its tracks; the number 2 wheel left metallic marks for the final 415 m of the landing run.

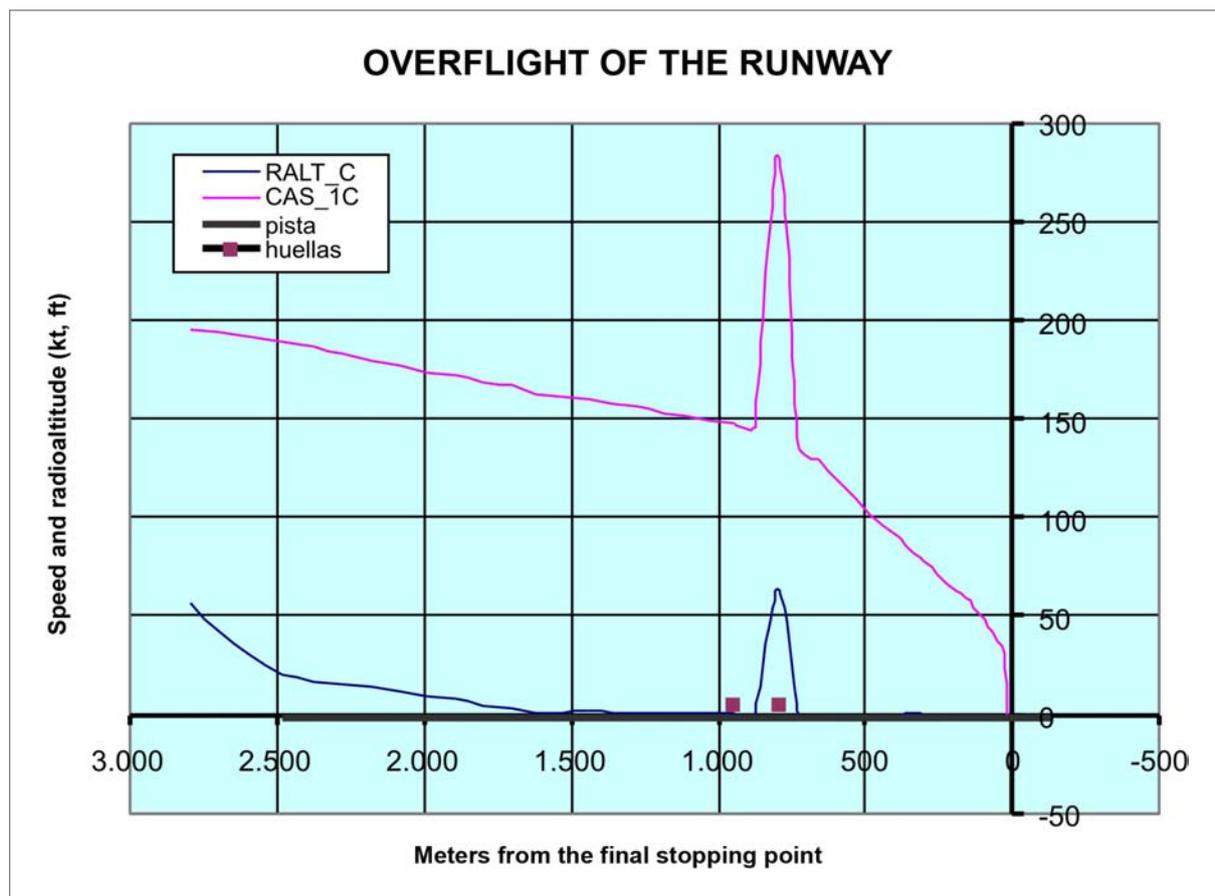
Figure 14. CAS, radio altitude during overflight of runway (meters from final stopping point)

- The aircraft flew over the runway threshold (2,520 m before the stopping point) at $t = -19.5$ s before positive contact was made, which is defined as $t = 0$.
- The aircraft's main landing gear left its first mark (930 m before the stopping point) at $t = -1.75$ s.
- The aircraft touched down a second time with the left leg at $t = -0.75$ s.
- Both aircraft legs touched down for good at $t = 0$ s at a spot that was 810 m away from the final stopping point.
- Based on this integration, the maximum vertical acceleration was recorded a few tenths of a second later, at some 763 m away from the final stopping point.
