**DATA SUMMARY**

Date and time	<b>Wednesday, 29 March 2006; 14:53 UTC<sup>1</sup></b>
Site	<b>Santander Airport (LEXJ)</b>

Registration	<b>N65MJ</b>
Type and model	<b>BEECHCRAFT 58P</b>
Operator	<b>Private</b>

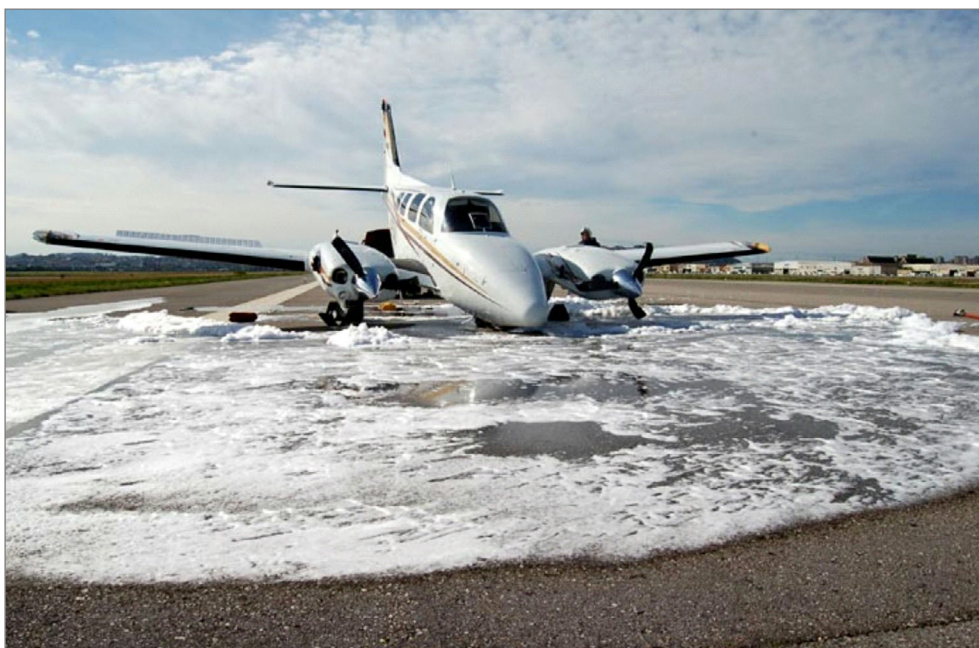
Picture 1. View of the aircraft following the incident

The aircraft's nose section (heating and radar), nose gear, propellers and engines were damaged (see Picture 1).

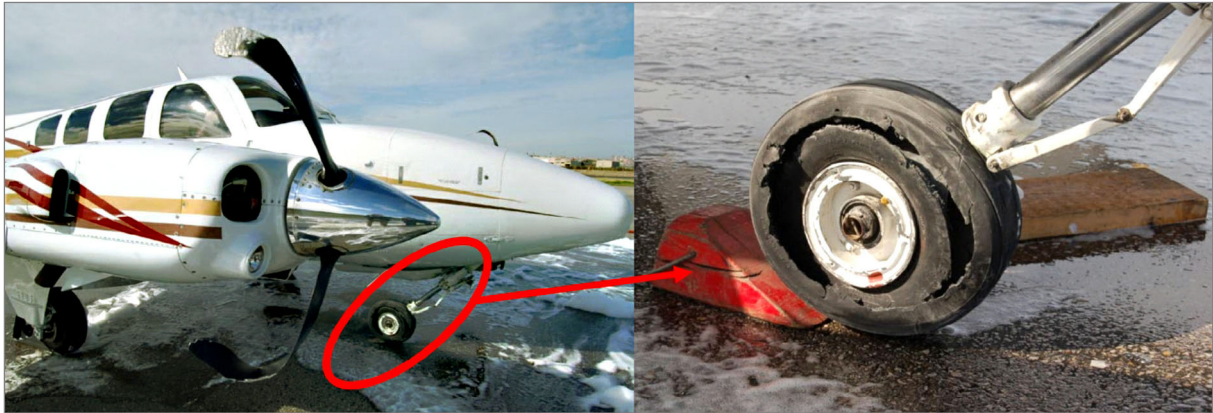
Picture 3. Detail of the nose gear

The nose gear structure was bent backwards in such a way that the nose and propellers were resting on the asphalt. The nose gear tire displayed a circular cut but retained its integrity (see Picture 3).

The nose gear tire had not been replaced during the maintenance check performed just before the flight to Santander, although its pressure had been adjusted. It is very likely that the tire's characteristics had been degraded by repeated low-pressure cycles (deformed casing, uneven wear, higher bending of the sidewalls). It is not known whether this loss of pressure reappeared following the check. Low tire pressure translates into increased friction since the contact area between the tire tread and the asphalt is larger. To this must be added the lateral forces produced by the crosswind on the nose wheel.

The circular shape of the cut in the tire appears to have been caused by a large momentary force on the nose wheel tire of such a magnitude that it allowed the casing to come in contact with the rim.

The most likely cause of the collapse of the nose gear support structure, therefore, is considered to be the rupture of the tire as a result of low pressure while taking off under high intensity crosswind conditions.
