## Report A-024/2006

Accident involving an  
Aerospatale SA 316 B aircraft,  
registration F-GPJF, operated  
by Helicópteros de Cataluña,  
in La Pobleta de Bellveí  
(Lleida), on 25 April 2006

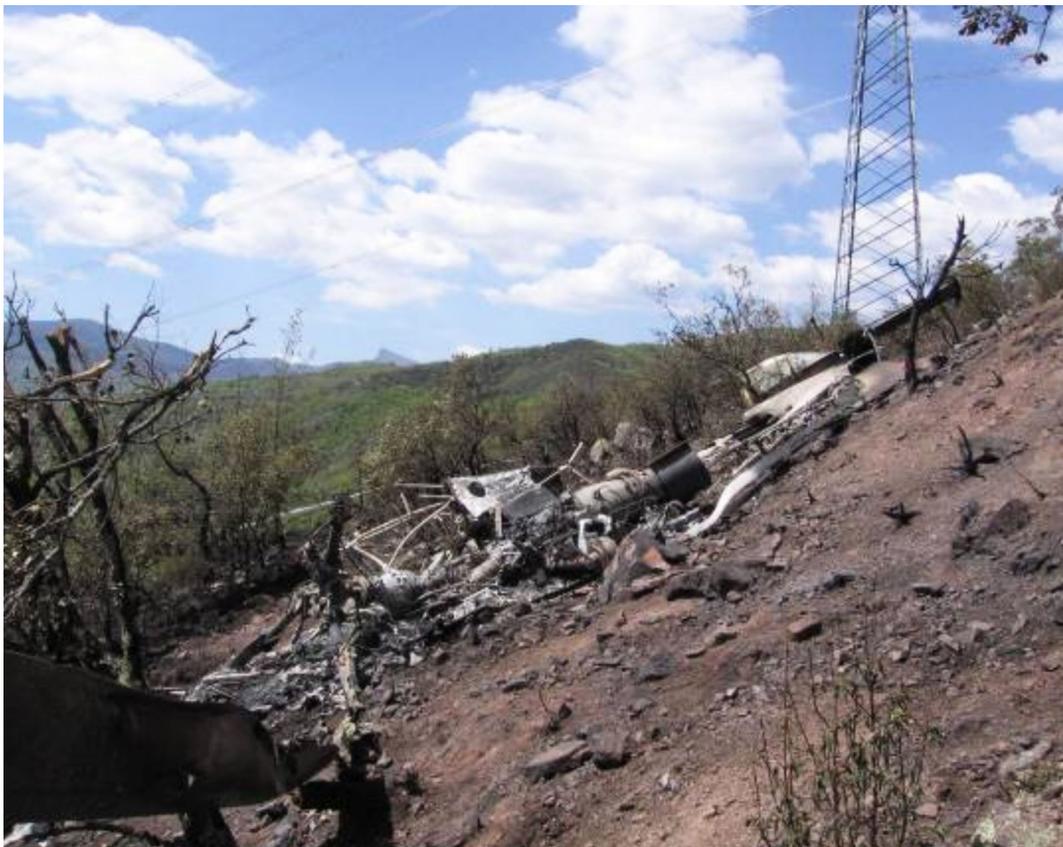
The aircraft wreckage was concentrated on the mountainside and had been affected by the fire that broke out (Figure 1). Emergency services responded immediately and were able to extinguish the fire before it spread.

Figure 1. Overview of the wreckage

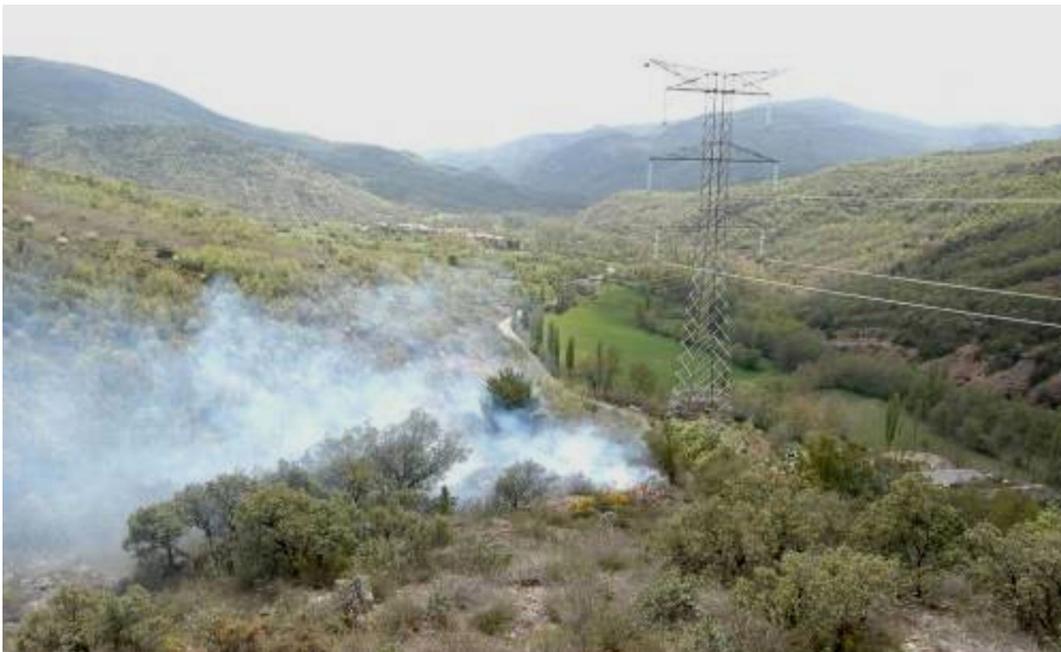
The wreckage of the aircraft were confined to an area of terrain situated to the right of the high voltage line, facing toward the north. Only the coupling shaft (freewheel), from the transmission assembly situated between the engine and the main gearbox, was found elsewhere, 27 m away.

Figure 6. View of the accident site looking south

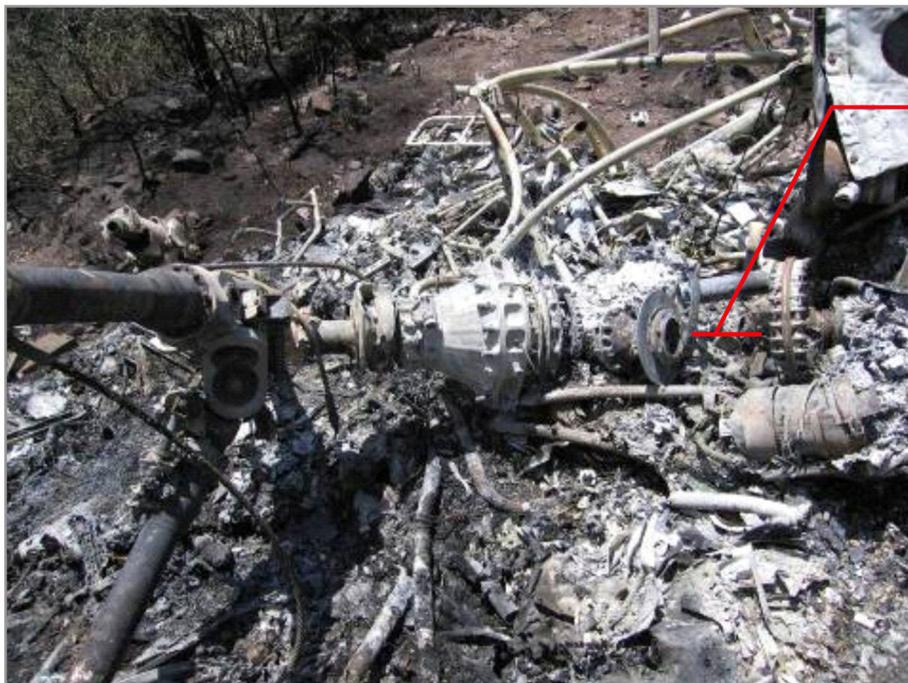
Area where the  
freewheel would  
normally be

Figure 7. Wreckage of the main transmission

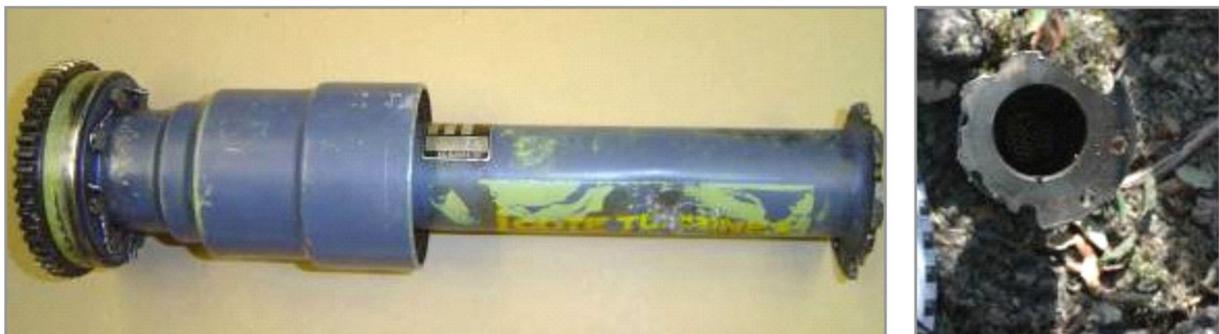
The freewheel surface connecting the coupling pinion to the clutch and engine was broken. The fracture line extended along six of the eight drill holes used to attach it. The other end was still attached to the main gearbox coupling pinion.

The body of the wheel was dented as a result of having impacted the terrain. The paint on the outer surface was worn, partially revealing the primer, Figure 8.

Figure 8. Freewheel

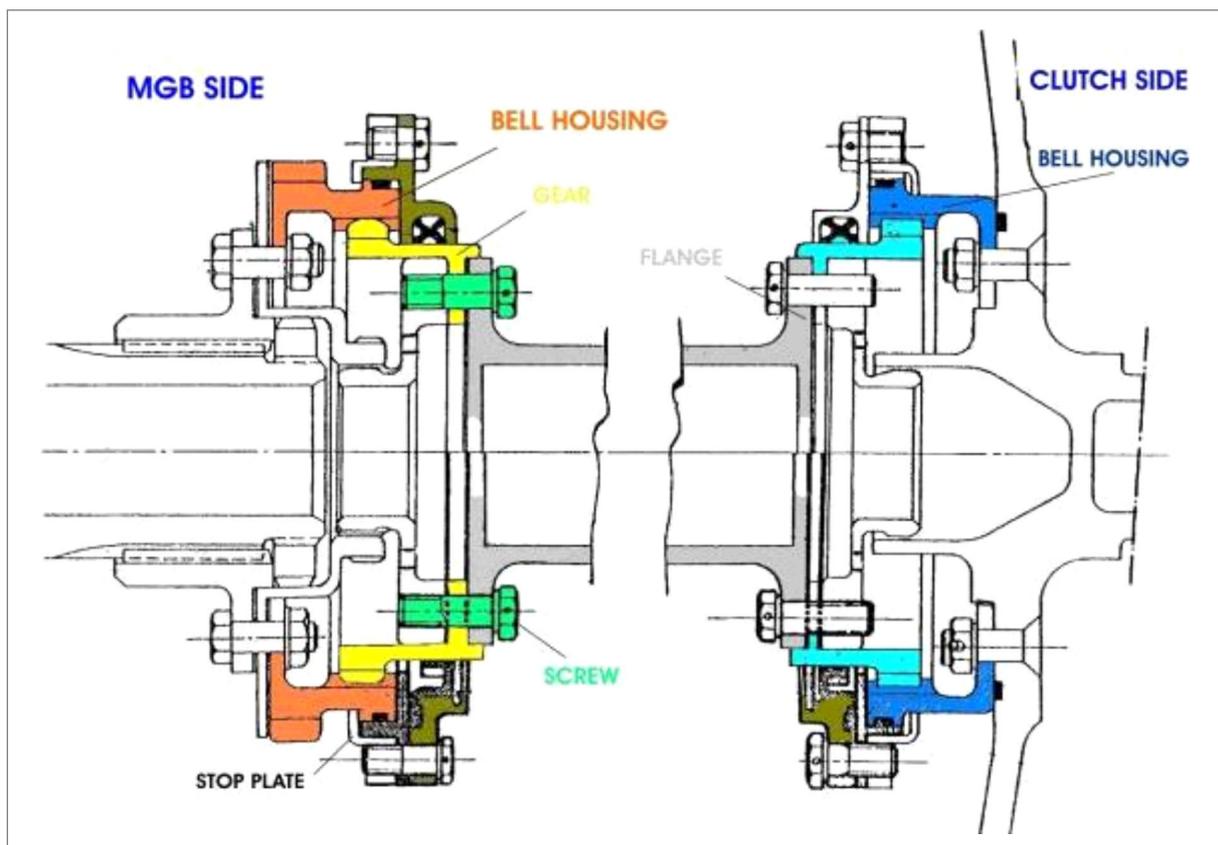
- F) There was no evidence of a malfunction in the coupling between the pinion and bell housing to the MGB, though there were marks from when the bell housing detached.

Figure 9. Detail of the freewheel connections

- G) The coupling on the clutch side showed signs of corrosion, of wear on the pinion teeth and of residue at the base of the teeth. These all point to an abnormal operation at this end of the freewheel.
- H) A check of the fractures at the freewheel flange, which is attached via eight holes, and of the bolts used to connect it to the pinion, revealed that the fracture was the result of a fatigue process.
- I) Lastly, there were areas of corrosion, but no cracks, on the connecting ring flange between the freewheel and the MGB.

As mentioned previously, it has been determined that the freewheel had been a poor lubrication and that corrosion had developed in its interior, resulting in generalized corrosion, wear of the gear teeth and deposits of metallic particles which, in turn, increased friction and limited the movement between the pinion and the bell housing at the clutch end of the freewheel.

As a result of this seizure, the misalignment between the engine and the MGB during the flight could not be absorbed by the MGB coupling. This induced excessive strain on the mounting bolts and the connecting flange, which resulted in primary fatigue cracks and the fracture of the bolts and the coupling flange.

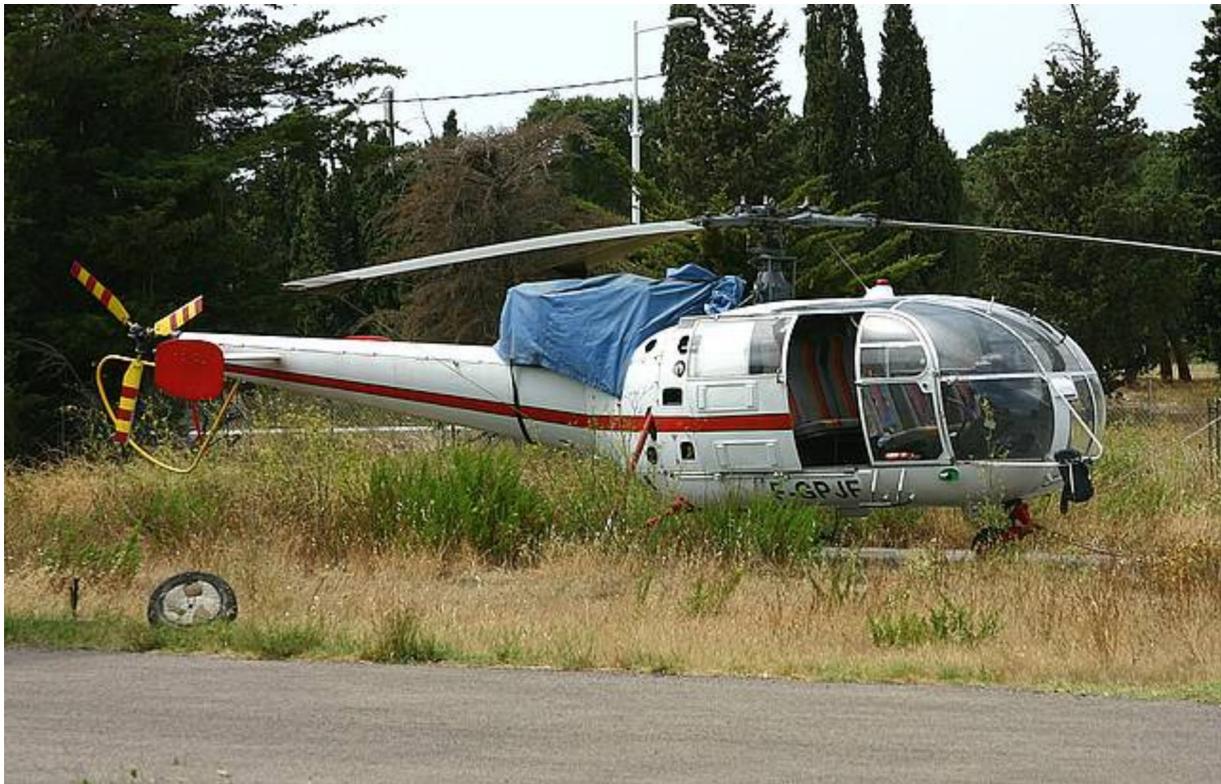
As already stated, the aircraft had flown 17 hours in the time frame between May 2005 and March 2006. During that time, it had been parked at the Persignan-Rivesaltes Aerodrome in France, protected only by a cover over the engine while the mast and the MGB were left unprotected (see Figure 10).

Figure 10. Condition of the aircraft at the Persignan-Rivesaltes Aerodrome

The aircraft was parked outdoors for an extended period of time at the Perpignan aerodrome, during which time (ten months) it only flew for 17 hours. In addition, the method used to protect the helicopter during storage did not conform to any of those listed by the manufacturer in its maintenance manual, nor were the recommended steps taken to protect the rotor head against rain. It should be noted that "short-term" storage calls for draining the lubricant from the MGB, which was not done in this case.

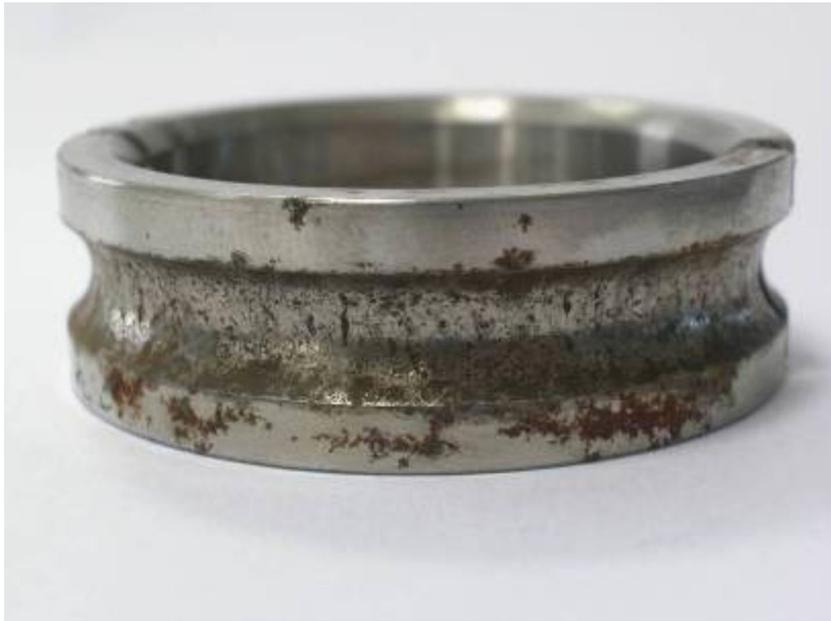
Figure 11. Example of the corrosion found on the inner race of the freewheel

The resulting stresses led to the formation of fatigue cracks at the mounting bolts and at the flange through which they were threaded. The propagation of the cracks resulted in the freewheel detaching from the aircraft.

An analysis of the above data revealed that the corrosion was most likely triggered by the contamination of the MGB lubricant.
