DATA SUMMARY

Date and time	Saturday, 27 May 2006; 19:00 local time
Site	Santa Cilia Aerodrome. Jaca (Huesca)

Aircraft No. 1	Aircraft No. 2
Registration	D-KIDL	EC-JPE
Type and model	Glasser Dirks DG 500 M	Twin Astir III Grob
Operator	Private	Private

REPORT

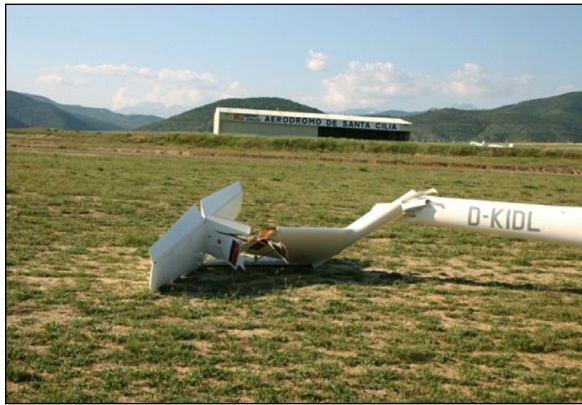
On May 27 at around 19:00 UTC, two aircraft landed at the Sta. Cilia Aerodrome. One, a Twin Astir glider, registration EC-JPE, landed on the grassy area next to the gravel runway; the other, a Glasser Dirks motorglider, registration D-KIDL, landed on asphalt runway 27R. On its landing roll, the German glider crossed in front of the Spanish glider, which struck and severed the tail section of D-KIDL with its left wing. There was also damage to the latter's VHF antenna and its associated cabling.

Figure 1. Damage to aircraft D-KIDL

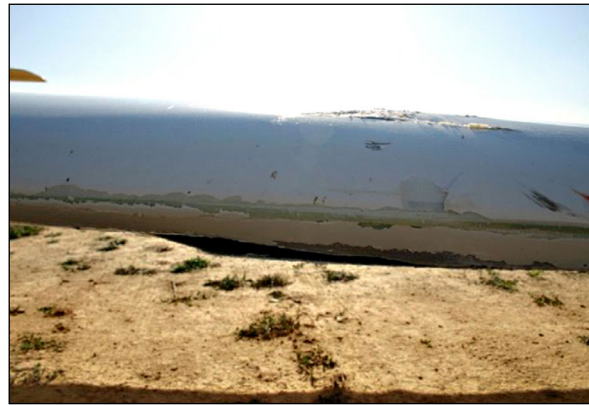
In his statement, the pilot indicated that before reporting downwind, he observed the aerodrome traffic, seeing other gliders in the vicinity but none in the landing pattern. According to his statement, he reported «downwind runway 27, grass, fixed landing gear», which the runway supervisor acknowledged before informing him of the estimated wind direction and intensity. He continued his approach, still with no other aircraft in sight, verifying there were no other gliders on the dirt runway on which he was going to land. He also noted there were gliders parked on the gravel runway. He turned at the end of the base leg, verifying once again that the grass runway was still clear, but was surprised to see a previously unidentified glider landing on the asphalt runway. He adjusted his landing so as to touch down on the usual spot and landed beyond the grass runway's taxi point. A few seconds after landing, he saw how the other glider ahead of him on the asphalt runway suddenly turned to the left, in his direction. Since the gliders parked on the gravel to his left prevented him from going that way, he opted to turn right. Given the small manoeuvring margin available, he could not avoid hitting the other glider's tail section with the leading edge of his left wing.

Figura 2. Damage to aircraft EC-JPE

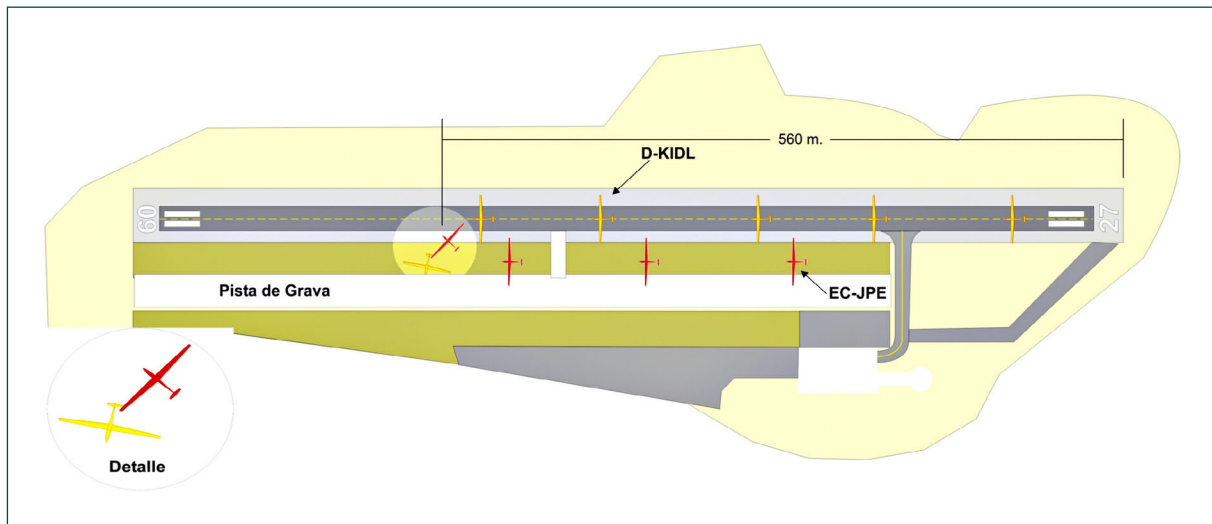
Both gliders proceeded to land, D-KIDL touching down first on the asphalt runway, followed 5 or 10 seconds later by EC-JPE on the grass. About two-thirds of the way down the runway, D-KIDL abruptly changed its course to the left, leaving the asphalt runway at high speed and entering the grass area in front of EC-JPE's path, which could only manoeuvre slightly to the right to avoid the impact, since two other gliders were parked on the gravel runway to its left.

Figure 3. Aerodrome layout and schematic of the incident
