DATA SUMMARY

Date and time	Sunday, 28 May 2006; 17:20 local time
Site	Ocaña Aerodrome (Toledo)

REPORT

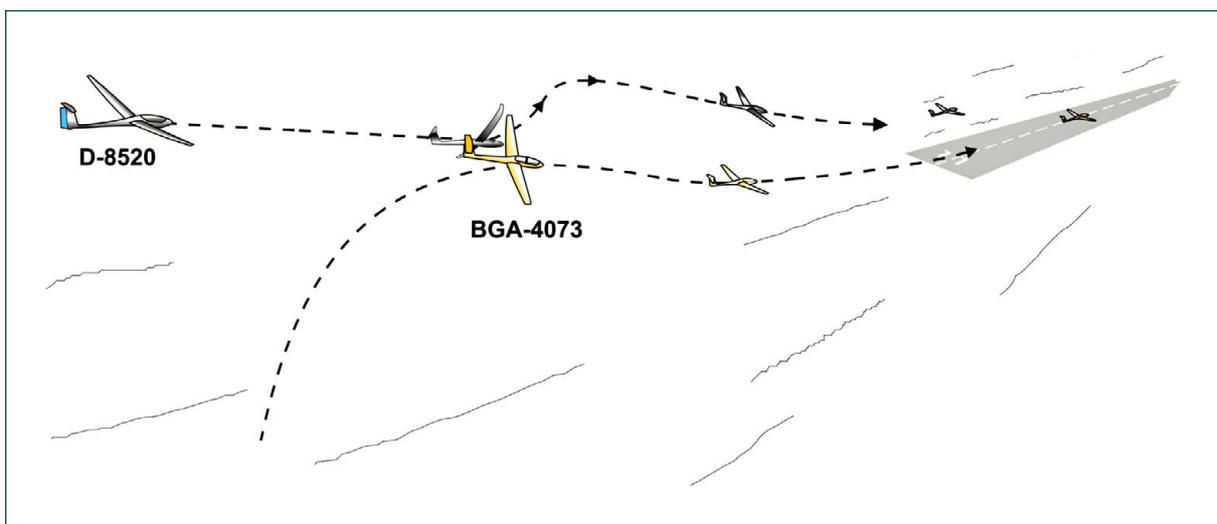
The runway supervisor indicated that the incident took place when glider BGA 4073 cut off glider D-8520, which was on final approach and correctly positioned some 30 m. above the ground and 70-80 m. away from the runway 11 threshold.

He stated that while glider D-8520 had notified him of and flown the approved traffic pattern (downwind, base and final), glider BGA 4073 did not adhere to the established

Figure 1. Diagram of the event

pattern and entered directly on final from a wide base, even after having been notified by radio, in English, of the presence of other traffic on final.

The cause of the incident, therefore, was the crossing in mid-air of the two aircraft's trajectories, resulting from the failure of BGA 4073 to observe the aerodrome's local procedures which specify that, in addition to conveying position and intentions, the landing pattern will be followed, differentiating between its downwind, base and final legs.
