**DATA SUMMARY**

Date and time	<b>Thursday, 8 September 2006; 22:00 h (UTC)</b>
Site	<b>Madrid-Barajas Airport</b>

Registration	<b>A7-ABV</b>
Type and model	<b>AIRBUS 300-600 (B4-622R) MSN 690</b>
Operator	<b>Qatar Airways</b>

Operation	<b>Scheduled – International – Passenger flight</b>
Phase of flight	<b>Taxi prior to takeoff</b>

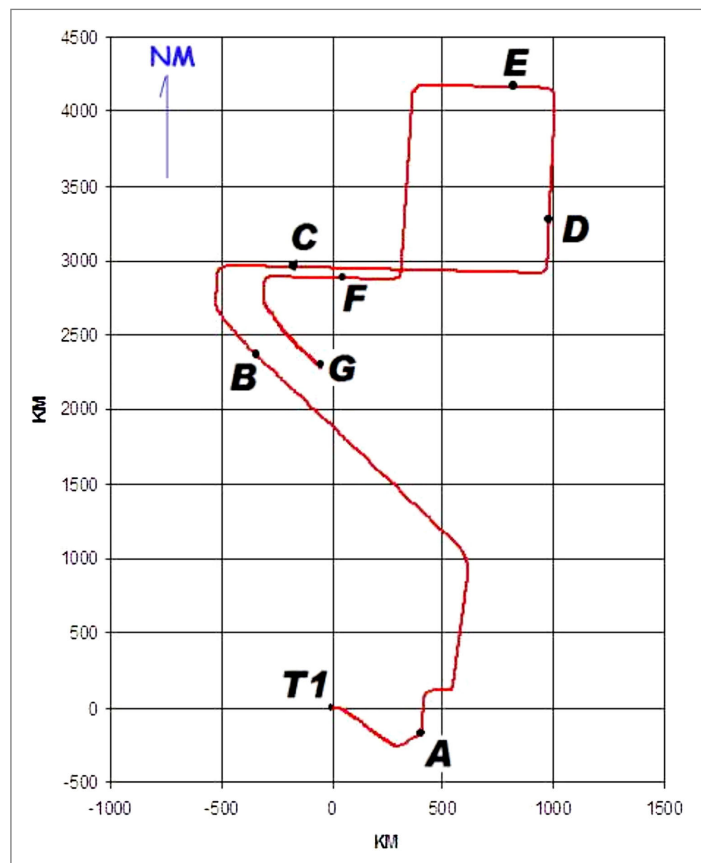
Trayectoria A7-ABV

GMC at Madrid-Barajas is divided into several sectors, which flight QTR 068 contacted on various radio frequencies as it taxied. The diagram of the route taken shows several concrete points of interest to the investigation where brake temperatures in the rear wheels of the left leg started to exhibit problems.

At point A, shortly after pushback, the aircraft stopped momentarily when it encountered a certain resistance as it attempted to turn north onto taxiway C-5. Communications were with GMC S-NORTH on a frequency of 121.85 MHz.

At point B, at 21:11, the aircraft was under GMC Central-South Control on 121.975 MHz. As stated by the crew, the temperatures on wheels 5 and 6 (rear wheels on the LH gear) were at 150 °C, while those for the other tires were only at 100 °C. The aircraft had traveled some four kilometers since the chocks were removed.

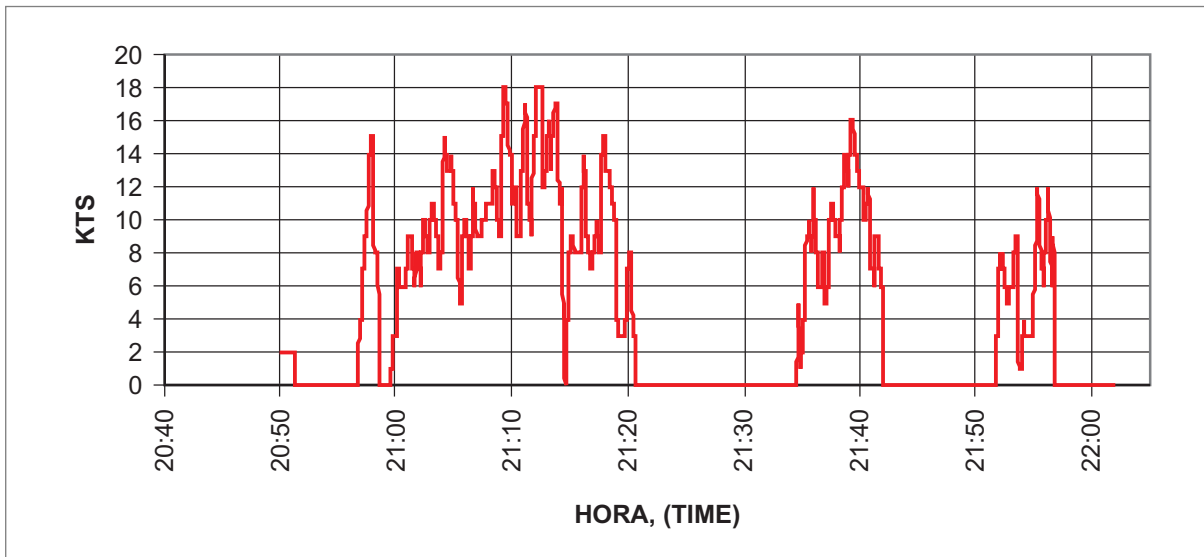
Taxi speed (kt)

The speed graph shows the values recorded for this parameter while taxiing. It did not exceed 18 kt. Noticeable are the stops in the taxi run at certain times, and of 12 and 9 minute waits at points E and F on the trajectory graph. Taxiing was resumed after the last wait period at 21:51:41.

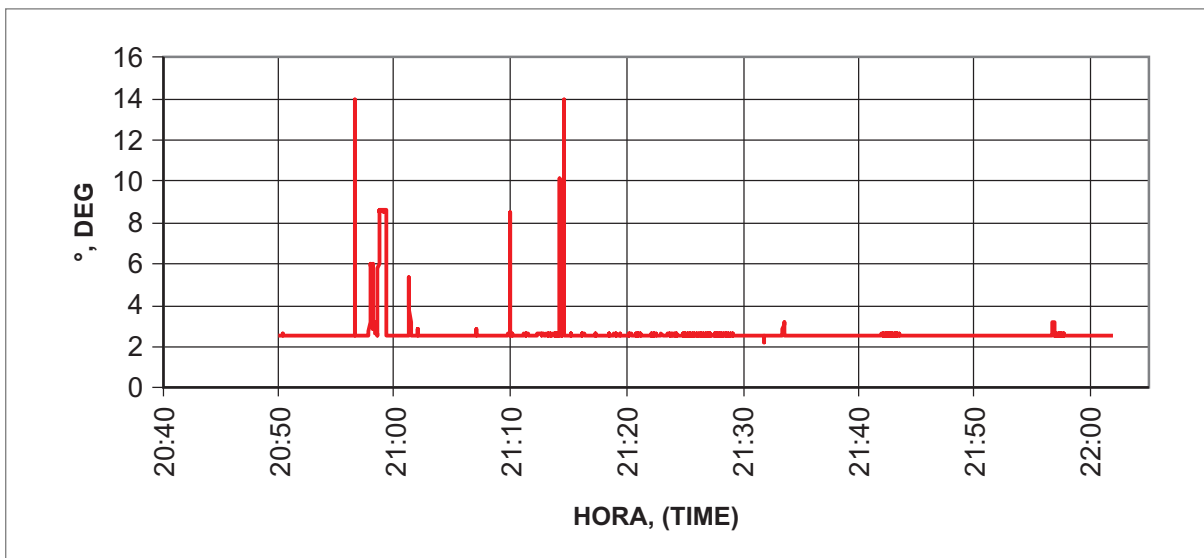
LH brake pedal

The brake pedal input recording shows the use that was made of the brakes while taxiing. From 21:14 on, there were practically no inputs to the left brake.

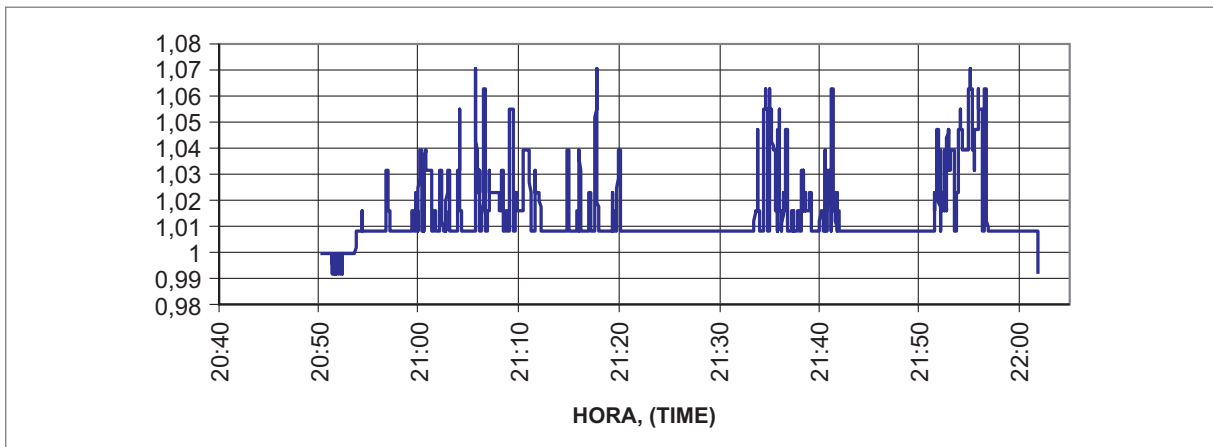
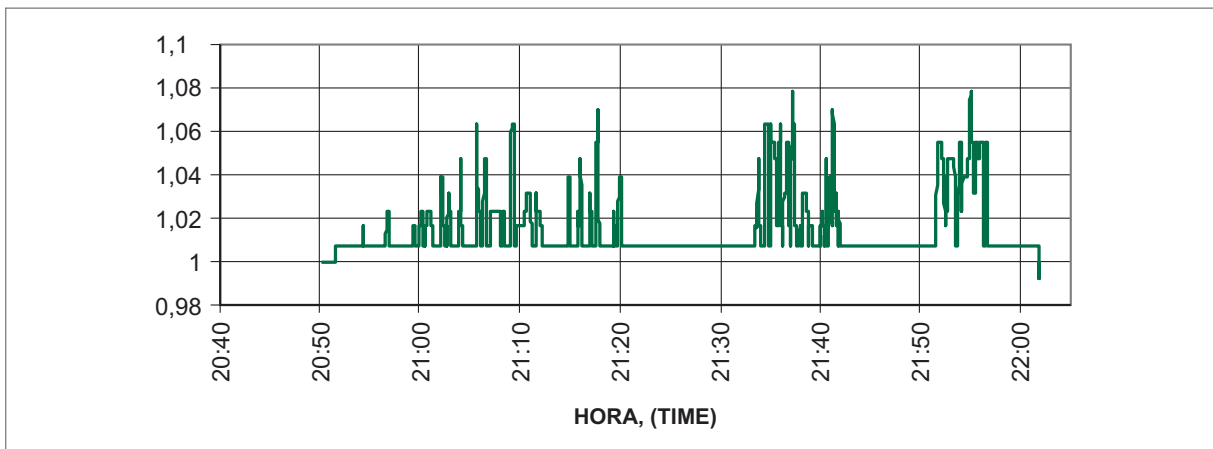
Lastly, the two graphs that follow show the engine power levels used to taxi. At no time was thrust in excess of 1.08 EPR used and the two engines were used simultaneously.

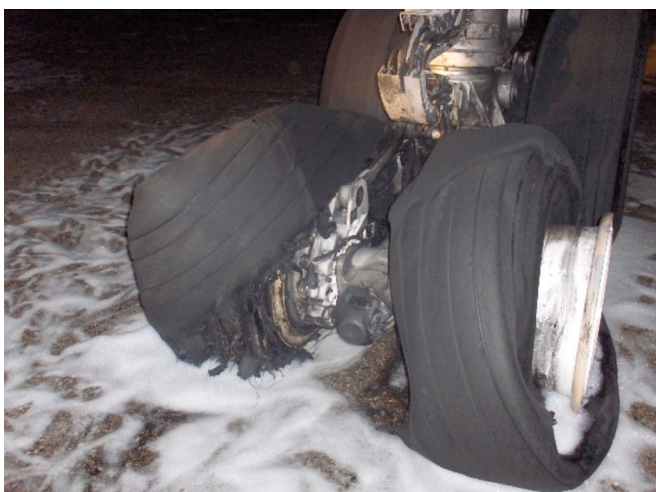
While these conditions can be reproduced in a laboratory oven, they are not present in a wheel with a deflated tire rolling on its rim. It can be assumed that the environment around a rolling tire had a relatively low temperature, making spontaneous ignition unlikely. The same considerations are applicable in the case of rubber particles coming into contact with the brakes.

Figure 1. Condition of tires on wheels 5 and 6

It is highly improbable, therefore, that a deflated tire would cause a fire without the presence of other inflammable liquids. One possible scenario conceived by these experts is if the carcass is torn up and disintegrates while rolling flat and damages a nearby hydraulic hose.

The two deflated and burned tires were found as shown in Figure 1, which reveals no loss of integrity of the rubber.
