Report A-059/2006

Accident involving a PZL
M-18A DROMADER aircraft,
registration EC-FBI, operated
by AVIALSA, on 7 October 2006,
in the vicinity of Castellón
aerodrome

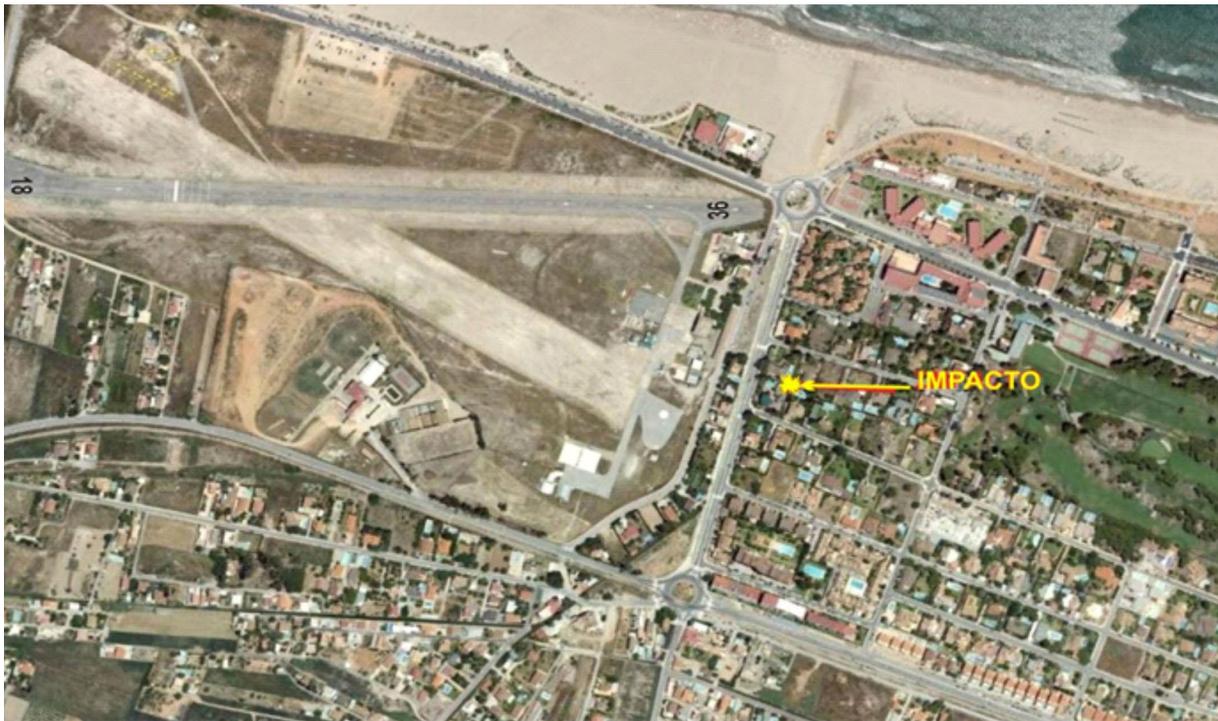
Figure 1. Aerial view of impact site

The aircraft crashed violently into the ground at a point located between four single-family dwellings some 150 m away from the aerodrome perimeter and to the right of the extension of runway 18. The aircraft impacted the fencing around the lot, support buildings and two contiguous pools, without affecting the main structure of the houses, which were some 10 m high. There was slight damage to the surrounding trees.

The debris field was confined to a circle of some dozen meters in diameter around the main wreckage. There was practically no movement of the aircraft along the ground after the impact.

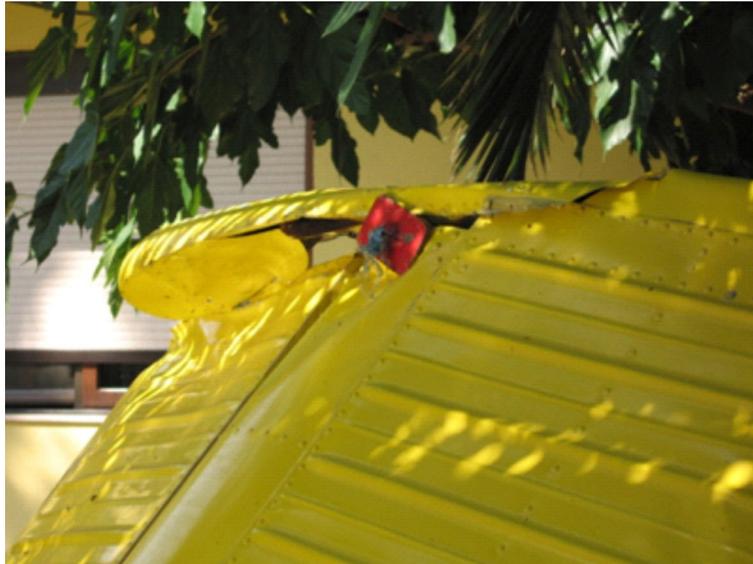
The airplane's attitude at the time of contact with the ground was estimated at 45° pitch and at 60° bank, in a steep turn to the right. The aircraft lost its structural integrity on impact. The forward fuselage and wings were completely destroyed. The empennage preserved its shape to a certain degree and the pin that immobilizes the left elevator was found installed in the left horizontal stabilizer (Figure 2). The pin did not have its warning flag attached.

Figure 2. Pin installed in the left elevator

The presence in the wreckage of the pin used to immobilize the left elevator while on the ground shows that the accident occurred as the result of a blocked elevator on the aircraft. Since the pin used to immobilize the right elevator was not found in the storage location where the pins are usually kept when removed from the aircraft, it is suspected that the right elevator pin was also installed, even though it was not found among the wreckage. In any case, since both elevators work together, installing just one pin would suffice to prevent all motion of both control surfaces. It is very difficult to believe that the pilot could manage to control the airplane with the elevator controls blocked.

The left elevator pin did not have a flag, as was verified following the accident. While it may have been lost during the brief flight, the presence of other pins without their corresponding flags on this and other aircraft of the fleet leads one to suspect that those installed on the aircraft possibly did not have them, which contributed to the presence of the pins not being noticed on the airplane prior to takeoff. A recommendation to maintain the pins in good working order is issued as a result of these findings.

The cause of the accident was the installation in the left elevator of the pin used to immobilize said component while on the ground. The lack of motion of the elevators made the aircraft practically uncontrollable.

Finding among the wreckage the pin installed in the left elevator was evidence that the free and clear check of the controls was not completed before starting the takeoff run.

REC 24/09. It is recommended that AVIALSA maintain in good working condition the lock pins for the flight controls and the flags used to clearly signal their presence and installation.
