**DATA SUMMARY**

Date and time	<b>Tuesday, 16 January 2007; 15:30 local time<sup>1</sup></b>
Site	<b>Tenerife South Airport</b>

Registration	<b>G-VCED</b>
Type and model	<b>AIRBUS 320</b>
Operator	<b>My Travel Airways</b>

Aircraft	<b>None</b>
Third parties	<b>Collapse of the platform on the boarding vehicle</b>

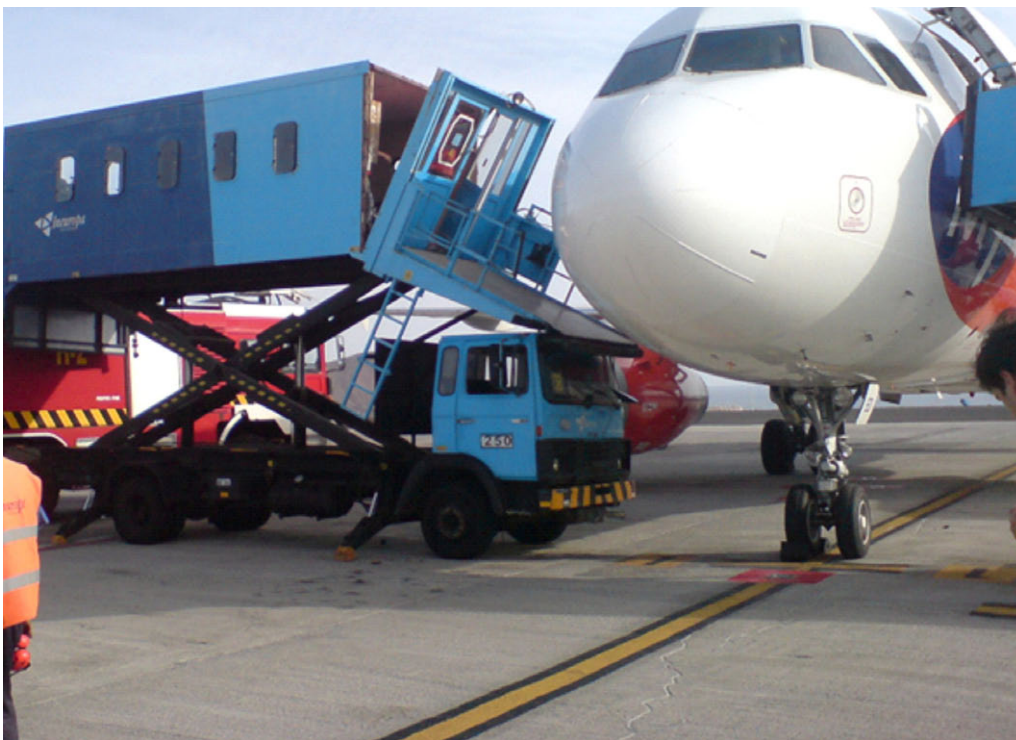
Figure 1. Condition of the vehicle after the accident

It has been determined that the collapse of the platform on the ground service vehicle resulted from corroded anchor rivets attached to a rotted wooden structure. Both conditions resulted from the high degree of deterioration evident in the vehicle, resulting from generalized corrosion and rotting.

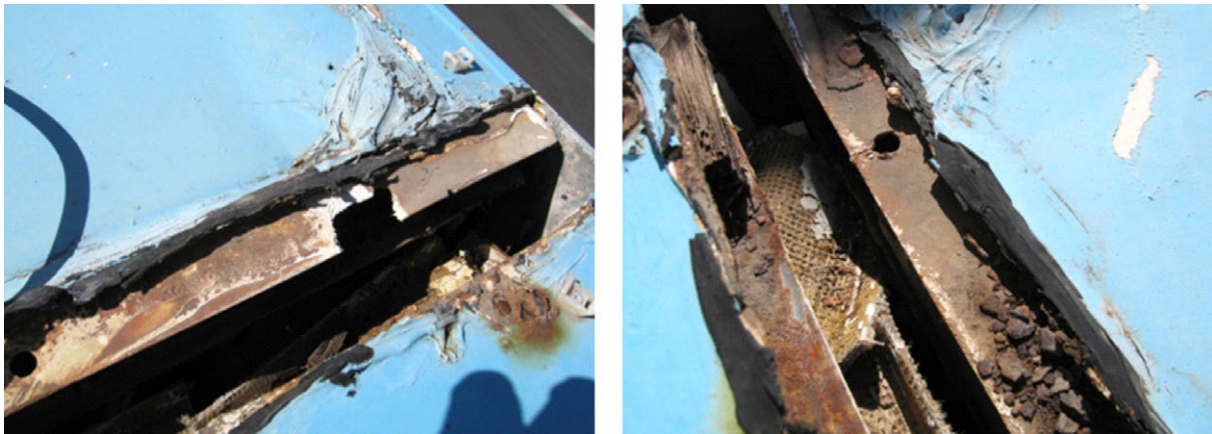
The platform that detached was fixed to the cabin of the passenger truck by a frame that was fastened by twelve rivets along the top horizontal part and another twelve on the sides, eleven of which were aligned vertically, with the twelfth forming a triangle with the two rivets at the top and in front of them. All were so corroded that some had completely worn away, while only the head remained of others. The rivets were nailed to the passenger cabin's wooden beams, which had completely rotted.

Figure 3. Close-ups of the cabin's top frame

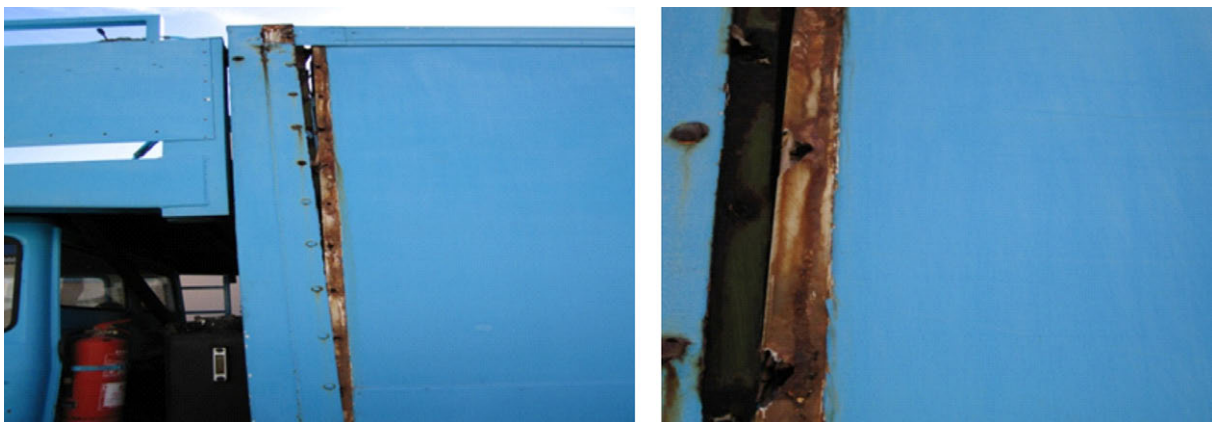
Figure 4. Close-ups of the cabin's left frame

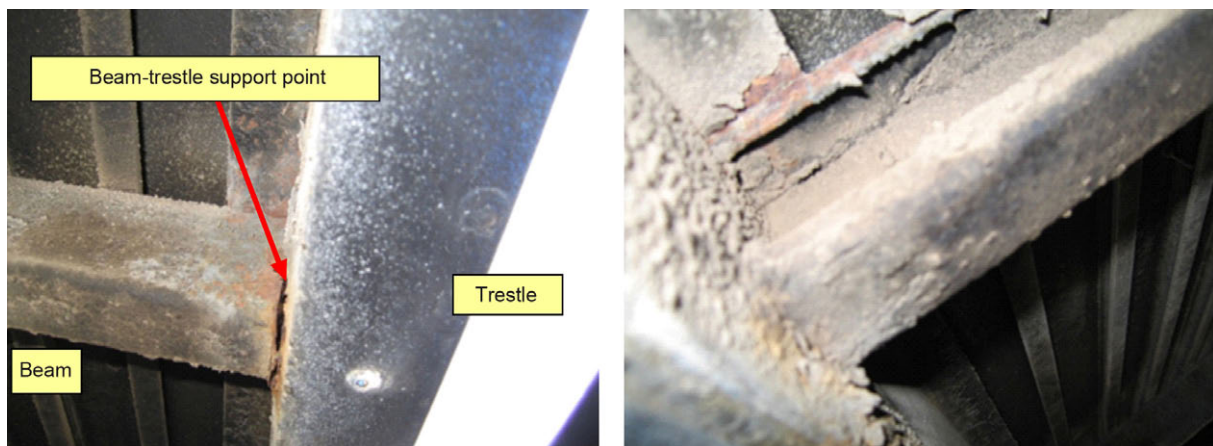
The vehicle's overall condition was one of advanced deterioration, as evidenced by the corrosion on the metal components and the rotted wood. Corrosion was clearly visible along a solder line on a bar used as a handrail on the side of the rear platform. The truck's passenger cabin was mounted atop a trestle that had four crossbeams along its length. A significant amount of material was missing from several of the crossbeam-trestle unions due to corrosion, such that some of the supports were exposed to the air, as shown in Figure 5. The vehicle's undercarriage, both in the driver's and passenger cabins, exhibited corrosion and a shortage of material.

Figure 5. Close-ups of the crossbeam-trestle union
