DATA SUMMARY

Date and time	Tuesday, 10 March 2007; 11:42 UTC¹
Site	Casarrubios del Monte Aerodrome (Toledo)

Registration	N1271B
Type and model	COLUMBIA 350
Operator	Private

REPORT

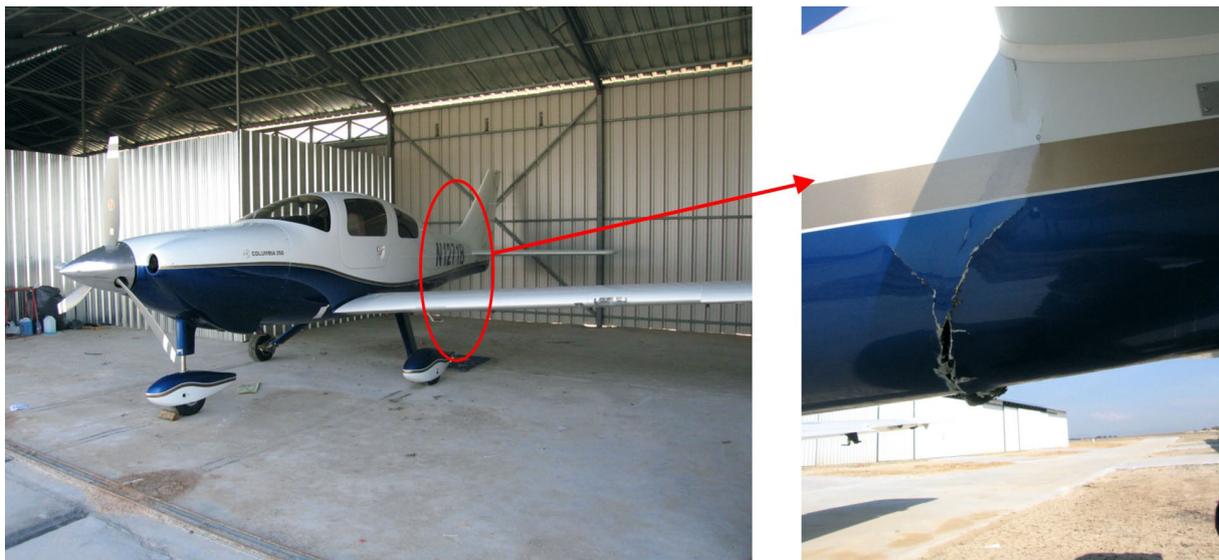
The right gear fairing detached at the end of the run, although once on the stand the pilot noted that, in addition to other damage, the most significant consequence was the presence in the tail of the aircraft of a large crack in the skin along the bottom of the fuselage with deformations that extended diagonally to the top (see Figure 1).

Figure 1. Close-up of the damage evident in the right wheel fairing and in the tail

- Fracture of the skin on the lower part of the tail with permanent deformations of the fuselage in the adjacent area and ascending at about a 45° angle with respect to the aircraft's longitudinal axis.
- Fracture of the interior structure in the same area (see Figure 2).
- Deformation of the belly access panel of the fuselage corresponding to the main landing gearbox with fracture of some of the screws that fasten this panel to the fuselage.
- Cracks in both rear windows of the aircraft.
- Missing fairing on the right main landing gear wheel and damage to the wheel fairing including scratches in the fairing area where the leg is attached to the fuselage.

- The tail of the aircraft fractured at the juncture of the vertical shear web and the antenna bulkhead.
- The composite material that makes up the aircraft's fuselage, particularly in the proximity of the tail fracture, had been repaired after being damaged by hail.

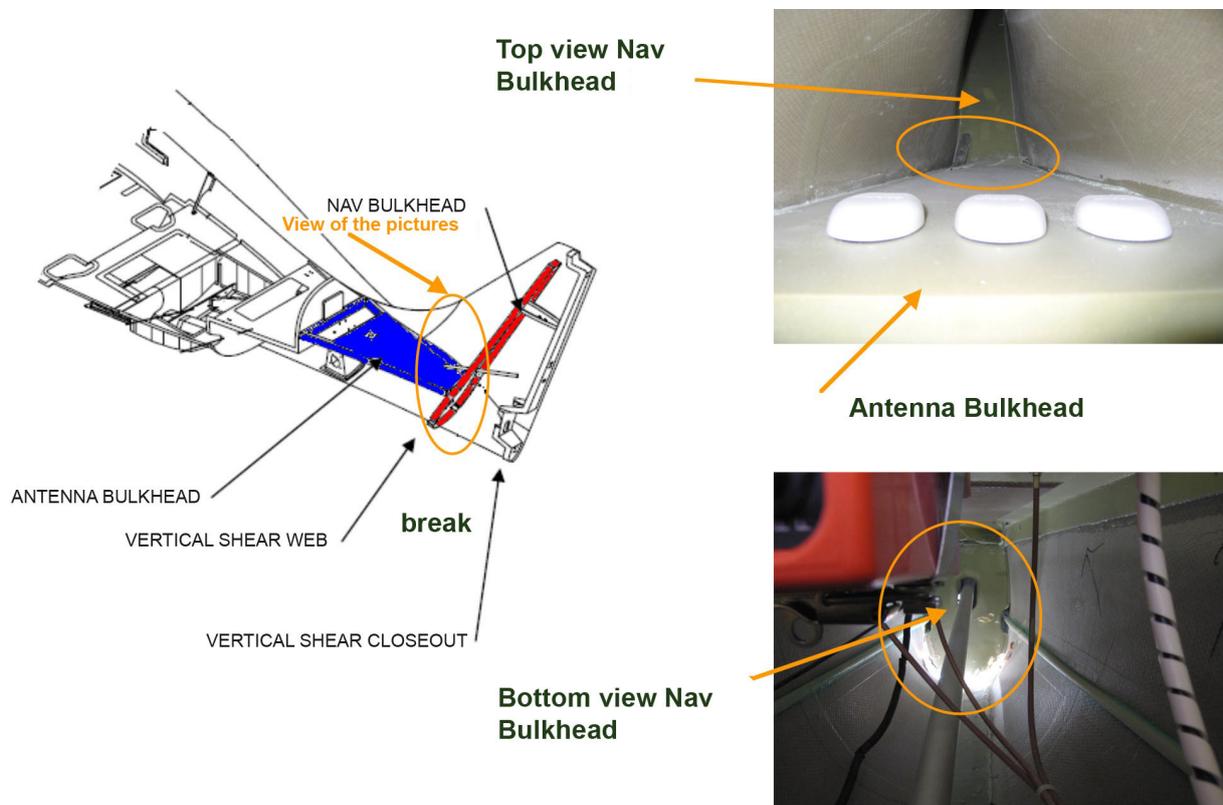
The fracture took place at the juncture of both elements (antenna bulkhead and vertical shear web). See Figure 2.

Figure 2. Close-up of tail structure

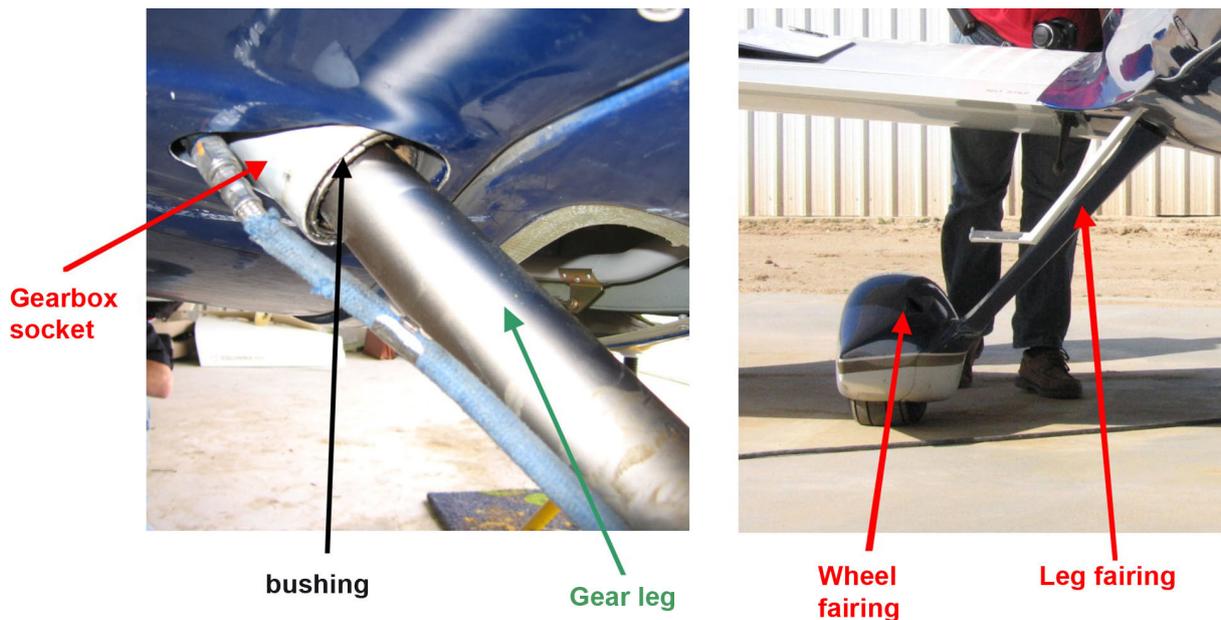
Figure 3. Close-up of gear structure

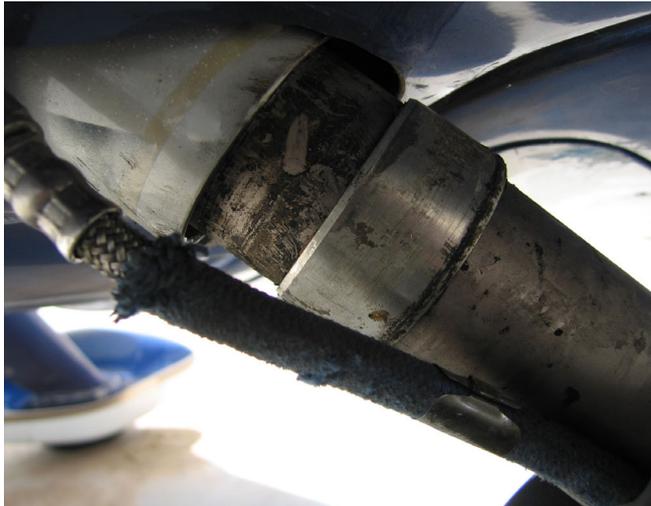
Figure 5. Close-up of the right wheel bushing displaced from its housing

easily due to the absence of the wheel fairing (see Figure 5), and clearly showed that the bushing situated between the gearbox socket and the leg itself was not in its housing (see Figure 5). The other leg was then checked. Though the check was made more difficult by the fairing, it was likewise noted that the bushing was in the same condition as the right one, out of its housing.

The maximum play allowed, according to the manufacturer, between the gearbox socket and the leg with the bushing installed is 0.016 inches. The actual value on the incident aircraft was 0.03125 inches, about double.

- An Obligatory Service Bulletin (SB-07-005A) had been issued which required that the bushings be inspected during the annual inspection or in the next 100 hours. If the bushings were found displaced during this inspection, new ones had to be installed using Loctite 660. It was subsequently noted that in the latest version of the Service Bulletin (SB-007-005C, 7 April 2008), the P/N of the bushings was also changed. According to the manufacturer there is no change to fit, form or function between the old and new bushings. A new item was also added to the Pre-flight Checklist that required pilots to ensure that the bushings were correctly housed as part of every pre-flight check.

After the comments phase, manufacturer informed that the main gear leg design has been updated with a new machined shoulder or “bump ring” that fit against the gear box socket and physically retained the gear bushing in the socket should Loctite failure occur. This design improvement was implemented in early 2008 only for production aircraft and was available to fielded aircraft as a replacement part. CIAIAC considered that this action did not assure that other cases with loose of bushings in existing aircrafts and their consequences could occurred, so CIAIAC keeps the Recommendation issued at the end of this report.

REC 02/10. It is recommended that FAA requires manufacturer CESSNA (formerly COLUMBIA) to undertake the necessary measures to ensure the continuous airworthiness of the aircraft already manufactured that do not have incorporated the landing gear design modifications taken by the manufacturer after the incident.

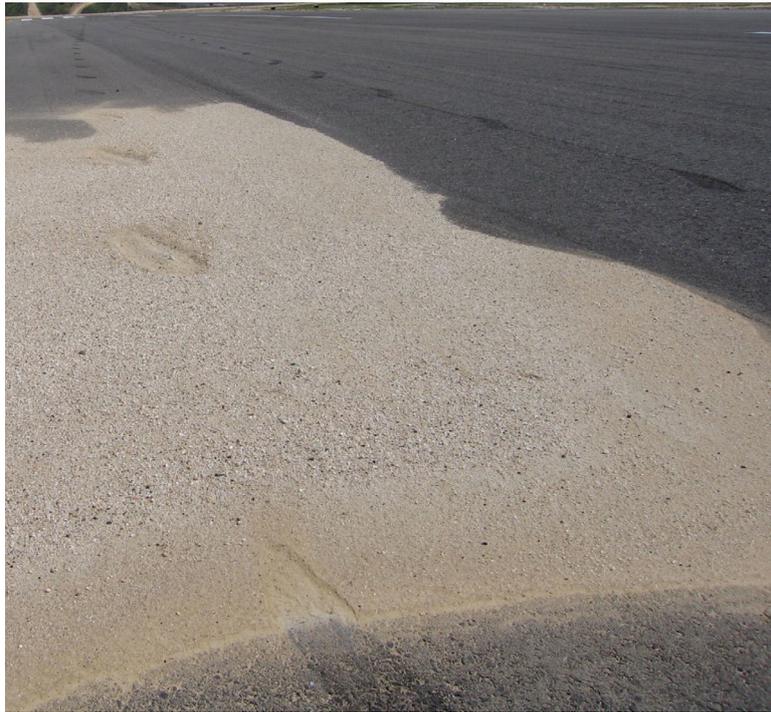
The marks left on the runway by the aircraft tires (see Appendix A) show an initial continuous segment that deviated from the runway centerline to the left. The tracks then oscillated continuously before becoming discontinuous, with a change in angle with respect to the aircraft’s longitudinal axis, and non-parallel, and dashed, as if the airplane had been “hopping” alternately from one wheel to the other. There was a sandy area on the runway which the airplane was determined not to have traveled over and which shows three perfectly distinct tracks (see Figure 6).

Figure 6. Close-up of tire tracks on sand and on asphalt

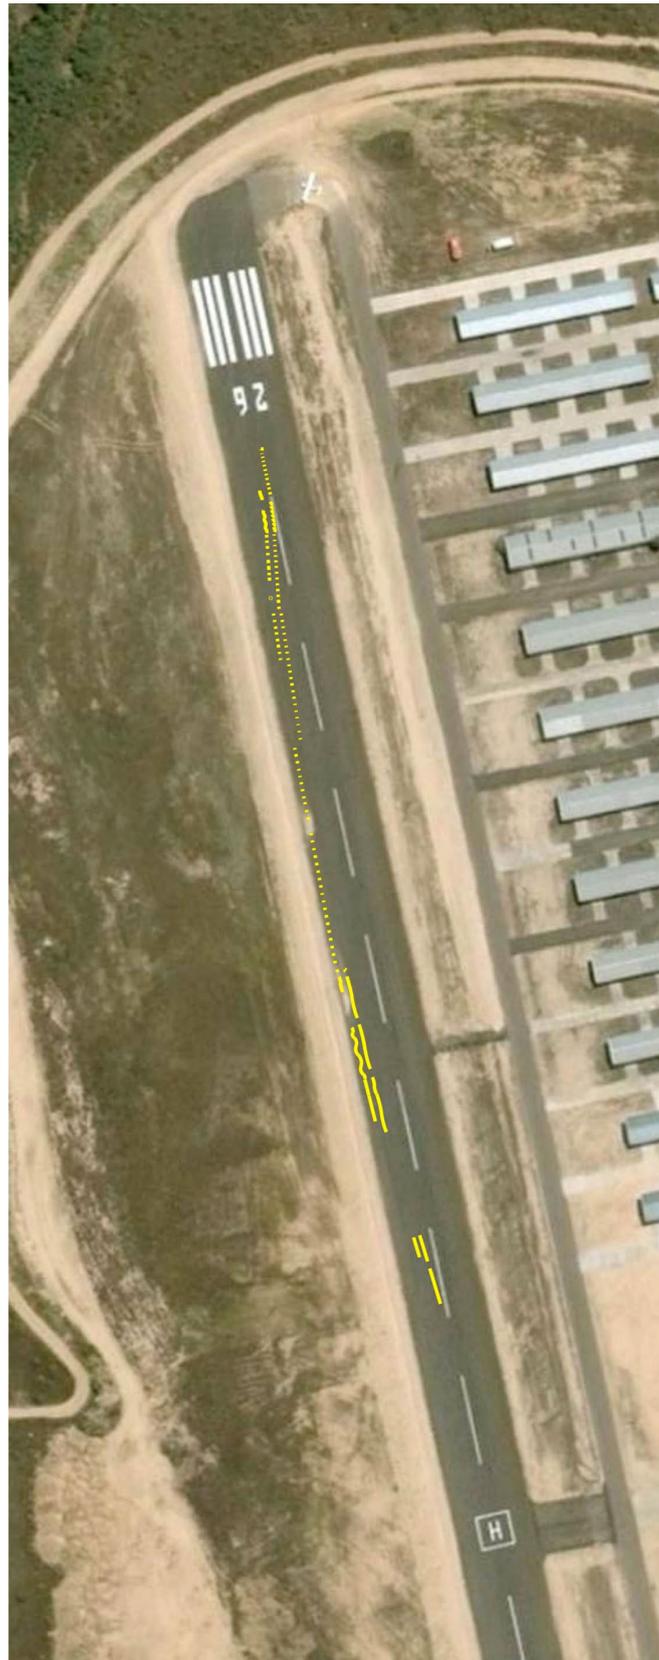
The tire marks showed no obvious signs that both tires had locked and were slipping down the runway because the wear was even. The marks did show that the airplane had been "hopping" first on one wheel and then on the other as the angle with respect to the airplane's longitudinal axis varied. There was a sandy area on the runway which revealed that the airplane's wheels were not rolling and where three perfectly distinct marks could be seen (see Figure 6). The only area of uniform wheel rotation was during the initial segment, in which the aircraft started to veer from the runway centerline, leaving uninterrupted skid marks before subsequently starting its continuous oscillations (see Appendix A).

Figure 7. General view of traces on Casarrubios Aerodrome runway
