DATA SUMMARY

Registration	EC-BMA
Type and model	BEECHCRAFT A23-24
Operator	Private

REPORT

Date of approval	24 October 2007
------------------	------------------------

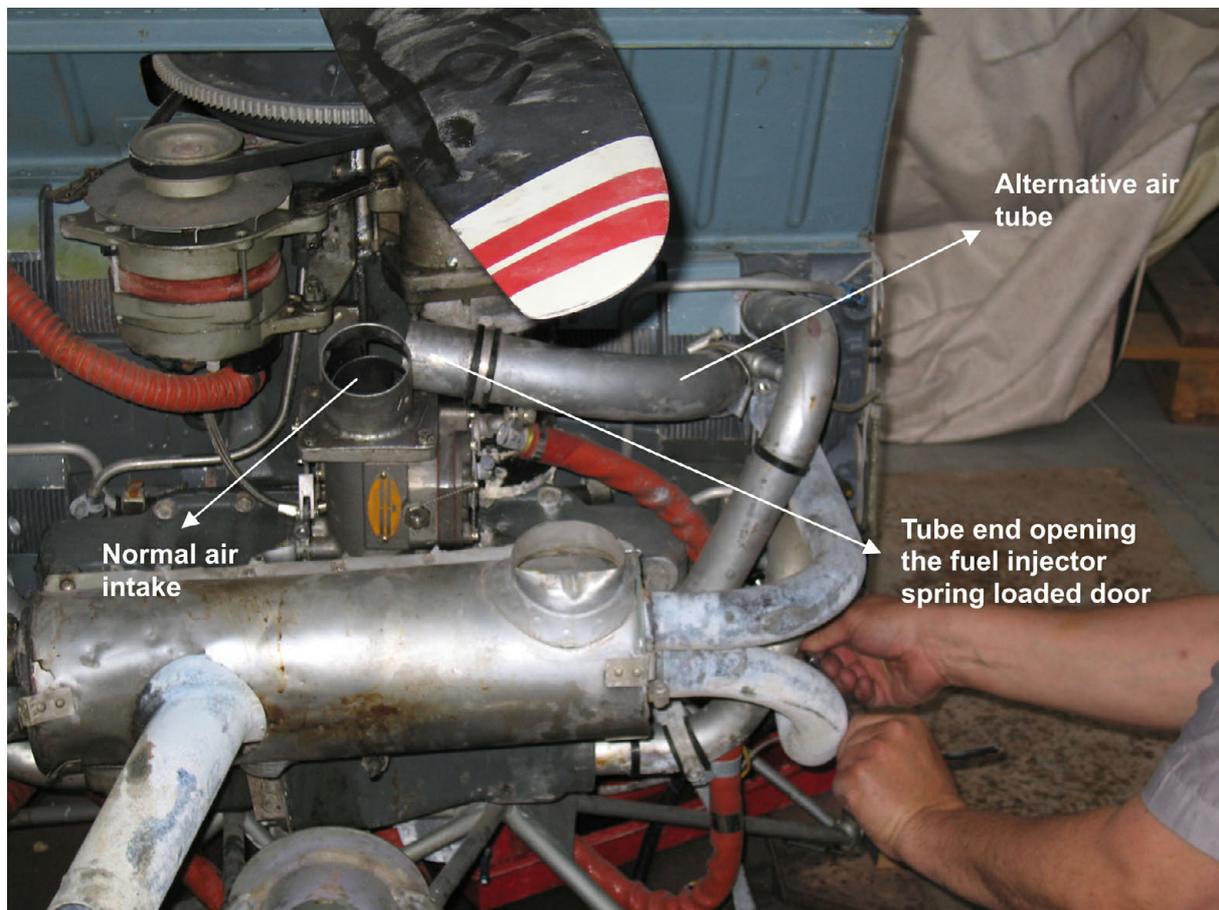
Figure 2. Alternative air tube

Of particular interest during the dismantling was the alternative air tube, which seemed to channel air from number 2 cylinder's cooling fins to the engine intake. One of the tube's ends was in contact with the engine intake, which was keeping the fuel injector's spring-loaded door open. Figure 2 shows the as-found condition of the tube.

The disassembly of the engine revealed that the alternative air tube was not in the correct position; it was opening the alternative air spring-loaded door to the fuel injector. This may have been due to the improper installation of the tube or to a shift in position resulting from a jolt which moved the alternative air tube from its initial position.

In any case, the admission of hot air to the engine would only result in a drop in power, and not a stoppage of the engine.

The cause of the accident, therefore, is considered to be the admission of hot air to the engine while in flight, resulting in a loss of power from which the pilot could not recover.

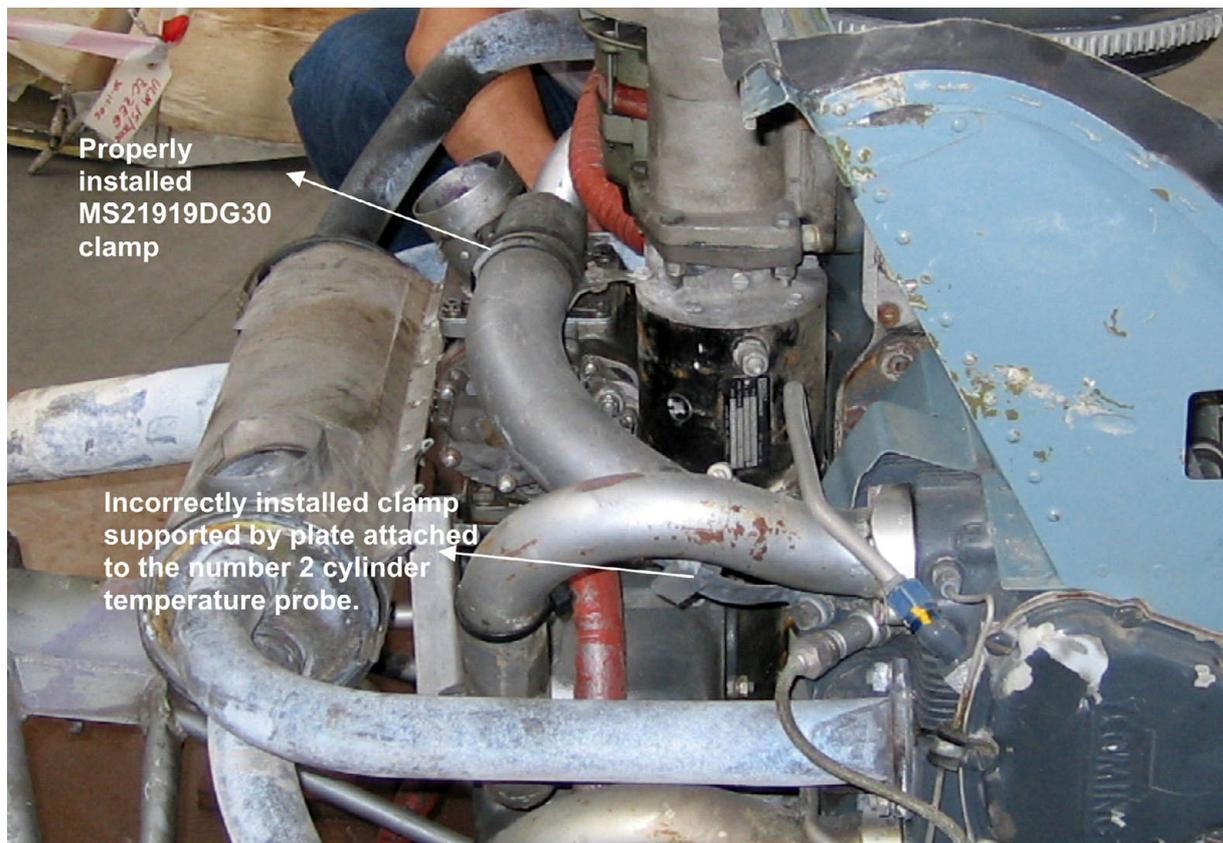
Figure 3. Alternative air tube installation

The aircraft manufacturer also provided information on said tube's installation. Specifically, it stated that in order to install it, the tube's length and shape had to be shop developed prior to attaching it with three MS21219-DG clamps. The ends of the tube had to be 2 inches away from the alternative air inlet port and 0.5 inches away from the cylinder head. This description did not match the actual installation conditions in the aircraft, as seen in Figure 3.

Note in the figure how the tube is more than 0.5 inches away from the cylinder head and that one of the clamps, in addition to being incorrectly installed, is not of the specified type.

When the tube was inspected, it was noted that the assembly was inconsistent with the manufacturer's instructions, in that a wrong clamp was used and the tube was not attached as specified in the instructions. Maintenance personnel, however, assured that the tube was properly situated during the last engine maintenance activity performed in July 2006, meaning that, for some reason, between that date and the time of the accident, the tube had probably shifted position and opened the alternative air spring-loaded door on the fuel injector.
