DATA SUMMARY

Registration	BGA 4843
Type and model	SCHEMPP HIRTH DISCUS 2A Glider
Operator	Private

REPORT

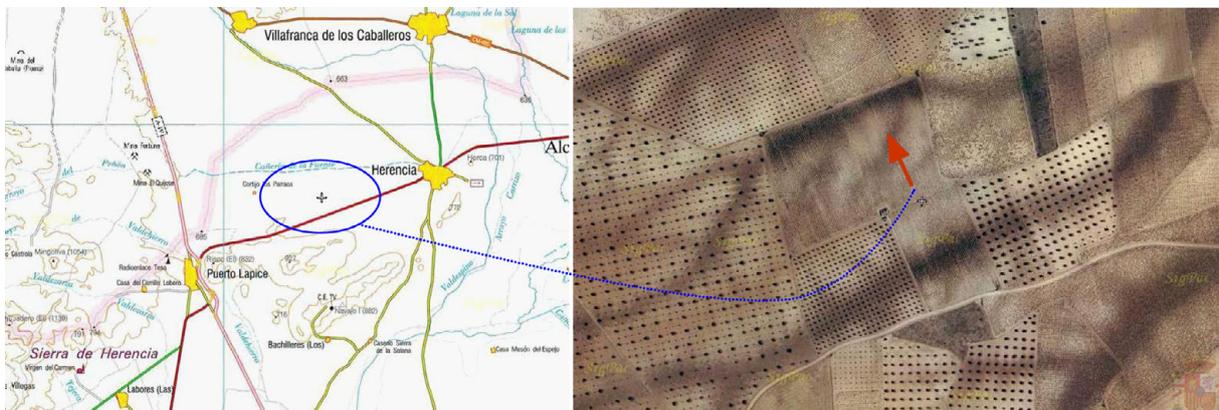
The aircraft's wings and the tail were damaged as a result of striking the metallic posts. There was a significant loss of gelcoat, possible delamination and considerable damage to the leading edge of the tail. There was damage to various parts of the fuselage, with a loss of gelcoat, especially along the underside.

Figur3 1. BGA 4843 landing spot

The accident is considered to have resulted from an emergency landing in a vineyard field whose physical characteristics were unsuitable for a safe landing. This landing was necessary when the flight conditions were deteriorated, with an excessive drop in altitude due to a lack of rising thermals. The pilot's decision to land in that place was conditioned by the lack of fields with suitable characteristics in the surrounding area.
