Report A-025/2007

Accident involving
a Bell-212 aircraft,
registration EC-FBM,
operated by Helisureste,
on 13 June 2007, in Oñati
(Guipúzcoa)

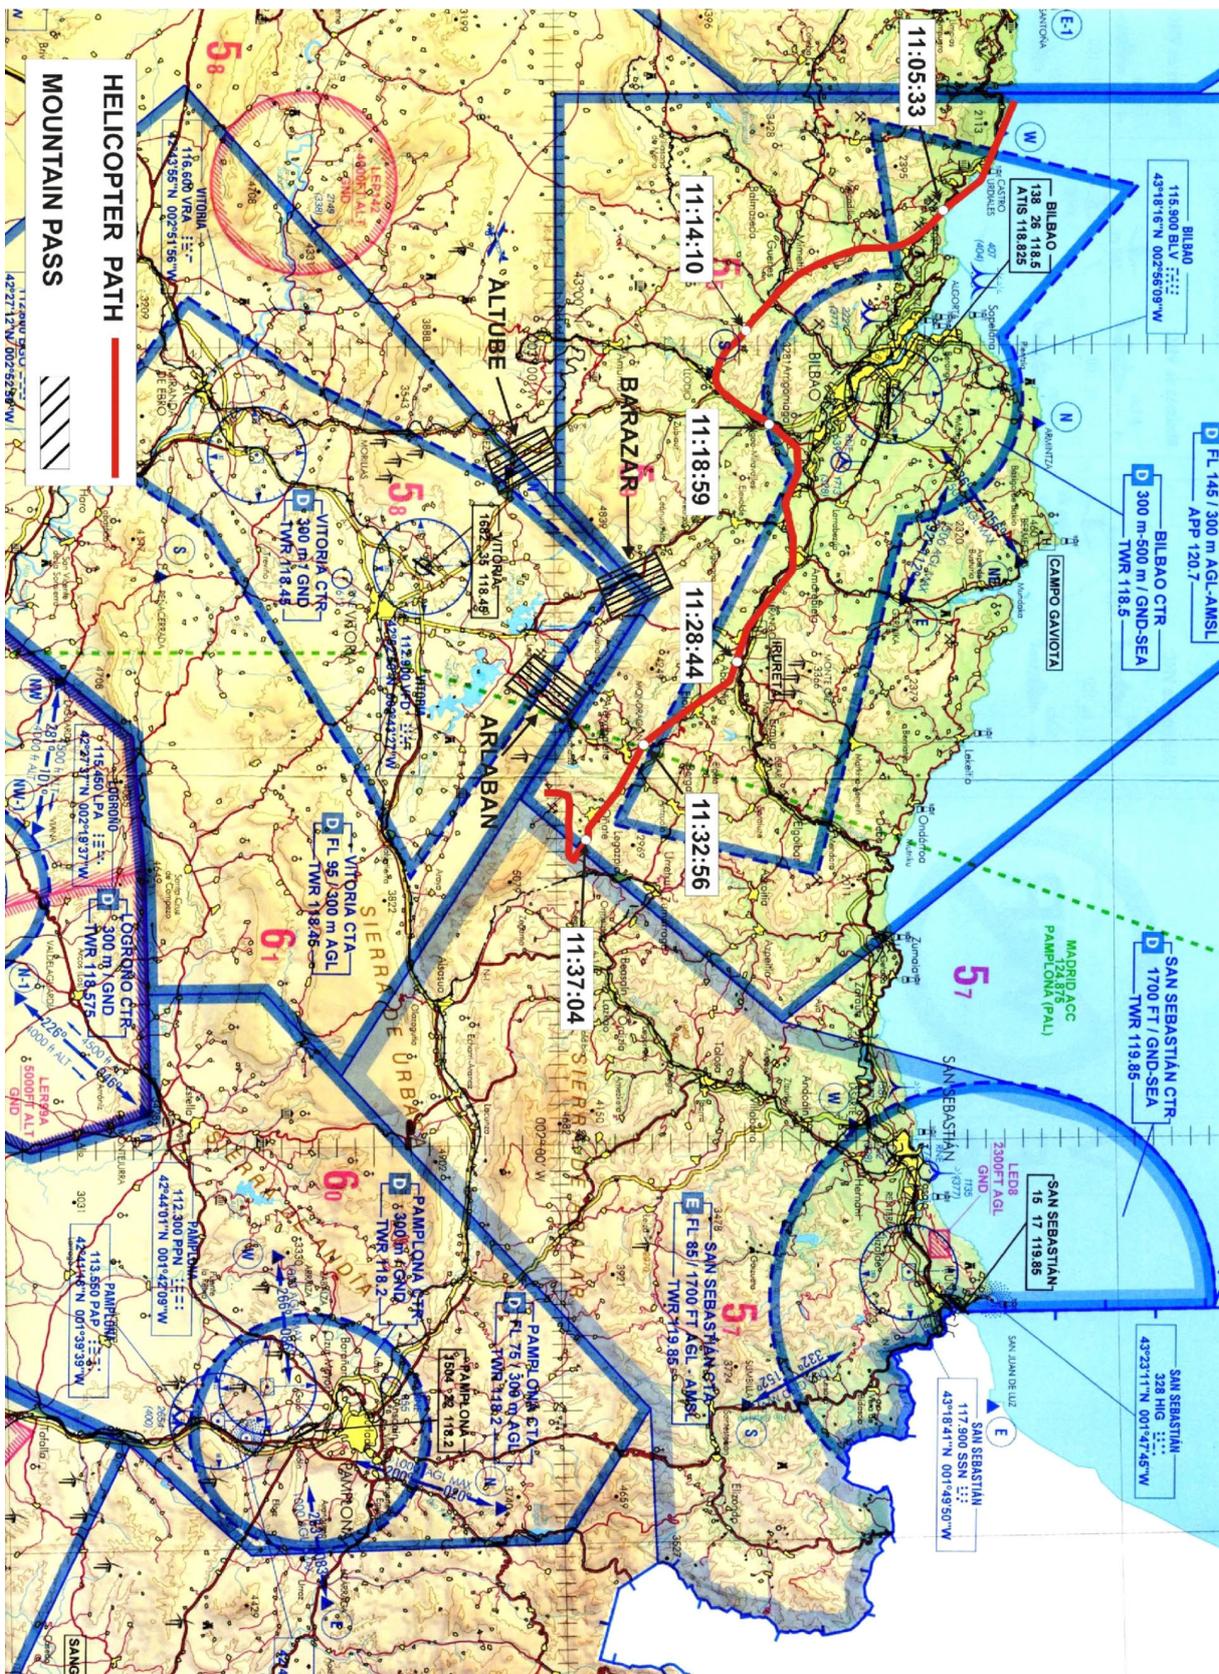
Figure 1. Path taken by helicopter from Point W and location of mountain passes

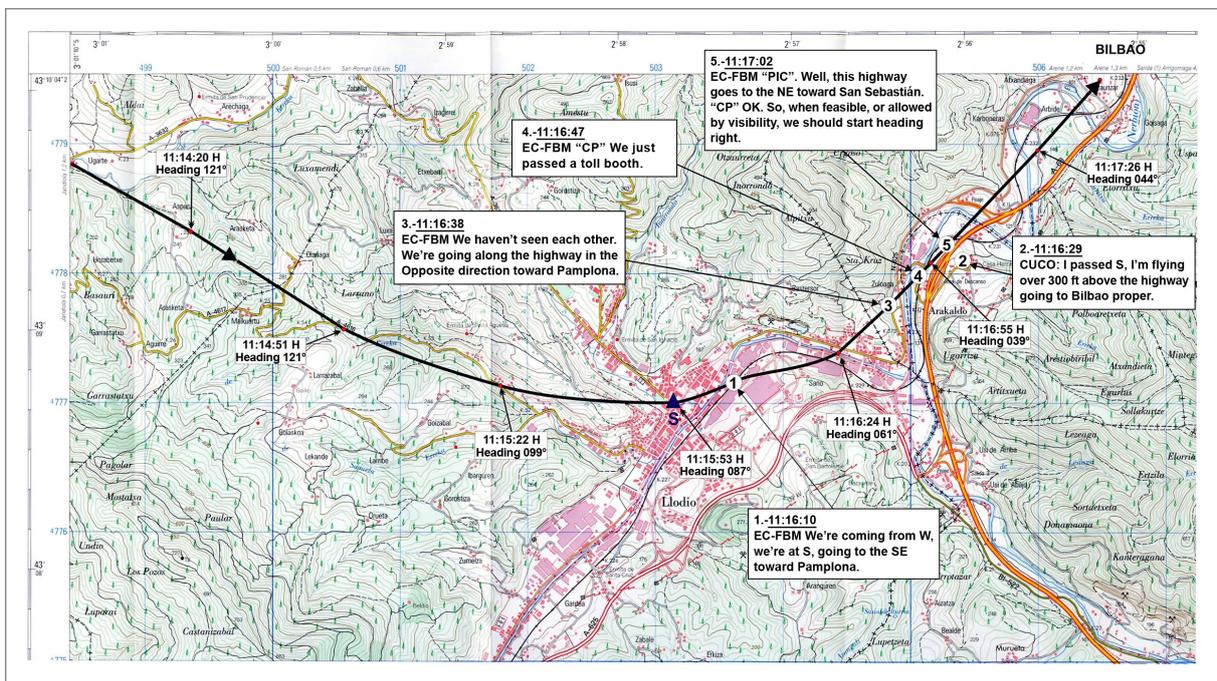
At Point S the crew changed course to the NE, and once in the vicinity of Amorebieta, while flying to the SE, acknowledged via CUCO 34X the message to contact Vitoria Tower on 118.5 MHz. There was no further contact with Bilbao Tower.

Figure 2. Route via Point S of the Bilbao CTR and communications between Helicopters EC-FBM and CUCO 34X

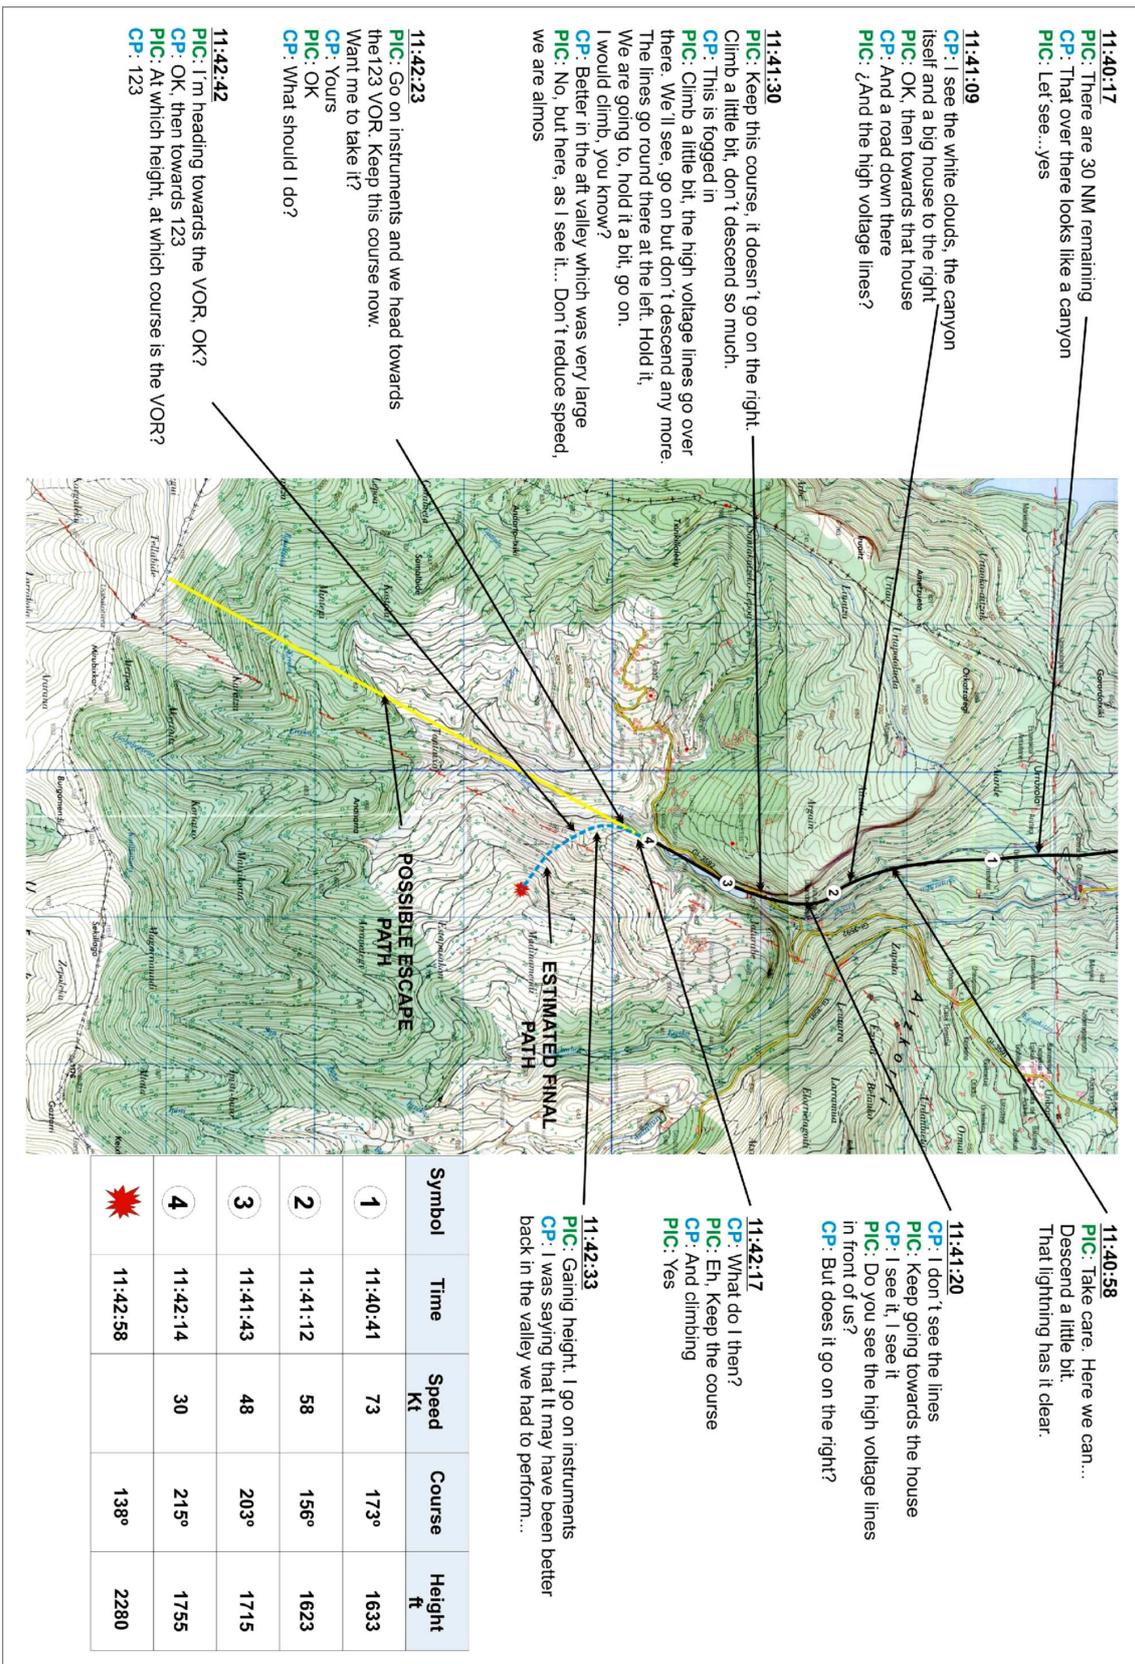
Seconds later they noted that the visibility had worsened because the clouds were staying close to the mountains, so they decided to turn around and go back along the same path. Two minutes later the Captain said: “This valley ends here, we have to find another way, we can’t get through here, maybe this way”, after which they headed for the Araotz River valley.

Figure 3. Estimated final leg of the helicopter's path, with indication of the possible escape path

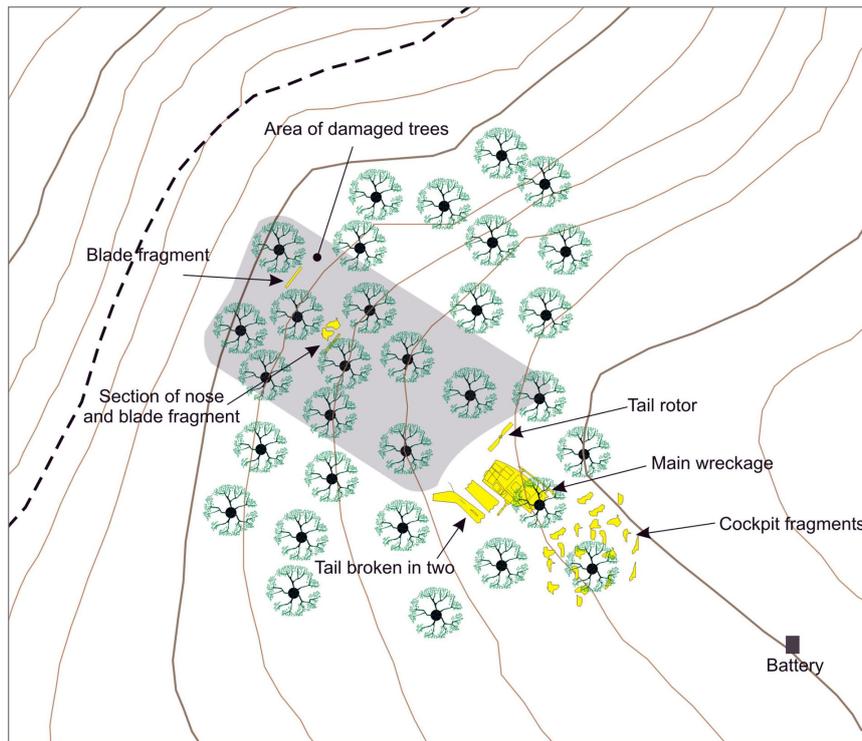
A visual inspection of the area revealed that the first impact had been by one of the main rotor blades against a pine tree that was located downhill, some 100 m from the site where the main wreckage was found and 30 m lower in elevation. The gradient between the two points was 30%.

A few meters beyond this first impact point was the second, where the helicopter struck three more trees.

From that point on there was debris from the blades and specks of fuselage paint. The helicopter's path then progressed full into the forest, such that the impacts against the trees were increasingly frequent.

Figure 4. Diagram of debris field

Part of the aircraft's nose, fragments from the cockpit glass and more pieces from the main rotor were found 35 m away from the first impact. From that point on until the site of the main wreckage, there was a constant stream of debris from the aircraft that included fragments from the blades, doors, fairings, glass and one of the cyclic controls.

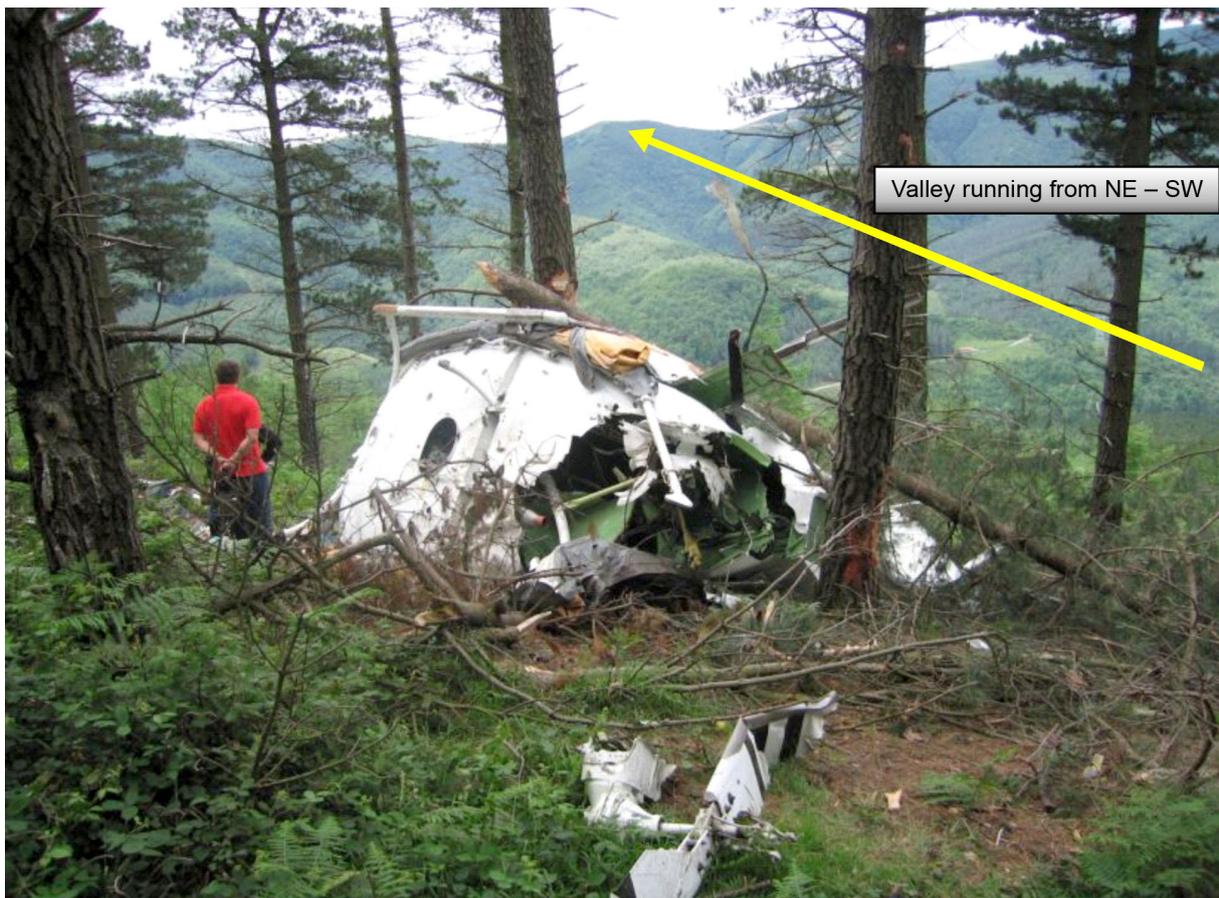
Most of the material on both main rotor blades detached, leaving only the leading edge, which was severely bent. The tail rotor was alongside the main wreckage and had detached during the final impact. The tail cone was broken in two and also situated next to the aircraft. Due to the severity of the damage, it was not possible to check the continuity of the controls or to check the positions of the engine controls or the indications.

Figure 5. Photo of main helicopter wreckage and the southern end of the Araotz River valley

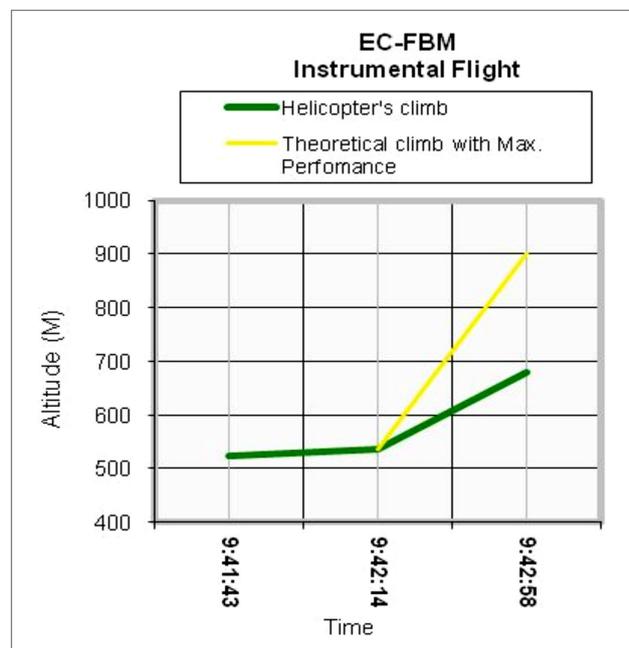
Figure 6. Graph of helicopter’s climb during final moments of flight and theoretical climb applying the aircraft’s maximum performance

Flying with the helicopter between mountains and in adverse visibility conditions, losing outside references and transitioning to instrument flight, the crew should have performed a controlled maneuver to reach the area minimum altitude for that grid or an altitude that would have allowed them to fly in VFR conditions. This required initiating a climb as quickly as possible using the optimum climb rate based on the helicopter's performance while maintaining course. The crew, however, did not react properly and continued flying as if they were in an obstacle-free area.
