DATA SUMMARY

Date and time	Thursday, 21 June 2007; 18:40 local time¹
Site	Abanilla (Murcia)

Registration	EC-HYM
Type and model	BELL 412
Operator	Helicópteros del Sureste, S. A.

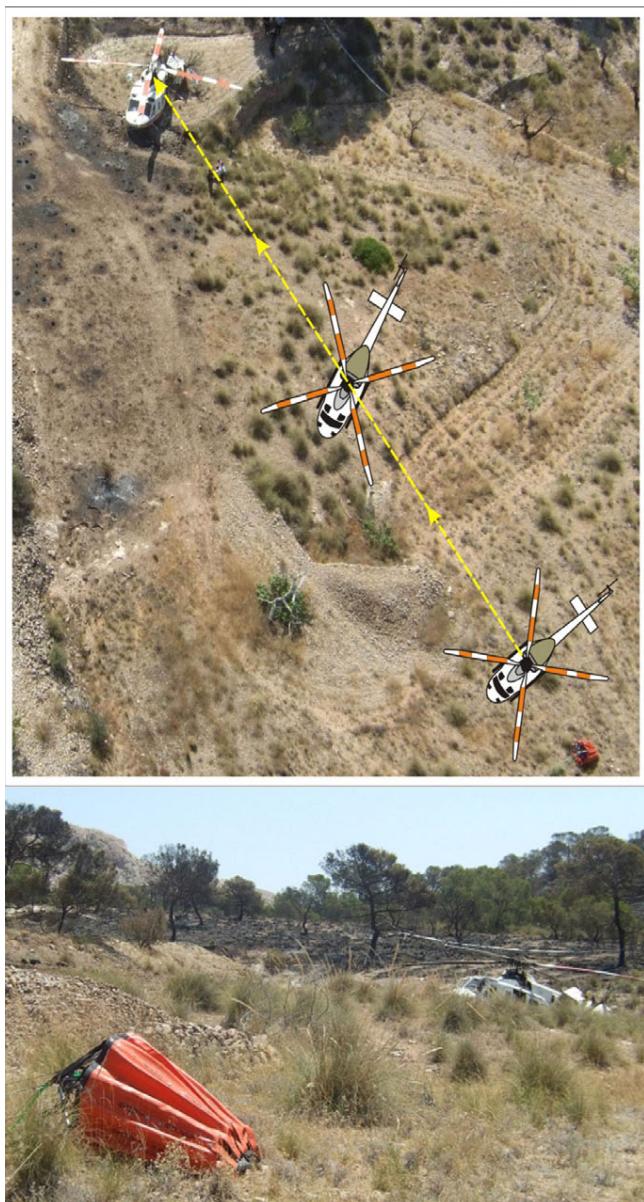
Figure 1. Relative positions of helicopter and bambi bucket

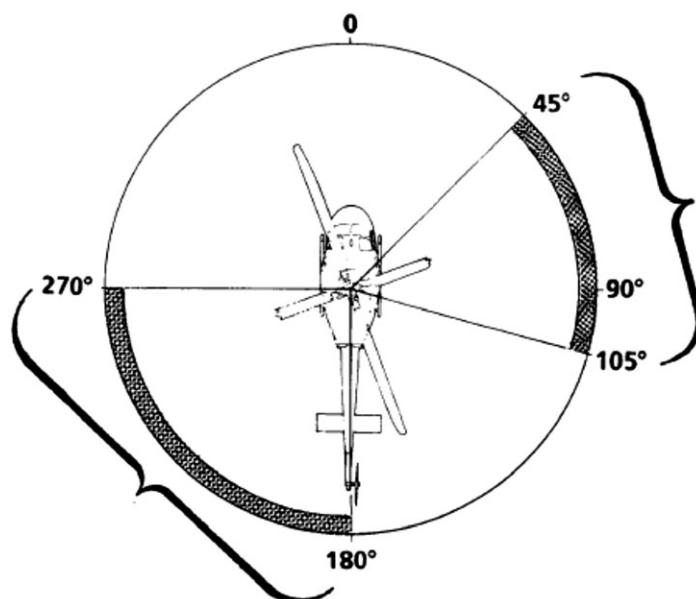
The flight manual specifies that the maximum allowed wind speed is 35 kt (see Figure 2) for a density altitude equal to or below 3,000 ft when the wind is from the left aft quadrant or from a relative angle between 45° and 105°. It also states that while hovering when the helicopter is subject to ground effect, the longitudinal motion of the cyclic lever is critical when the wind is from said range of angles, and can interfere with the proper operation of the AFCS if ATT mode is engaged. During the investigation it was not possible to determine the system's mode of operation.

Figure 2. Wind limitations

When the vibrations occurred, the wind was blowing from the helicopter's left aft quadrant with an intensity, including the gusts, far below the maximum allowed. It seems, therefore, that the wind did not have a determining influence on the longitudinal cyclic control that could have resulted in any type of vibration.

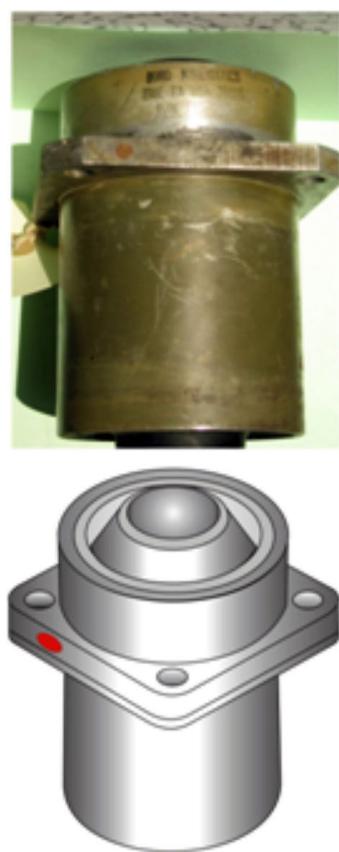
Figure 3. Part of a mount

There was corrosion on the inner wall of the outer surface of the front left mount housing, which had caused part of the outer cover of the elastomer material to detach.

The depth of the cracks on the elastomer material of the mounts was checked. Only the front left mount was within specified limits (the maintenance manual states that the mounts must be replaced if the depth of the cracks exceeds 0.25 inches).

When the distance (height) between the upper ends of the internal and external parts of the mounts was measured, it was noted that none of the four mounts complied with design requirements.

The elasticity indices, both static and dynamic, of the mounts were also checked. It was noted that the static elasticity index on two mounts was below the range required in at least one direction, and three had dynamic elasticity indices outside design requirements. The manufacturer reported that although the mounts function while hovering, the fact that the elasticity indices on some of them were below the required range along at least one axis could result in a change in the way the assembly dampens vibrations from the transmission, such that it could resonate with the main rotor vibrations causing excessive lateral movement and hampering control of the helicopter.

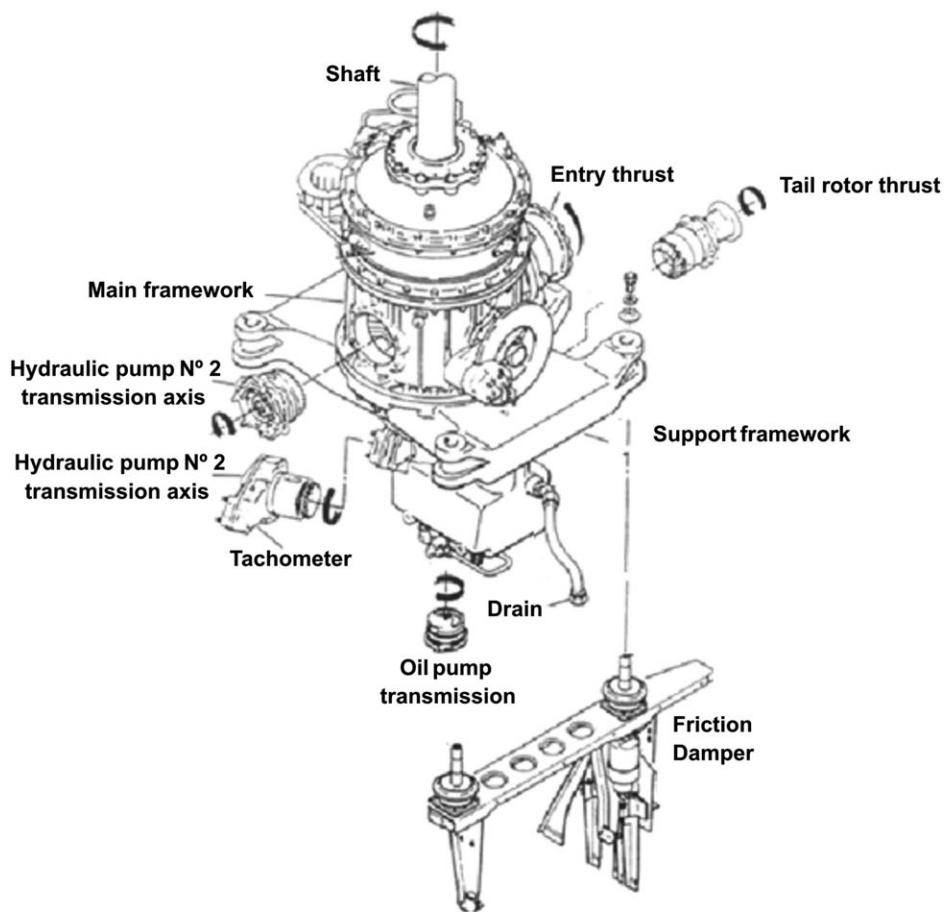
Figure 4. Support mount for structure and gearbox

The four mounts were disassembled, which revealed that the bolts in the front left mount had been swapped. The front left bolt was short instead of long, and the two rear bolts were long instead of short. The right aft mount also had the wrong right front bolt (long instead of short). Despite this, there were no signs of fretting between the

Another factor was the deterioration evident in the four mount assemblies, since one was corroded along its inner diameter, which had led to significant deterioration of the elastomer to the point that it was no longer within design specifications for static or dynamic spring rates. It is very likely that the corrosion resulted from water penetrating inside the mounts during all the time that the helicopter was out of service due to an improper state of preservation, and that this fact also contributed to the index of elasticity of some of the mounts being below minimum requirements in at least one direction.

On 20 July 1992, the manufacturer issued Technical Bulletin 412-92-111, which affected a certain number of helicopters with serial numbers that included 33045, and which recommended that any mounts with part number 204-031-927-105 be replaced by those with part number 204-031-927-107, as these offered improved performance in absorbing the vibrations transmitted by the main rotor. According to the bulletin, there was no flight hour prerequisite to carry out the replacement, though it did mention that both types of mounts could not be used at the same time. (On 5 January 2009, Bell issued Alert Service Bulletin 412-09-132, removing all -105 pylon mounts from service, replacing them with -107 mounts).
