DATA SUMMARY

Registration	EC-FTJ
Type and model	SOCATA TOBAGO TB-10
Operator

REPORT

Date of approval	30 September 2008
------------------	--------------------------

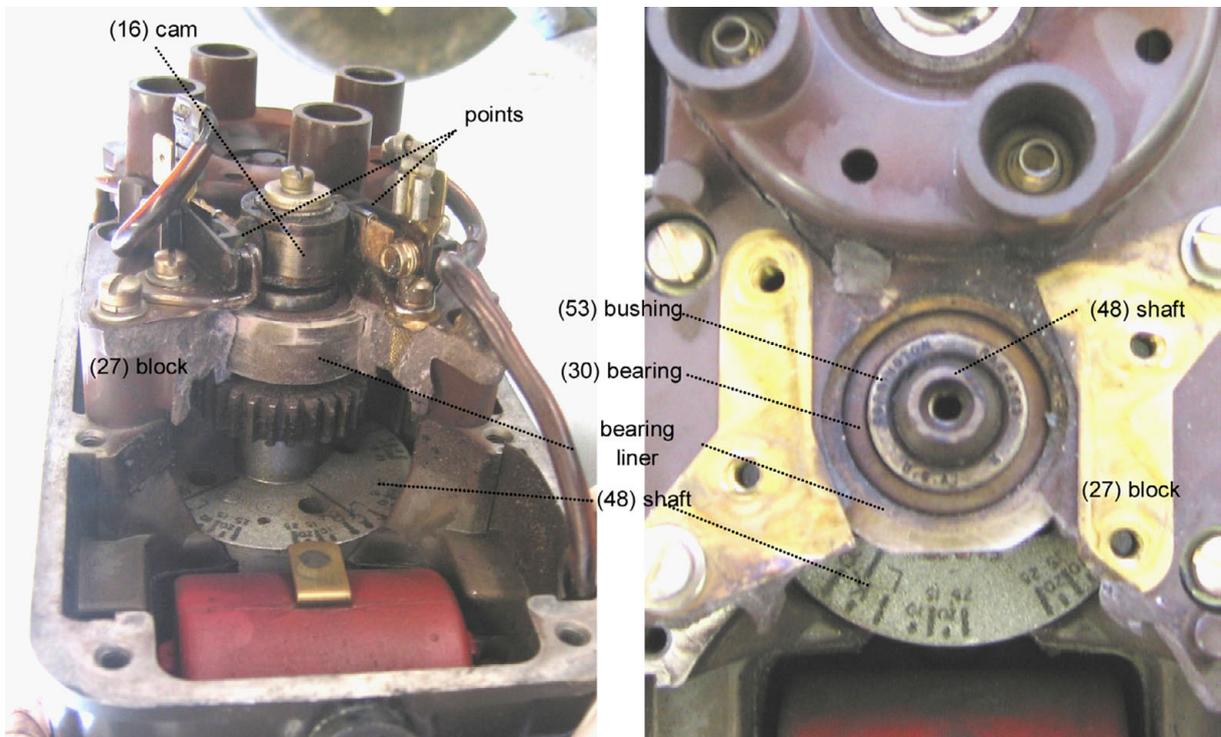
Figure 1. Damage to distributor block

The initial inspection following the incident revealed that the distributor block, P/N 10-682054, had broken in two down its centre, where the magneto shaft is housed. This fracture had left exposed the metallic bearing liner that sits between the roller bearing and the plastic material from which the block is made. During the disassembly of the magneto it was noted that both the bearing liner and the roller bearing had bound to the shaft and were spinning with it.

The bearing (30 in Figures 1, 2 and 3) showed obvious signs of intense overheating and friction with deformation and loss of material in the rollers, most of which had come loose from their housing. Two diametrically opposed friction marks were found on the contact face between the bearing and its liner in the distributor.

The bushing (53 in Figures 1 and 3), which rotates inside the bearing, had severe friction marks consistent with the damage in the roller bearings.

The plastic material in the distributors block was fretted due to friction in the central area where the shaft is housed. The magneto shaft was spinning off-centre at the distributor end and the entire area showed signs of overheating. One of the platinum points did not open and the other opened incorrectly.

The damage found after the incident showed that the roller bearing and its liner in the distributor had overheated and fused together with the bushing. This resulted in having these two normally-fixed components rotate with the bushing, and therefore with the shaft, which are the rotating parts within the bearing. The rotational movement

produced by the magneto shaft must have been transmitted along the shaft-bushing-bearing-liner assembly, which led to a torsion movement in the distributor block, resulting in its fracture into two parts and the loss of the block's plastic material due to friction.

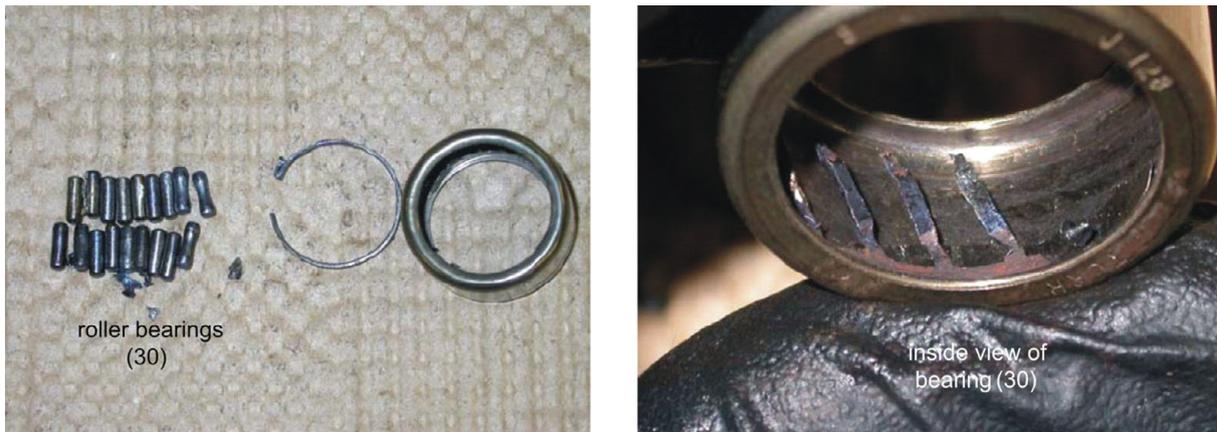
Figure 2. Damage to bearing (53)

The two diametrically-opposed friction marks found on the outer face of the bearing in contact with its liner in the block suggest an off-centre position with respect to the liner. This would lead to uneven contact between the bushing and the internal face of the bearing, since the rotational axis of the bushing would not have been parallel to that of the bearing. In this condition, the bushing, as it rotated about the magneto shaft, would have had greater contact with some rollers than with others, resulting in excessive friction and heating in the bearing, as evidenced by the damage noted following the incident.

This eccentricity between the bearing and its liner in the block seems likely to have originated during the installation of the bearing inside the block, since that is the only time in the life of the block when the bearing is handled. This places the problem in the bearing installation process inside the distributor block by the manufacturer. The data, however, suggest that this was an isolated case. The manufacturer is not aware of any similar previous occurrences. In addition, the manufacturer has been performing evaluations of the processes and procedures for the manufacturing and installation of the bearing and magneto components, without finding any anomalies so there is not sufficient cause to conclude that the reliability of the system is compromised. As a result, no safety recommendations have been issued.

The most likely cause of the roller bearing failure was an off-centre installation of the bearing inside its liner within the distributor block. This resulted in uneven contact between the bushing and the rollers in the bearing.
