DATA SUMMARY

Date and time	Monday, 24 September 2007; 17:07 local time¹
Site	Dalias (Almeria)

Registration	F-BTVI
Type and model	MORANE SAULNIER MS 893 E

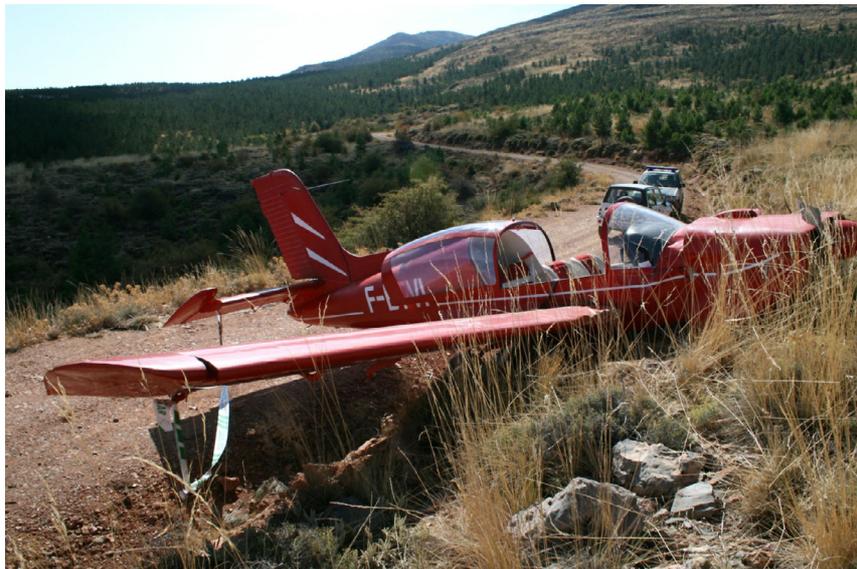
Figure 1. Condition of the aircraft after the accident

The aircraft was found in a southwesterly orientation, resting on its lower fuselage and perpendicular to a slightly inclined hill, with the front end pointing uphill. It appeared intact save for damage to the underside, the engine, the landing gear, which had bent backwards, the wing roots and the propeller.

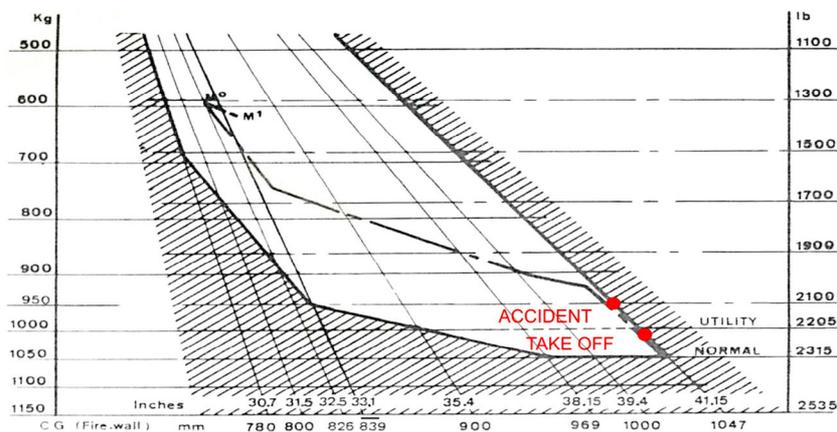
These values yield weights of 1,011 kg at takeoff and 951 kg at the time of the accident. The center of gravity in both cases was located at its aftermost limit.

Figure 2. Position of CG during takeoff and accident

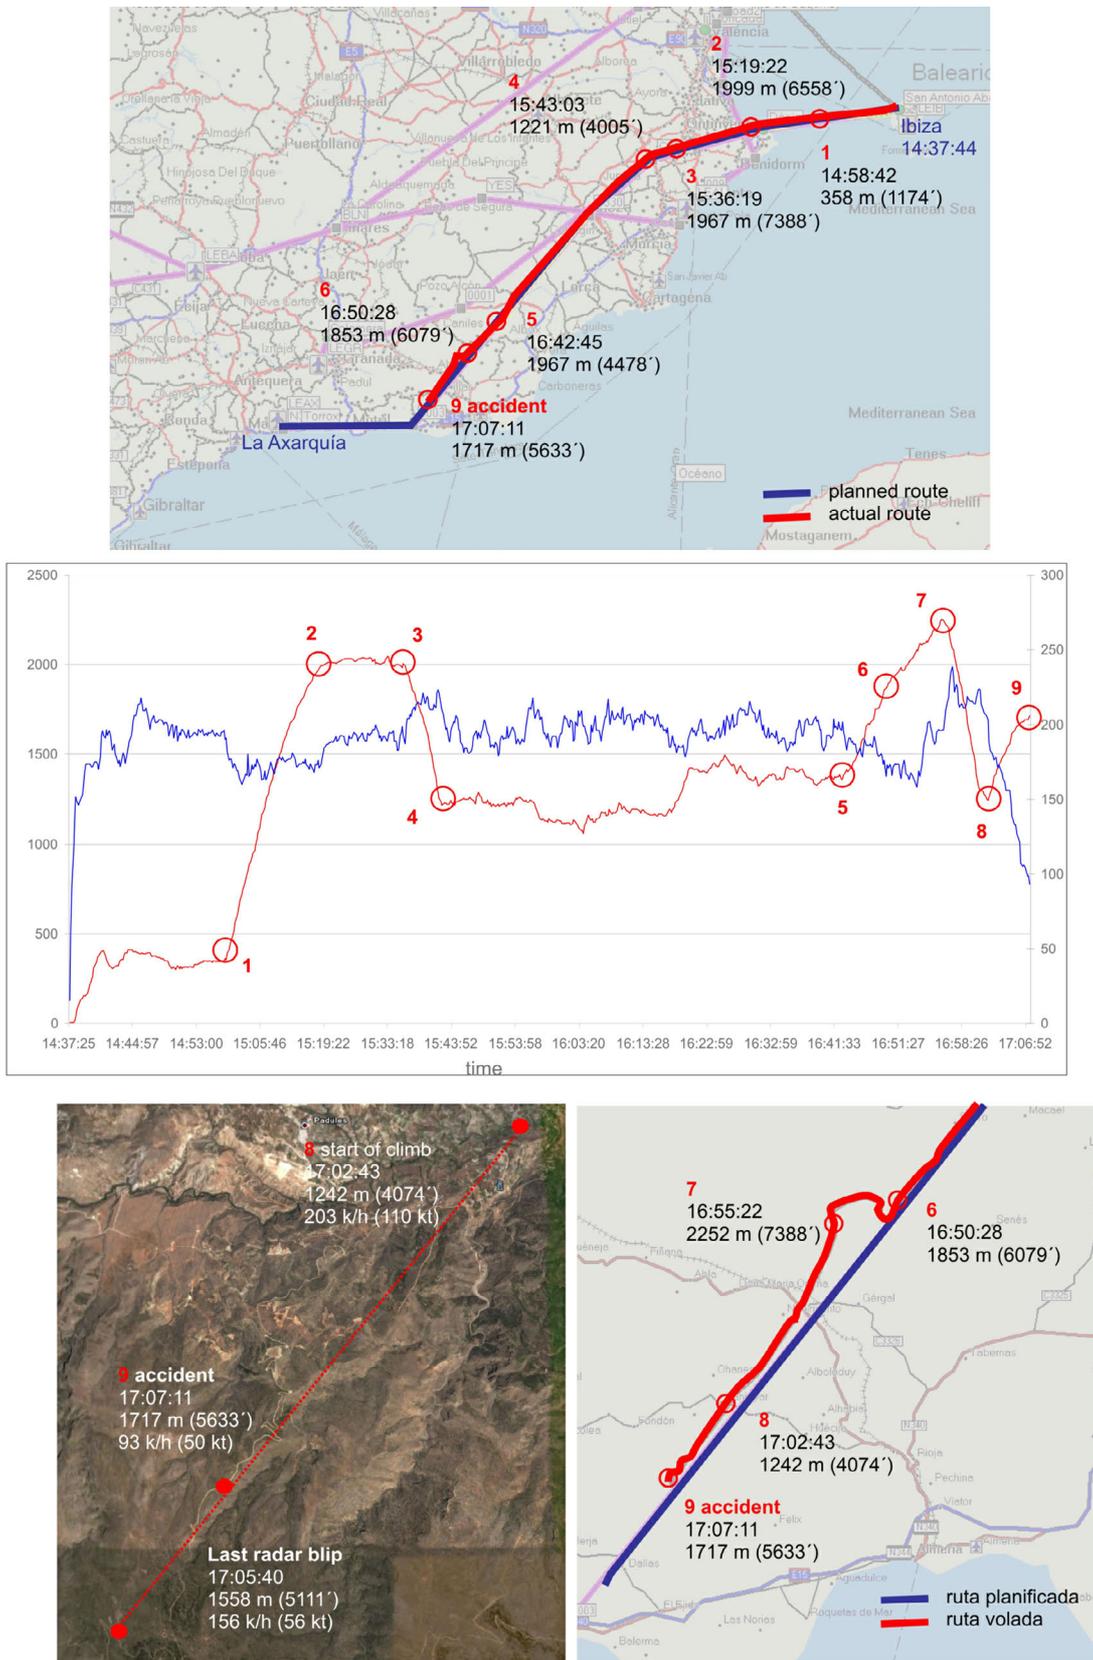
The pilot had a Garmin GPS receiver onboard which was undamaged by the accident, and which allowed for data from the accident flight to be downloaded. Among these data were the planned route from Ibiza to La Axarquia made the day prior to the flight. The data included waypoints along the route, but not altitudes, save for those associated with the departure and destination airports. As shown in Figure 3, the flight followed the planned route at an average speed of 200 k/hr. After taking off from Ibiza at 14:37:44, the aircraft climbed to 6,500-7,500 ft to enter the mainland over Denia (point 2). Once past the mountainous area, it descended to an altitude of 4,000 ft (point 4), which was maintained for one hour. At 16:42:45 (point 5), the aircraft initiated a climb and later a 10-minute detour so as to clear a mountainous area with elevations of 6,500 ft. The maximum altitude reached was 7,388 ft (point 7). After flying over this peak, the aircraft resumed the planned track and initiated a descent to 4,074 ft, reaching that altitude 7 minutes before the accident. At that moment (point 8), the aircraft was in the vicinity of Padules at an altitude of 4074 feet and an airspeed of 203 k/hr (110 kt). The final 5 minutes of the flight (points 8 and 9) took place in the increasingly mountainous region of the Gador Mountains, with elevations going from 700-800 meters up to 1,730 meters. The aircraft climbed from 4,074 ft to the 1717 meters at which the accident took place as it decelerated from 110 kt to 50 kt. The final course was 226° and the altitude indicated on the GPS was 1,717 meters, matching the actual elevation of the terrain.

Figure 3. Aircraft trajectory
